# Technical Service Bulletin

## 40 Cracking noise from front end when changing direction

40 22 43 2061464/3 June 9, 2022. Supersedes Technical Service Bulletin Group 40 number 21-23 dated February 16, 2021, for reasons listed below.

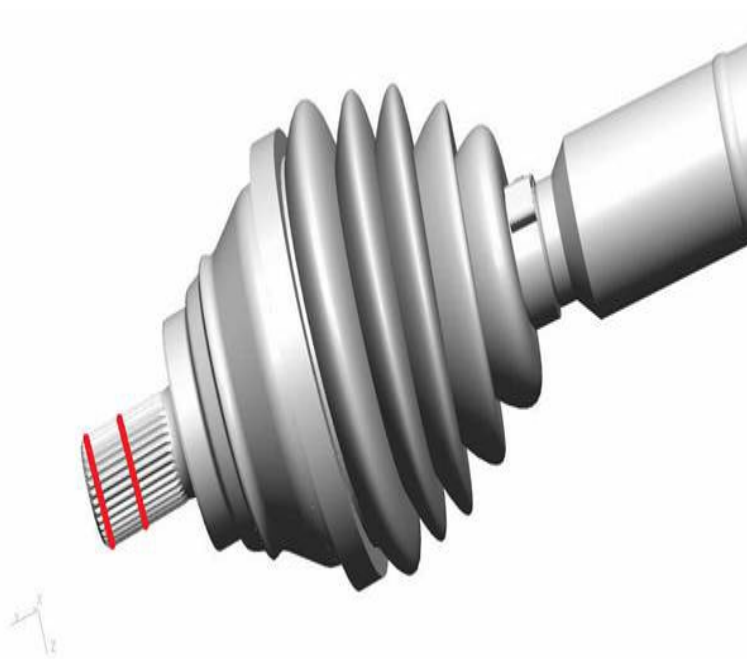
- When pulling away there is a one-off cracking noise from the front after changing direction.

Relative movement of the drive axle in the wheel bearings.

*Figure 1. Apply locking fluid around the threaded connection.*

3. Apply liquid locking fluid as shown in Figure 1 (red lines around the threaded connection).
