Technical Service Bulletin

01-18-13 - MIL ON DTC P0401, P2002 or P240F Exhaust Gas Recirculation Flow Insufficient

Release date: 6/14/2022

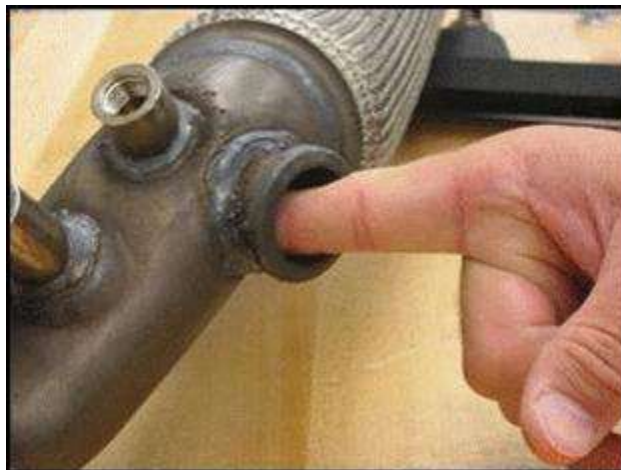
Figure 1

- Remove the EGR filter from the Diesel Particulate Filter (DPF) and swipe the inside of the exhaust pipe at the EGR filter connection point using a clean cloth or your finger. See figures 1 and 2 below.

If your finger or the cloth comes out with black soot:

- Replace the DPF & EGR filter together. The engine must be running correctly with no faults stored to perform the next steps.
- Read out 01 ECM control module OBD Basic Settings block 67 with engine at idle and at operating temperature. **Select activate and monitor field 3 when EGR is in the OFF position.**

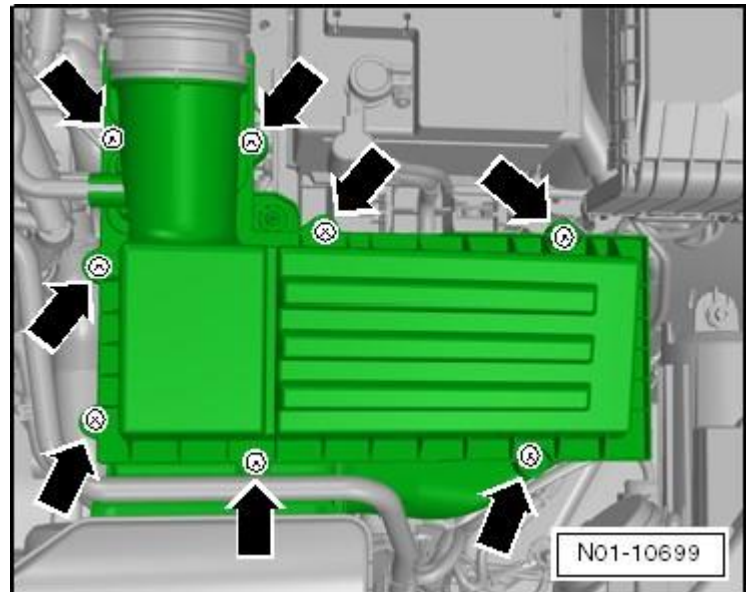
- Raise air filter upper section and remove airfilter element -1-.
Inspect air filter and if too contaminated with debris, advise customer to replace (non-warranty claimable item).
