Service Bulletin

Bulletin No.: 20-NA-148

Subject: Plastic to Metal Squeak/Creak Noise Heard Coming from the Driver or Passenger Side B-Pillar Area

Brand:	Model:	Model Year:		VIN:		Engine:	Transmission:
		from	to	from	to		
Chevrolet	Traverse	2020	2022			All	All

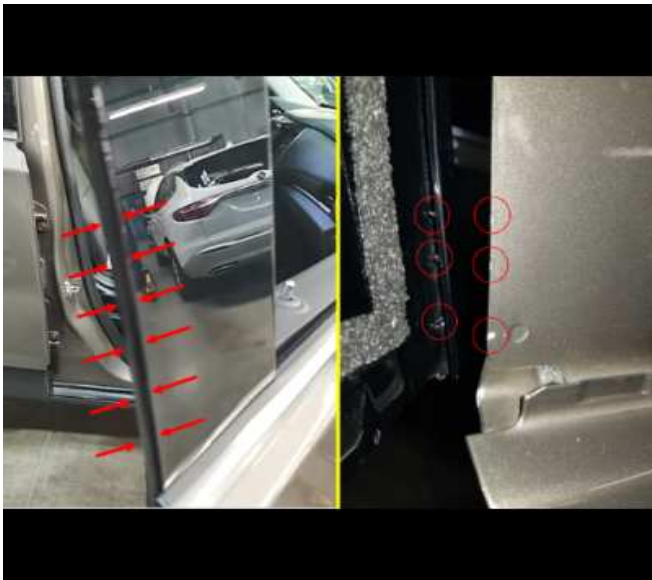
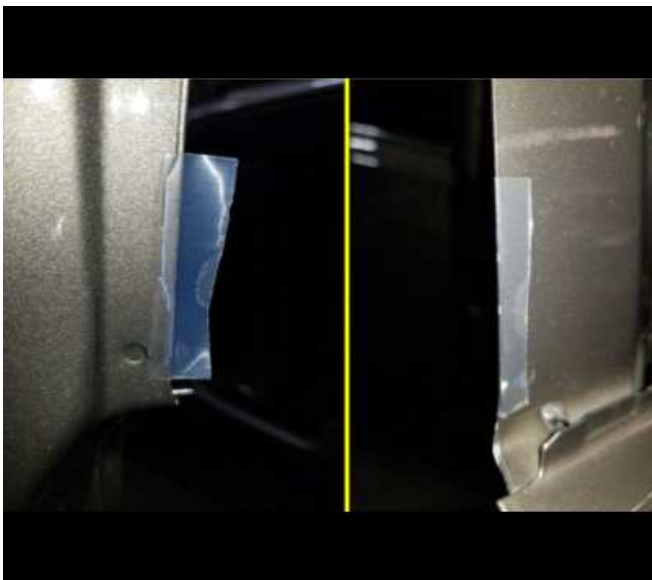
5633856

Note: The common area most effected is shown in the left graphic above, and visual wear markings that may be visible on the paint, which could assist with identifying affected areas, is shown on the right.

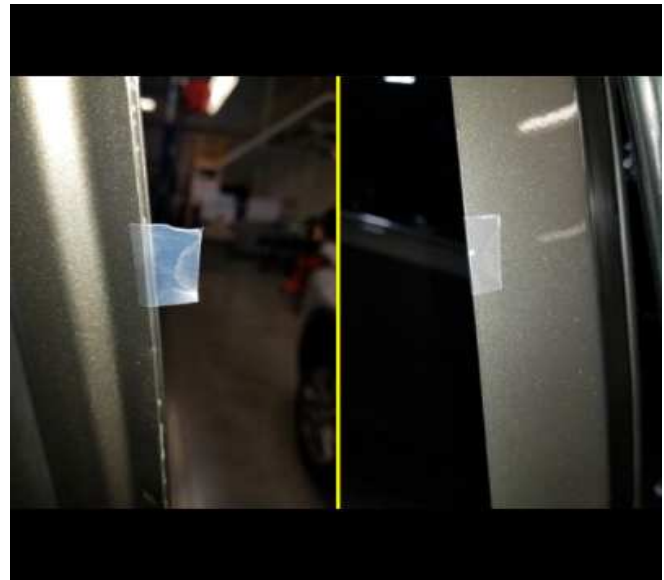
5633858

Note: Some examples of the common tape application locations are shown in the graphics above.

2. Apply strips of Kent Automotive Anti-Squeak Film Tape # KT13512, or an equivalent UHMW Polyethylene anti-squeak tape, to the affected areas on the B-Pillar of the front side door window frame where the rear applique connects.
