Service Bulletin

Bulletin No.: 21-NA-077

Subject: Information on Aero Shutter Related Diagnostic Codes

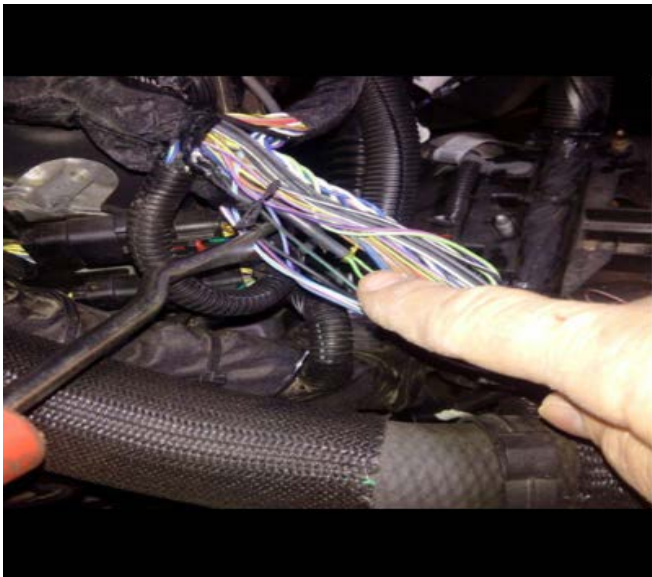
5821156

3. Check the integrity of the **J171 splice**. Moving this splice, even small amounts, can cause intermittent communication issues. If any issues are detected in the splice, repair the splice and report what was repaired.

Note: If the **J171 splice** is found to be an issue, replace the entire splice, do not attempt to repair it. Cut out the splice for part return and submit a photo, **taken prior to cutting the section where the issue has been detected**.

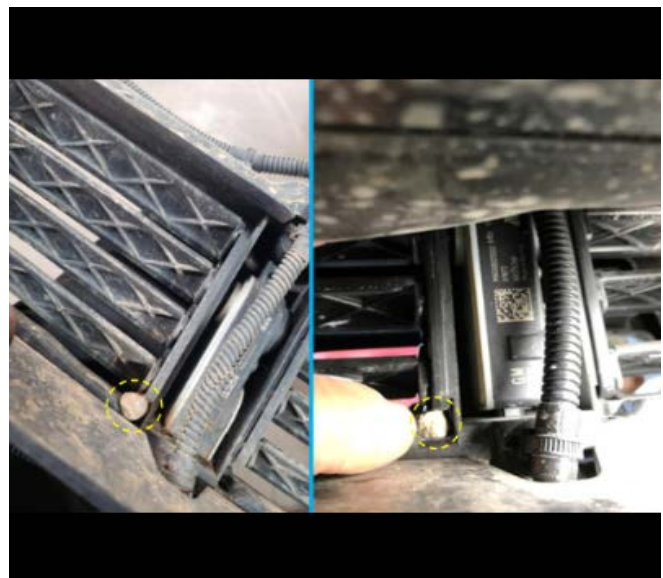
5821157

Note: For vehicles equipped with upper and lower shutters, the upper shutter, top passenger side louvre/vane is intentionally missing from the shutter assembly for airflow reasons. **DO NOT** replace the shutter for this reason.

1. Check for any debris in the upper and lower shutters. If found, please remove the debris.
2. If there is no debris evident, please look for a louvre/vane that is disengaged from the linkage. If the vehicle has a shutter with this condition, please engage the louvre/vane in the shutter assembly. If shutter is operational, DO NOT replace the shutter.
3. Check to see if the upper shutter in open position is binding on the air induction plenum. It is located on the driver's side upper behind the upper shutter. If this condition exists, secure the air induction plenum to structure behind, using a 2-stage push pin.
4. Check to see if the upper shutter is binding on the **HORN or BRACKET**. It is located on the passenger's side upper, behind the upper shutter

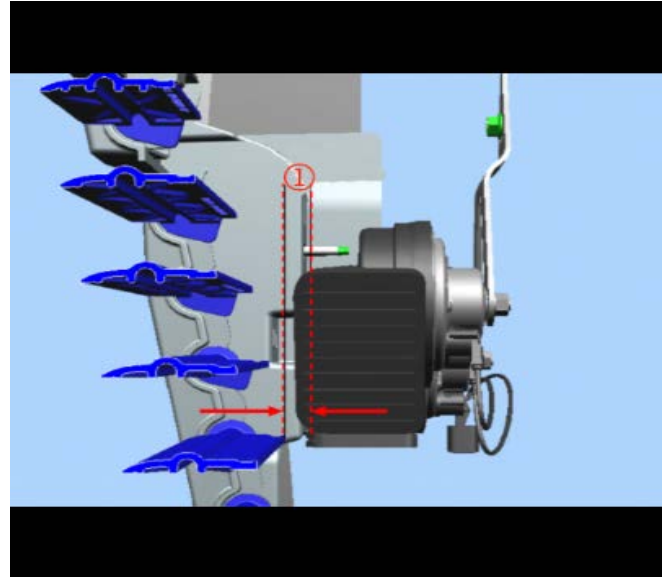
5880462

2. If there is no debris, please look for a louvre/vane that is disengaged from the linkage. If the vehicle has a shutter with this condition, please engage the louvre/vane in the shutter assembly. **DO NOT** replace the shutter.
3. Check to see if the upper shutter is binding on the **HORN or BRACKET**. It is located on the passenger's side upper, behind the upper shutter.

Important: Ensure there is at least 10 mm (0.40 in) clearance (1) between the shutter vane and horn. If there is NOT, bend the horn bracket away from the shutter until the 10 mm (0.40 in) of static clearance is achieved.
