Service Bulletin

Bulletin No.: 21-NA-286

Subject: Rear Hands-free Liftgate Feature Intermittently Inoperable or Difficult to Operate

Brand:	Model:	Model Year:		VIN:		Engine:	Transmission:
		from	to	from	to		
Buick	Envision	2021	2022

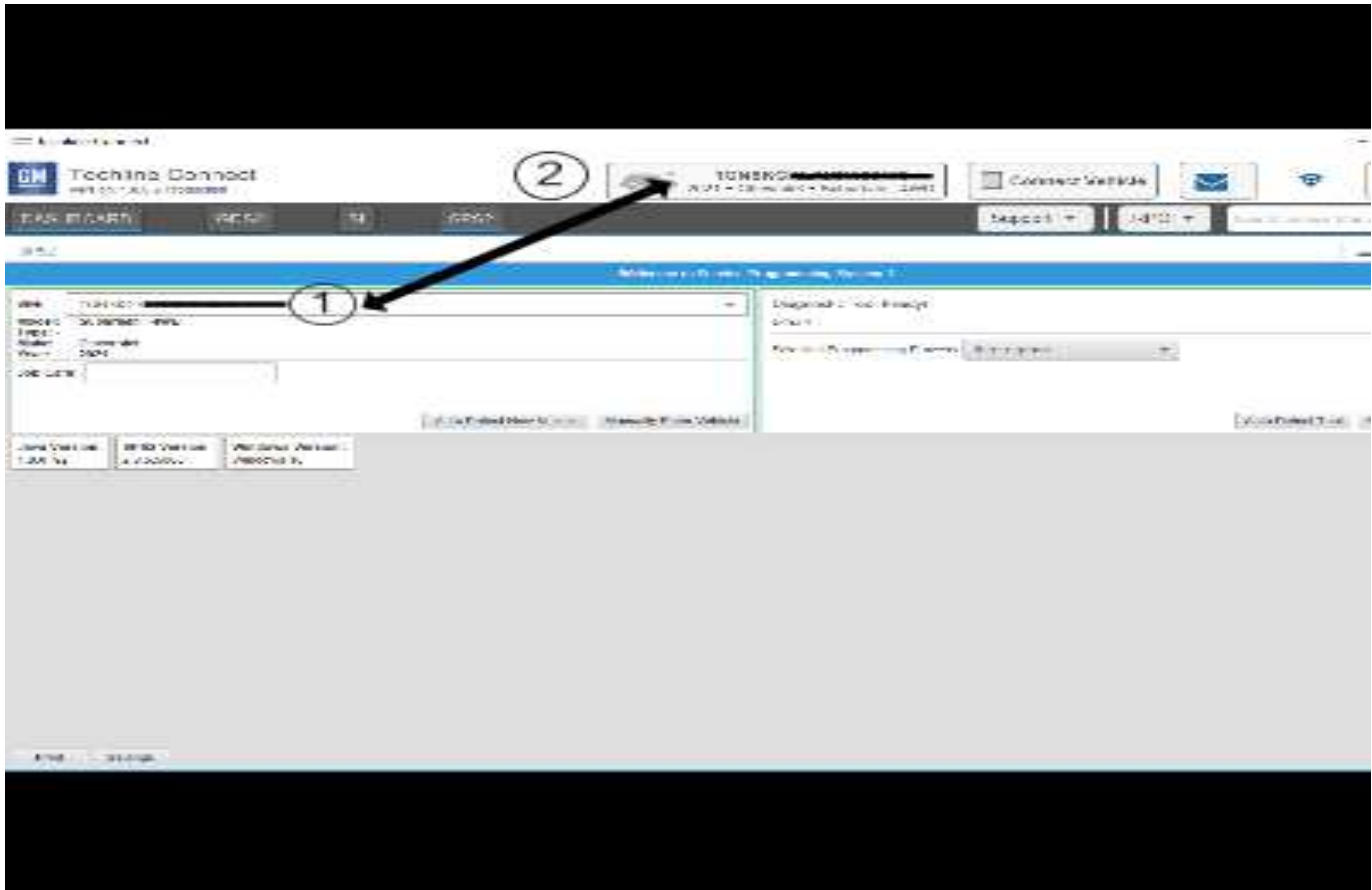
Caution: Be sure the VIN selected in the drop down menu (1) is the same as the vehicle connected (2) before beginning programming.

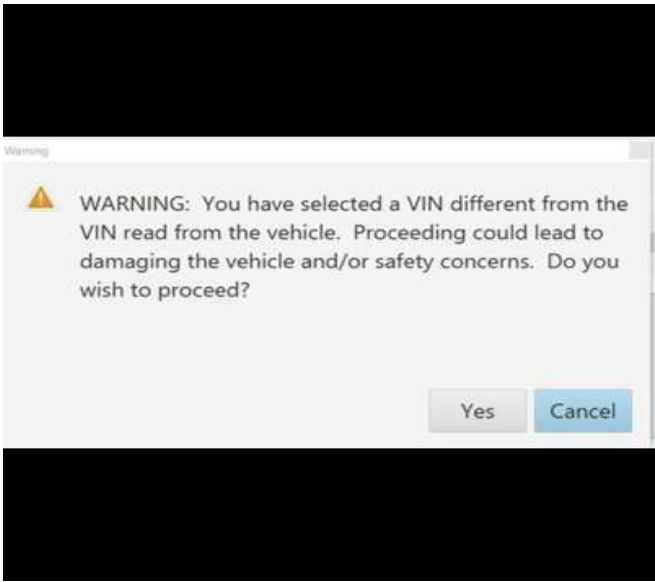
Important: If the vehicle VIN DOES NOT match, the message below will be shown
