STAR ONLINE PUBLICATION

Case Number: S2223000014 Rev B

Symptom/Vehicle Issue: Water Leaking From Overhead Console Or Headliner Microphone On Sunroof Equipped Vehicle

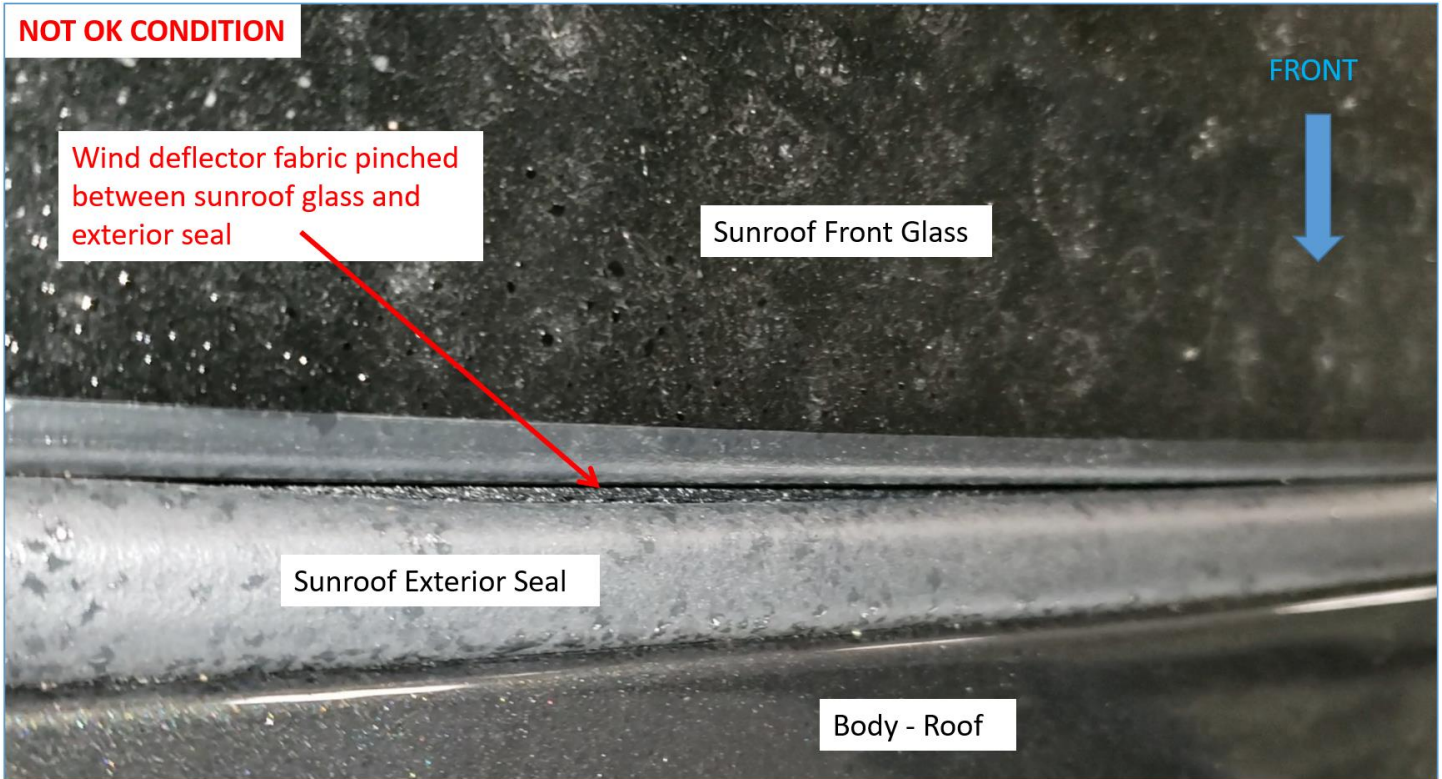
NOT OK CONDITION

Fig 1
Wind deflector fabric pinched. Incorrect installation.

Discussion: With sunroof glass in closed position visually inspect from top of roof the interface of front sunroof glass to sunroof exterior seal along the front for pinched wind deflector fabric (Fig 1). If wind deflector fabric is pinched between sunroof glass and exterior seal replace both the wind deflector and sunroof exterior seal. Next inspect the exterior seal for any areas where it has lifted up away from the body (Fig 2). If exterior seal is found to be lifted remove and replace the exterior seal. Next open sunroof glass and remove sunroof exterior seal (perimeter seal) by lifting up. Visually inspect for sunroof auxiliary seal trapped under body roof opening flange around entire perimeter of roof opening (Fig 3). If the auxiliary seal is folded and visible – sunroof frame will require removal to replace the auxiliary seal. See cut-away images (Fig 4 & 5).

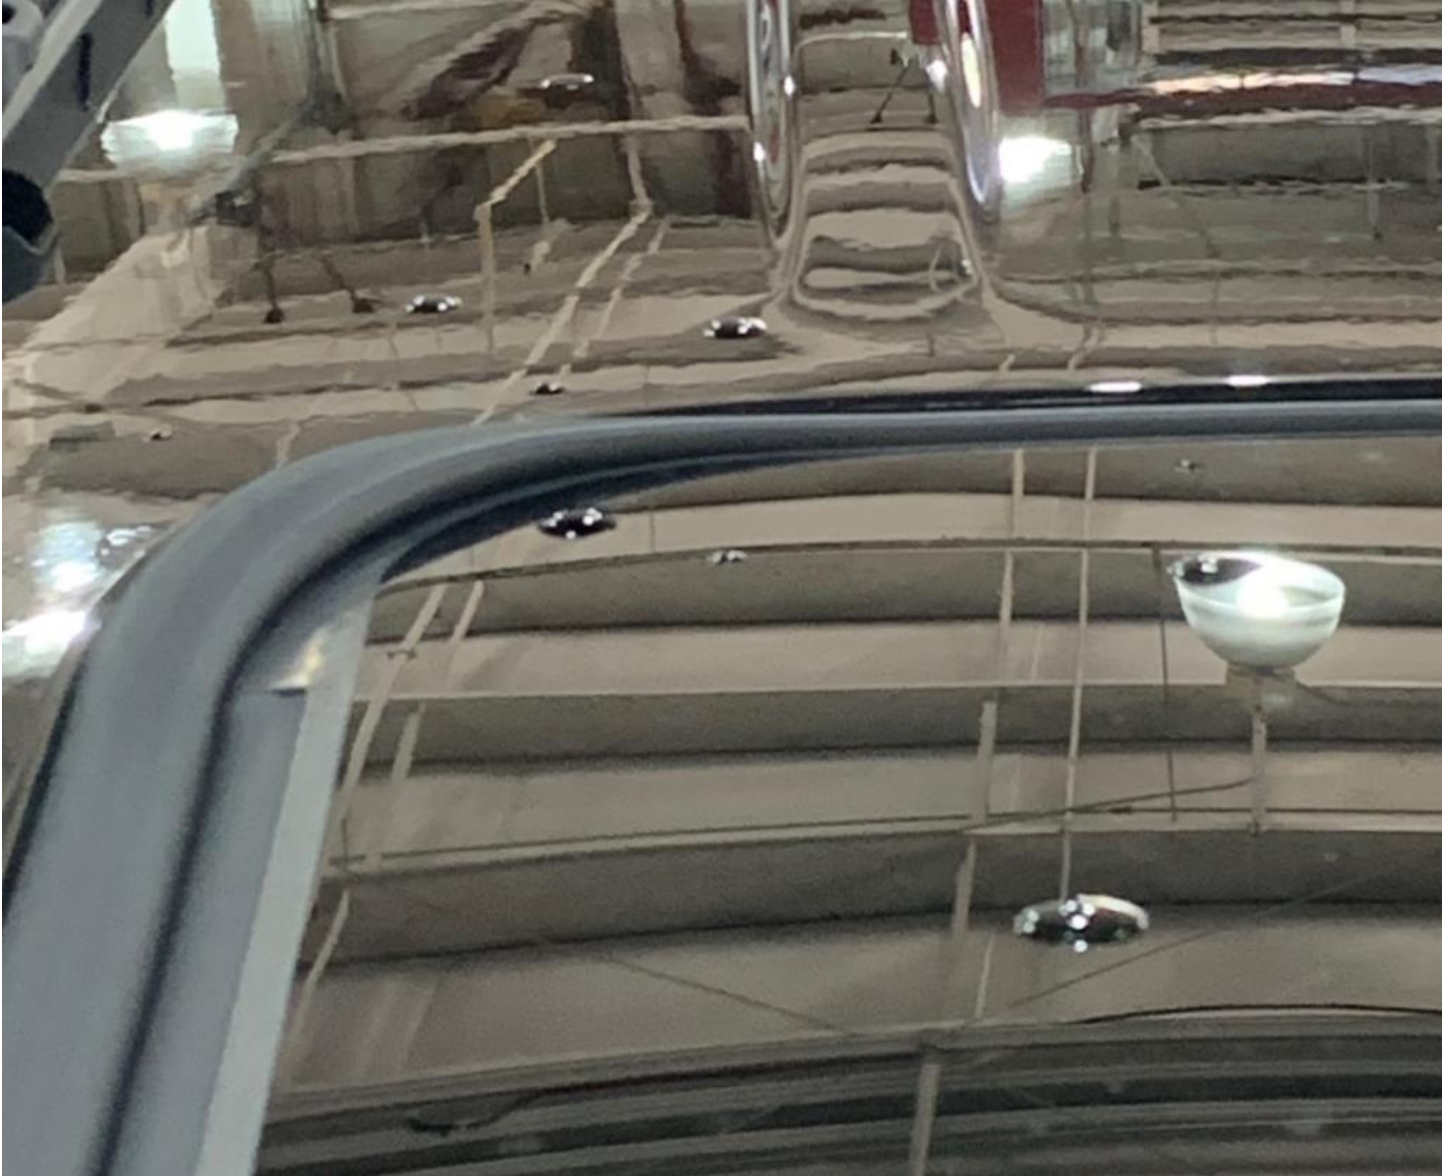
Fig 2
Example of sunroof exterior seal lifted

NOTE>>> Apply P-80 Grip It lubricant (Mopar # 68425736AA) to the new exterior sunroof seal to ease installation efforts. This lubricant has proven to drastically reduce the effort and time needed to properly seat the seal and avoids installation damage including stretch the seal.

NOTE>>> To begin installation, place the mold line (joint line where the weather strip is bonded) at the center rear of the sunroof. Lay out the seal lining up the corners and begin installing by hand and carefully using a trim stick where needed.

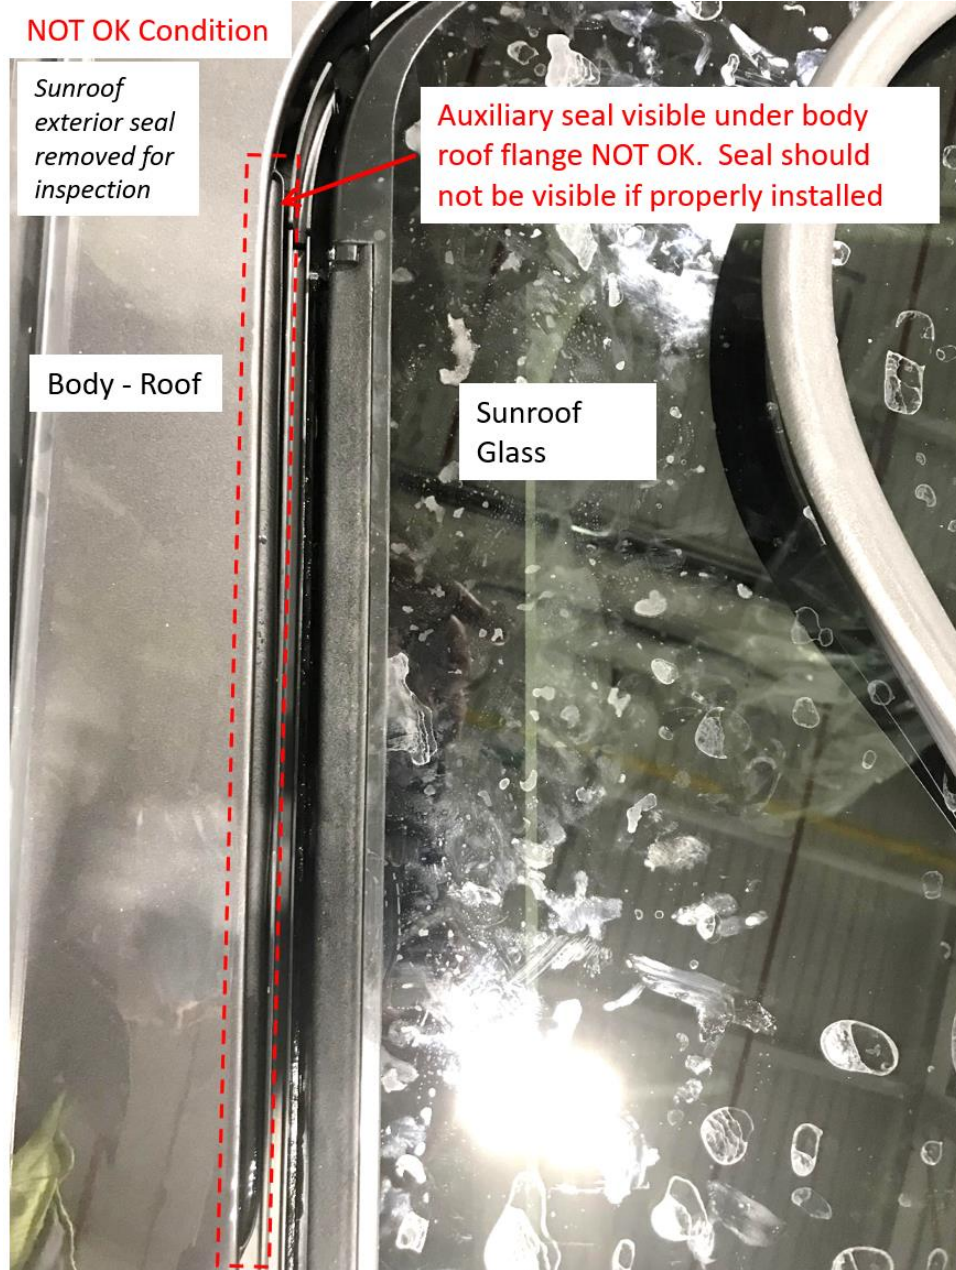
Fig 3

Sunroof exterior seal removed. Auxiliary seal visible from top of vehicle. Not correct.

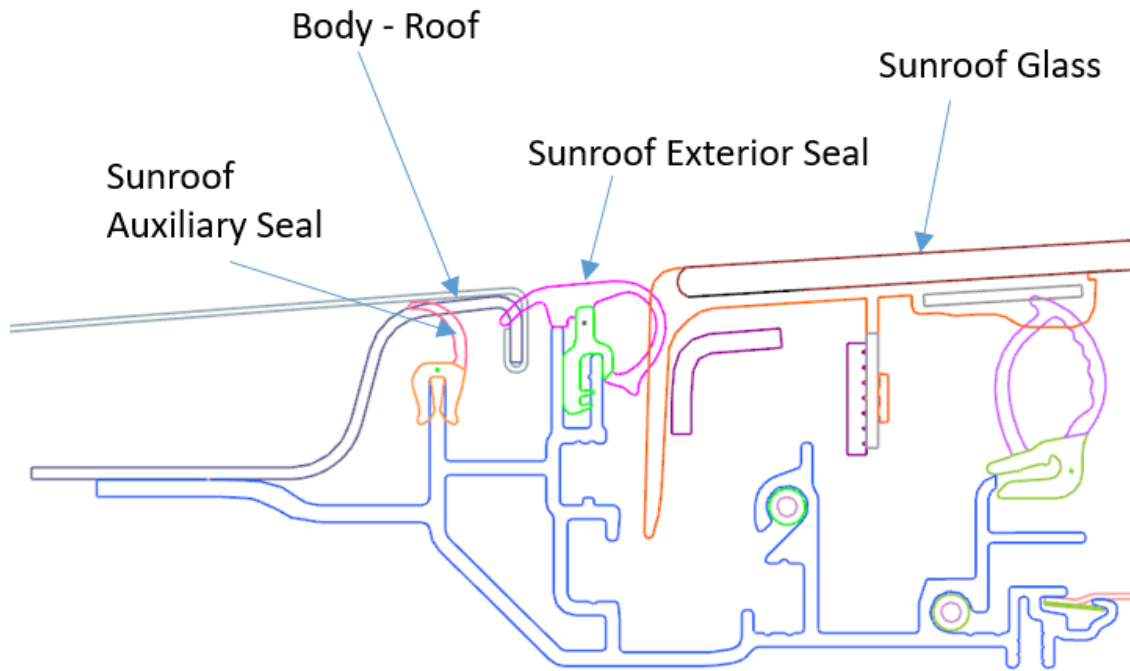
Correct Condition

Fig 4
Cut-away cross view of sunroof

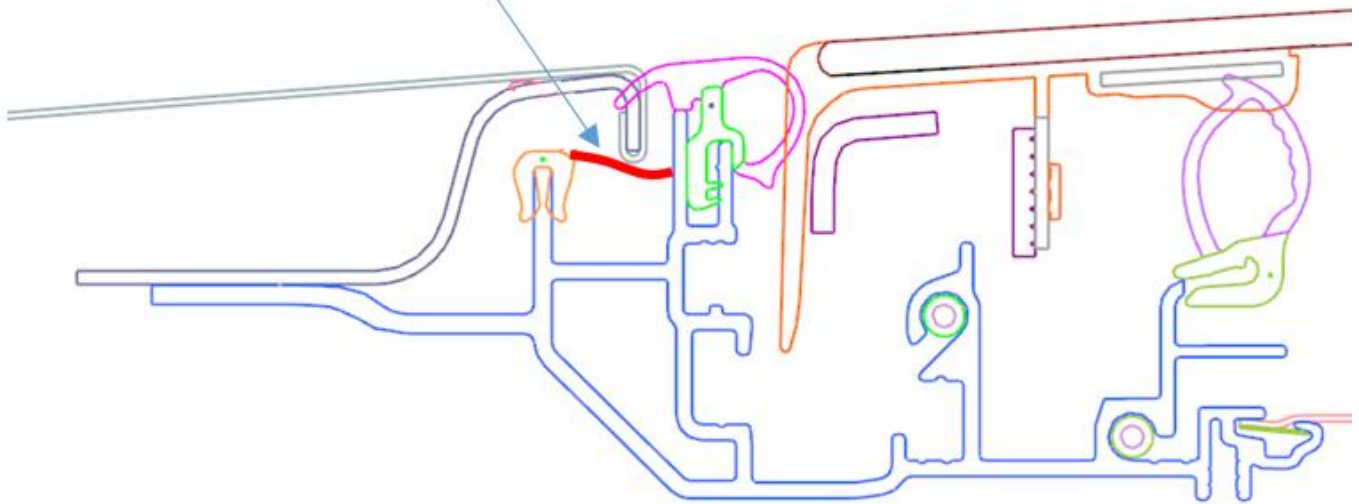
Not OK Condition

Auxiliary Seal trapped
under roof flange

Fig 5
Folded Auxiliary Seal
