STAR ONLINE PUBLICATION

Case Number: S222400006

Symptom/Vehicle Issue: Passenger Front Cabin Unable To Achieve Temperature Set Point.

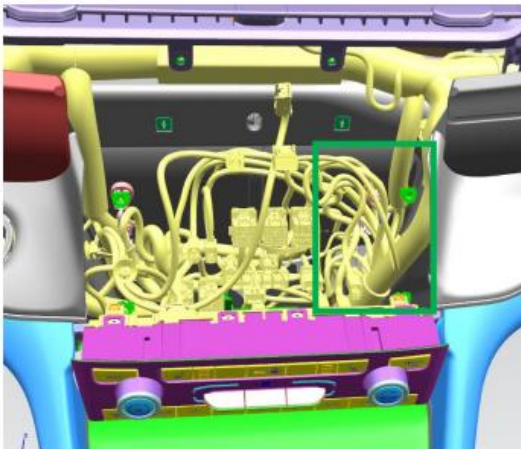
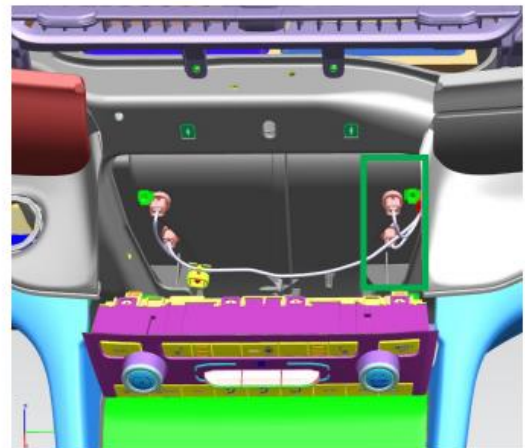
Locate DAT Sensors

- Move the wire harness bundle to locate the HVAC module and its DAT sensors
 - DAT sensors located on the Passenger Side of the HVAC

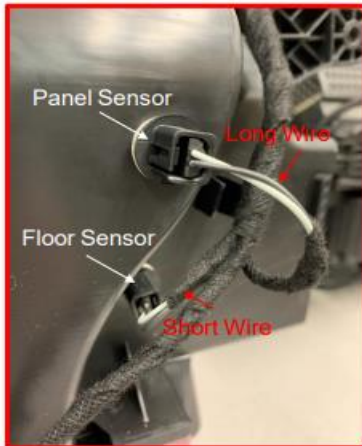
Step 1: Identify Sensor Wires

- Identify if the sensors are installed properly
- Shortened sensor shall be installed into the upper (Panel) sensor
- Longer sensor shall be installed into the bottom (Floor) sensor
