## STAR ONLINE PUBLICATION

**Case Number:** S2223000040

**Symptom/Vehicle Issue:** Tick, Click, Snap Noise From Passenger Side Of Instrument Panel

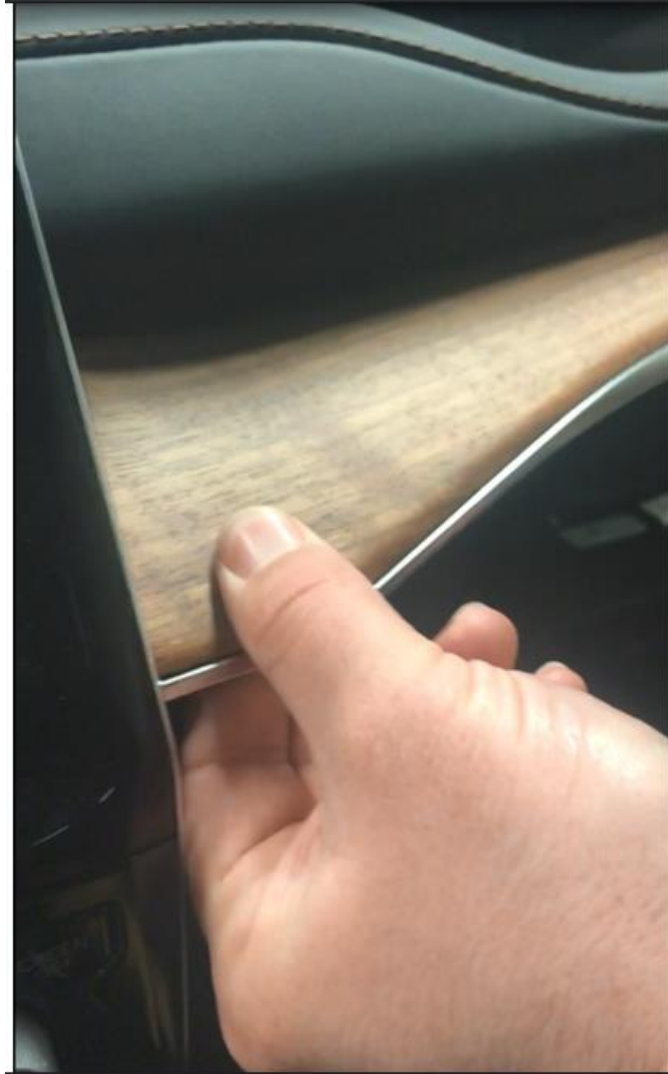
Fig 1  
Right side applique

**Customer Complaint/Technician Observation:** Repetitive ticking noise from the passenger side of the instrument panel.

**Discussion:** To isolate the noise, pinch the right-side IP applique as shown below. If the noise is eliminated, replace the applique. If the noise is not eliminated, continue diagnosis.
