STAR ONLINE PUBLICATION

Case Number: S2108000209 REV. A

Symptom/Vehicle Issue: Multiple Electrical Concerns, Reduced Cooling Fan Speed, Start Stop Does Not Work Intermittently, EPS Steering Warning Message, Check Engine Lamp On, Discharged Battery, No Start, Drained AUX Battery

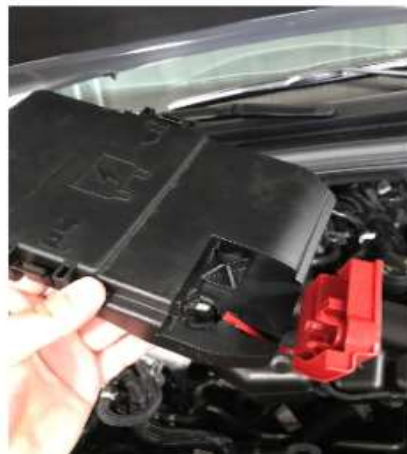
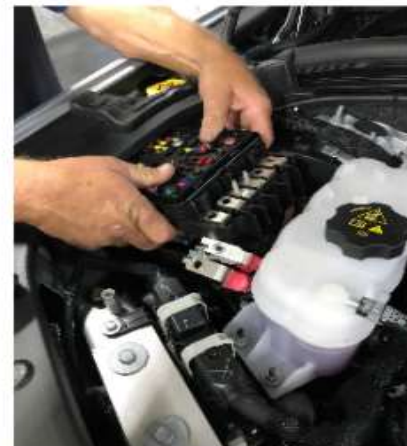
Front PDC

Jump starting the vehicle improperly can cause the 150amp fuse to open.
Part #68496448AA

This fuse open concern may not set any DTC's but can cause intermittent Start/Stop, EPS and cooling concerns as the aux battery is not getting fully charged.

Repair Procedure: Inspect the 150amp fuse (F11) at the at the front PDC. This circuit has a redundant power source with the PCR to supply AUX battery power during a fuse open concern. Inspect the rear PDC fuse array, #5 – C7 150amp fuse from the main battery, location #3 - C6 shunt from the aux battery Fig 4.

Disconnect stop start
and main battery

Access Under hood PDC

Remove Top Half

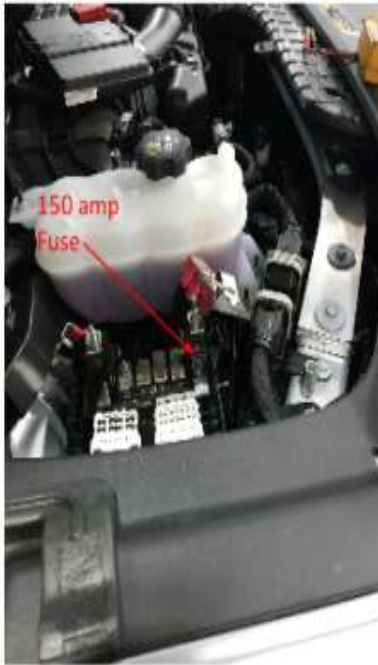
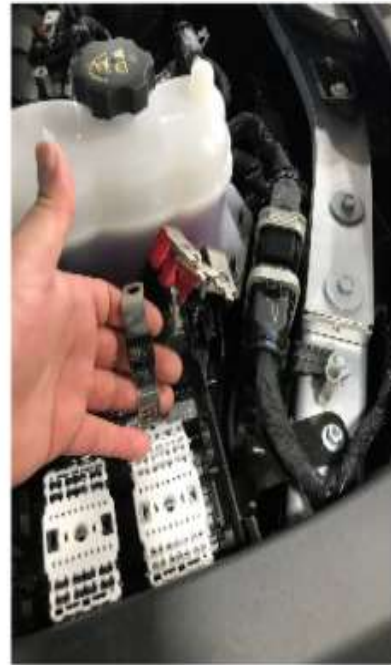
The circuit is redundant (gets power from more than one pathway) meaning electrical components of the circuit continue to operate but may have intermittent operation as support voltage is reduced.
