## STAR ONLINE PUBLICATION

**Case Number:** S228A000003

**Symptom/Vehicle Issue:** Uconnect Box Error Message On Radio Screen And DTC code B22A9-96 Set

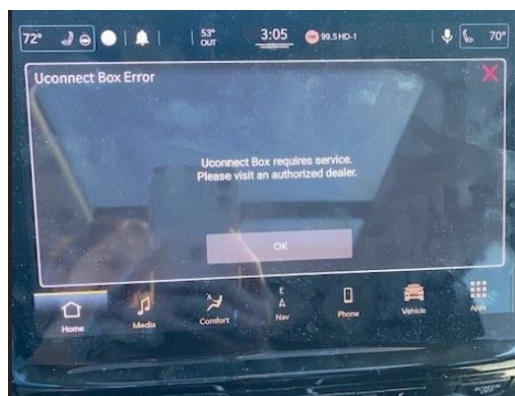
Fig 1 Error Message

**Discussion:** The customer may report “Uconnect Box requires service” error popup on radio screen every time the vehicle starts. wiTECH shows active DTC B22A9-93 (ECU internal performance) set by Telematics Box Module 2, TBM2. Engineering is looking into this code and is looking for error code details in the TBM2 data if code is set active. Please add this data to the Repair Order information. If a Star case had been opened, please provide the data in Star case. See procedure below:

Please use wiTECH tool to check the TBM2 data.

Select TBM2 module -> Data tab -> ECU internal fails screen and record the value of:

Log the name and “value” (yes/no) of those items to R/O and/or the STAR case.
