Rear Tail Lamp Condensation Clearing Procedure

This bulletin is to communicate the procedure for rear tail lamp condensation clearing.

**2021 - 2022	(WL)	Jeep Grand Cherokee
2022	(WS)	Grand Wagoneer/Wagoneer**
2019 - 2022	(KL)	Jeep Cherokee

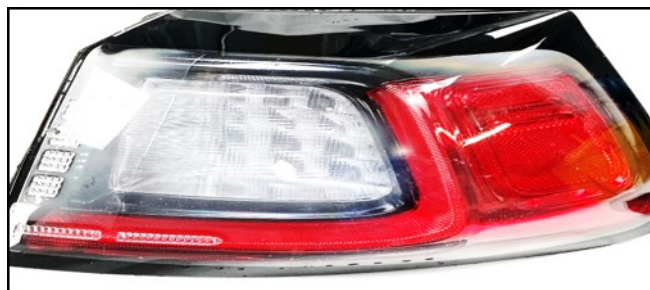
**Fig. 1**  
**Clear Tail Lamp Assembly**

2. The tail lamp should be checked every 10 minutes.
  - a. If the condensation/fogging has begun to clear from the tail lamp lens within 60 minutes with the tail lamps operating, this indicates the tail lamp sealing has not been breached, and the tail lamp does not need to be replaced (Fig. 1) .

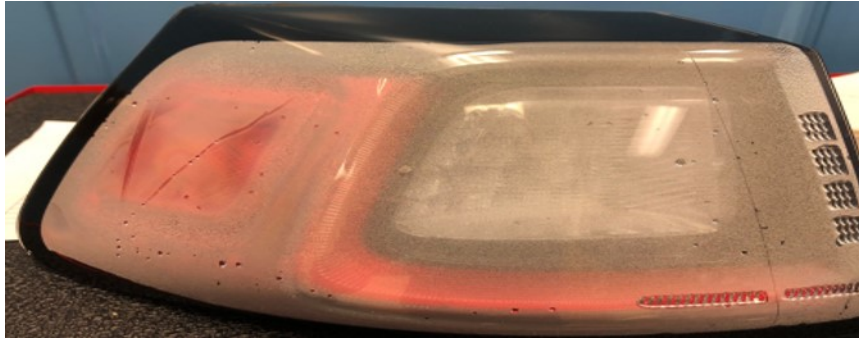
Fig. 2

Some customers may report that on occasion, vehicle exterior tail lamp assemblies are fogged with a light layer of condensation on the inside of the lenses. This may be reported after the lamps have been turned on and brought up to operating temperature, turned off, and then rapidly cooled by cold water (such as rain, or the water from a vehicle wash). Lens fogging can also occur under certain atmospheric conditions after a vehicle has been parked outside overnight (i.e., a warm humid day followed by clear cool night). This will usually clear as atmospheric conditions change to allow the condensation to change back into a vapor. Turning the tail lamps on will usually accelerate this process.

Tail Lamp Assembly with Condensation

- b. If the condensation/fogging has not begun to clear after 60 minutes with the tail lamps operating, or the lamp has large amounts of water droplets visible on most internal surfaces, this indicates a problem with the tail lamp sealing that has allowed water to enter the tail lamp. In this instance, the customer is also likely to report that moisture in the tail lamp is always present and never disappears (Fig. 2) . A tail lamp that exhibits internal moisture permanently should be replaced. Refer to the detailed service procedures available in DealerCONNECT/Service Library under: Service Info> 08 - Electrical / 8L - Lamps and Lighting / Lamps/Lighting - Exterior / Lamp, Tail / Removal.

1. A tail lamp that exhibits condensation/fogging should be evaluated in a service bay environment by first drying all water from the outside surface of the lens and operating the lamp for 60 minutes by starting the vehicle and turning on the head lights and hazard lights.
