NUMBER: 18-056-22 REV. A

GROUP: 18 - Vehicle Performance

DATE: May 24, 2022

Flash: Powertrain Control Module (PCM) Updates

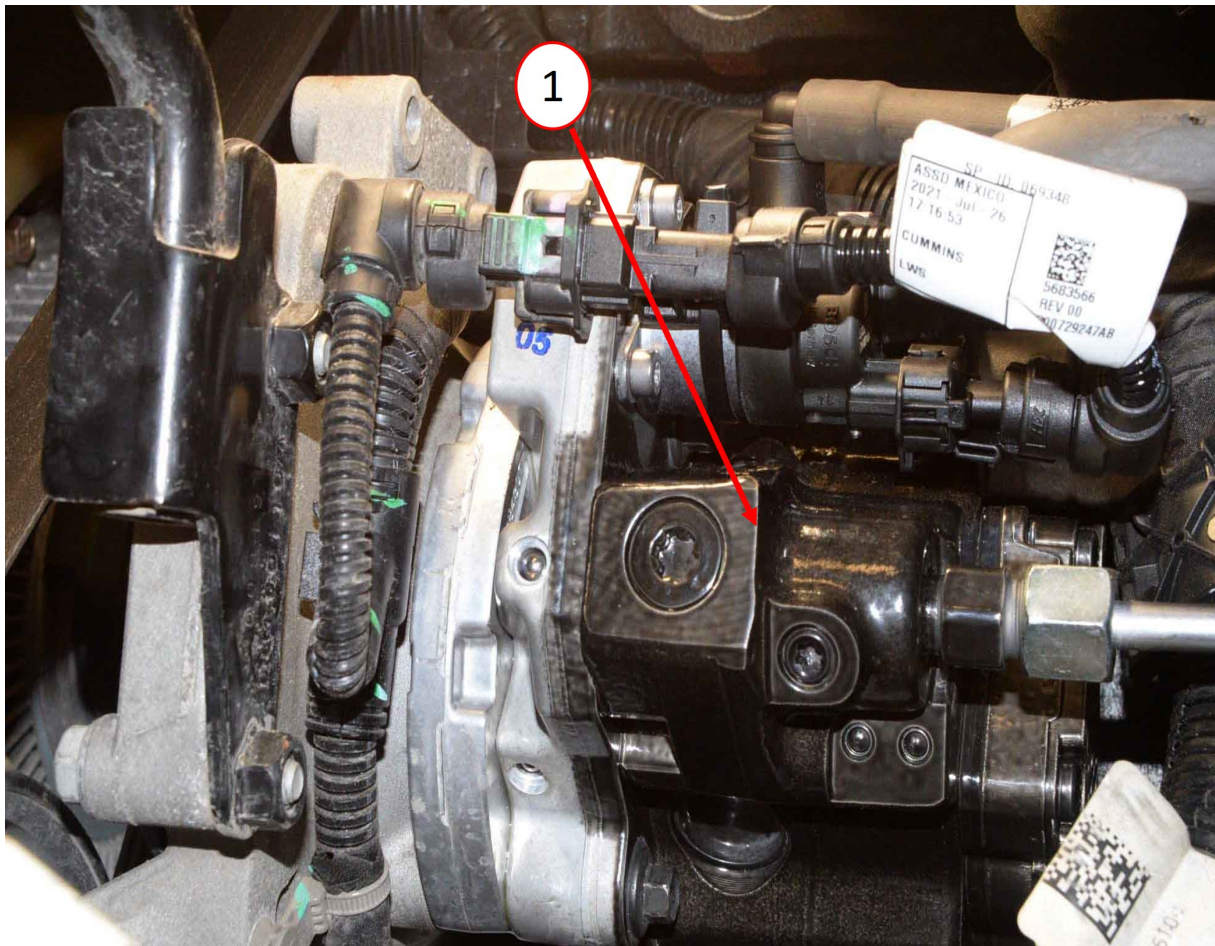
Fig. 1
CP3.3 Design Pump

NOTE: The only calibration available will be for the updated CP3.3 design High-Pressure Fuel Injection Pump (Fig. 1) . Please ensure that recall Y78 has been completed first before proceeding with this update.

1. Inspect the High-Pressure Fuel Injection Pump to see which pump is currently installed on the vehicle (Fig. 1) . Also review the vehicle VIP report to see if campaign Y78 has been performed.
