**NUMBER:** 14-008-22

**GROUP:** 14 - Fuel System

**SUBJECT:**

6.7L Cummins Engine High Pressure Fuel Injection Pump Identification Differences

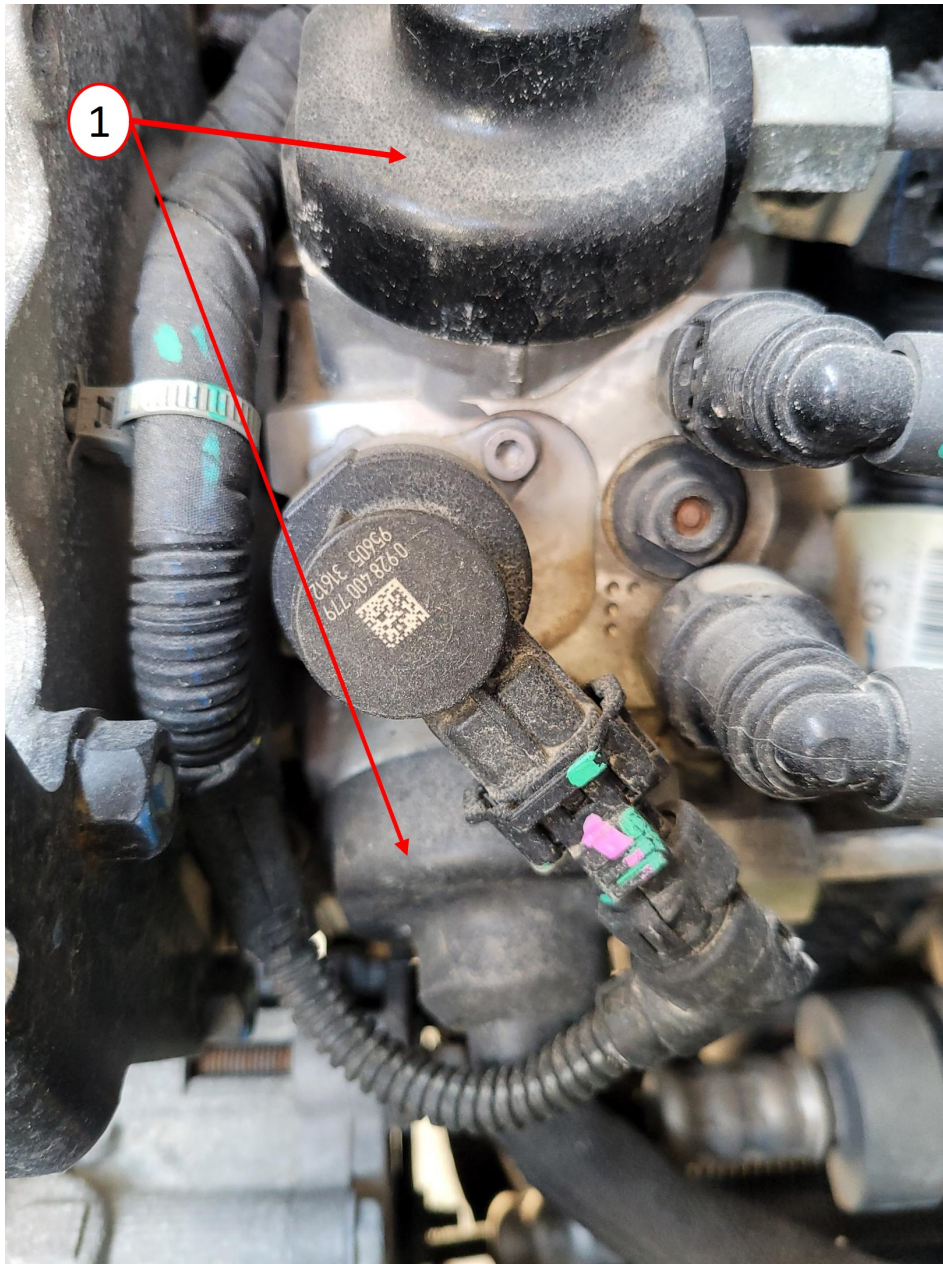
**Fig. 1**  
**CP4 Design Pump**

The CP4 pump can be identified by its two distinct pumping chambers in a V configuration, with the Fuel Quantity Solenoid (FQS) located in between. Each of the pumping chambers will have a high-pressure fuel supply line supplying fuel to the high-pressure fuel rail.

1. Inspect the fuel injection pump to see which pump the vehicle has, each pump is visibly different:
  - Vehicles with the CP4 pump will have the 2 distinct pumping chambers with the FQS located between them (Fig. 1).

1 - Two Distinct Pumping Chambers.

Whenever an PCM/ECM is replaced, or reprogrammed for any reason, the fuel injection pump must be inspected to determine which design pump is installed on the vehicle. If the vehicle is equipped with a CP4 style fuel injection pump (Fig. 1) , it must be replaced with the new CP3.3 injection pump (Fig. 2) released under recall Y78 or active Technical Service Bulletins (TSBs), before the PCM/ECM can be programmed or replaced.

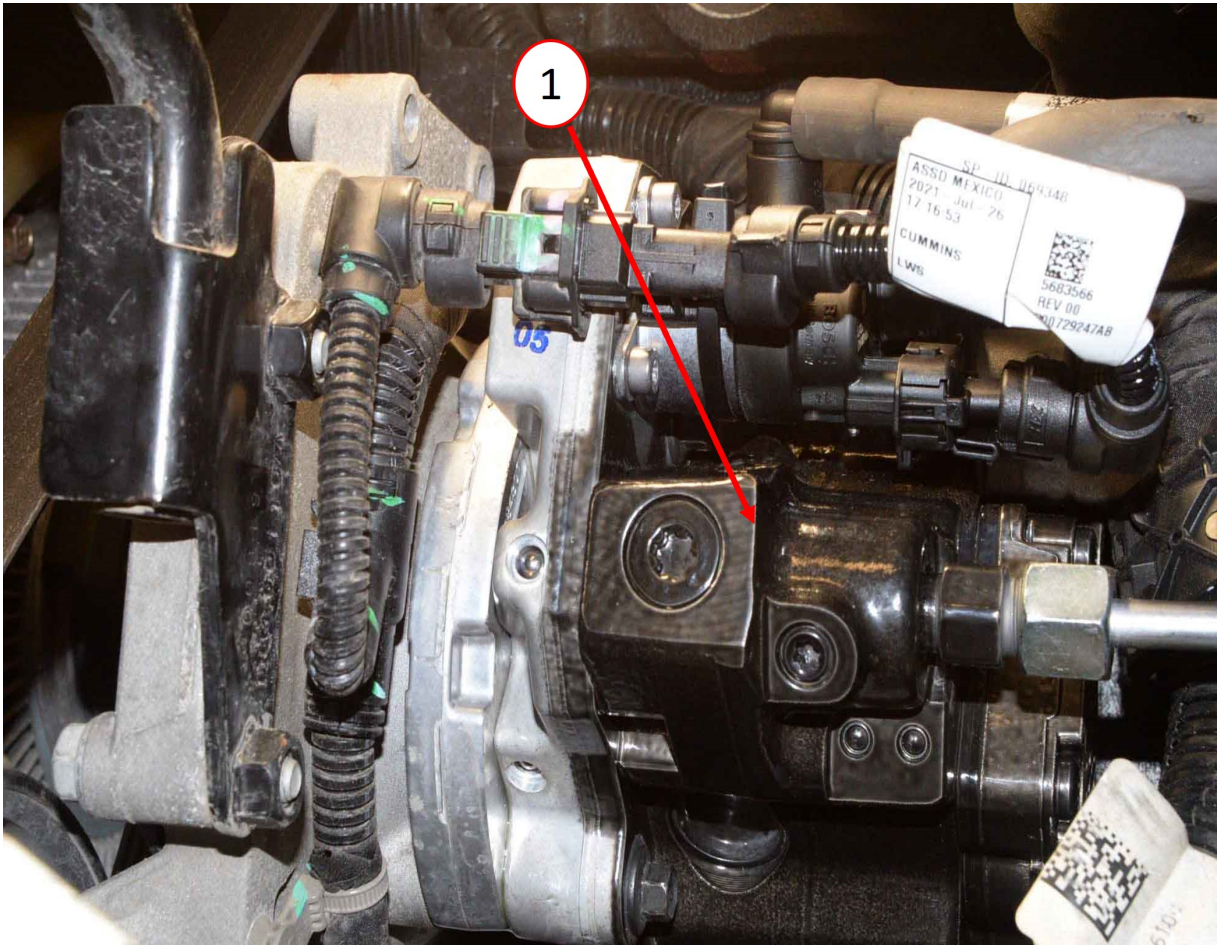
Fig. 2  
CP3.3 Design Pump

The CP3.3 style pump is a 3-piston, radial configuration pump (Fig. 2) that looks much different than the CP4 style pump (Fig. 1). There will be only one high-pressure fuel line attached to the body of the pump that is used to supply fuel to the high-pressure fuel rail.

- Vehicles with the new design CP3.3 pump installed under recall Y78 (Fig. 2) .

1 - CP3.3 Design Pump From Top View.

Additionally, when the fuel injection pump is replaced with the new CP3.3 design pump (Fig. 2) , the PCM/ECM must be updated to the latest available calibration to support the new pump.
