NUMBER: 18-102-22

DATE: May 24, 2022

Flash: Powertrain Control Module (PCM) Updates

2020	(DJ)	RAM 2500 Pickup
2020	(D2)	RAM 3500 Pickup

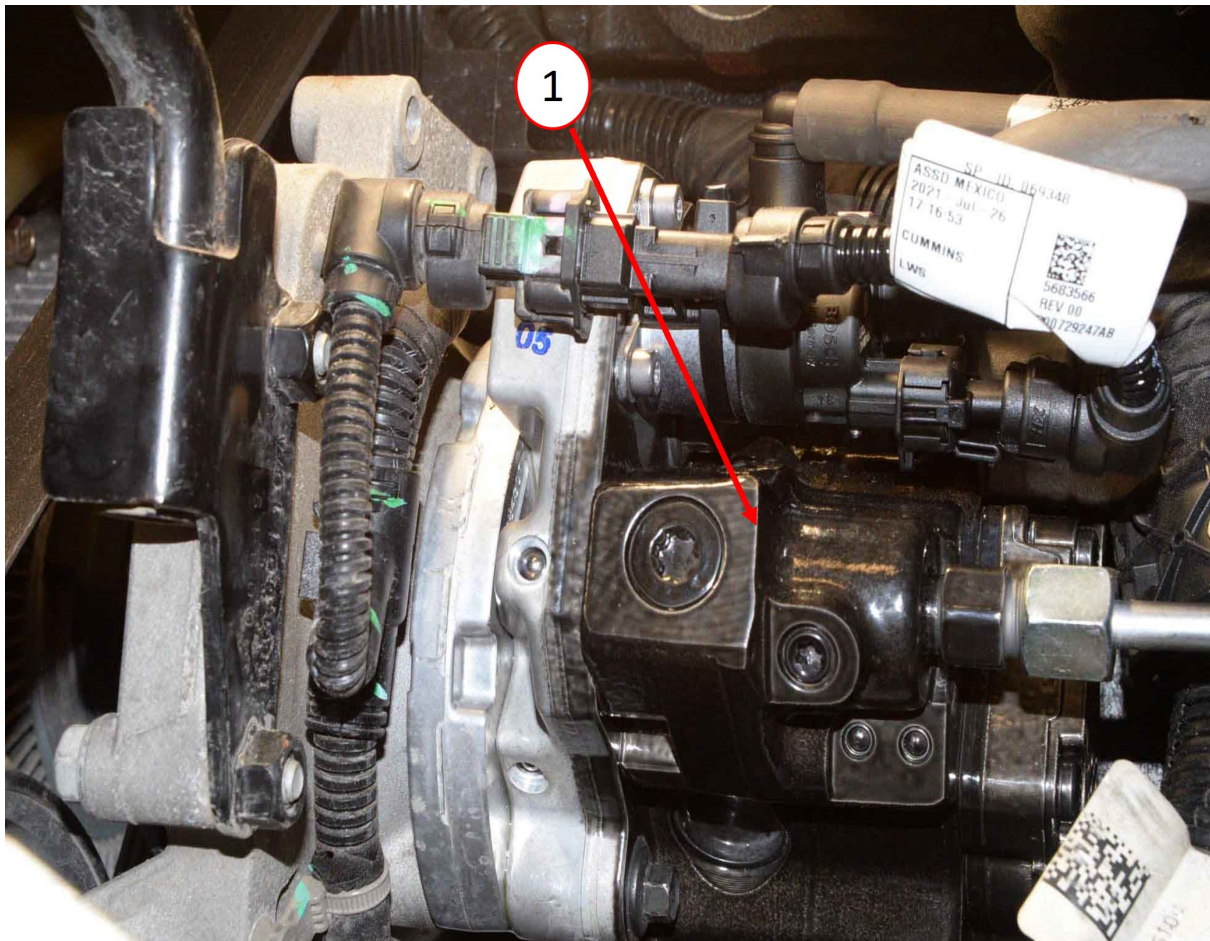
**Fig. 1
CP3.3 Design Pump**

NOTE: **The only calibration available will be for the updated CP3.3 design High-Pressure Fuel Injection Pump (Fig. 1) . Please ensure that recall Y78 has been completed first before proceeding with this update.

1 - CP3.3 Design Pump From Top View.

1. Inspect the High-Pressure Fuel Injection Pump to see which pump is currently installed on the vehicle (Fig. 1) . Also review the vehicle VIP report to see if campaign Y78 has been performed.

2. Does the VIP report indicate that Y78 has been performed, and is the vehicle equipped with the new design fuel injection pump released under the campaign?
 - YES>>> Proceed to [Step 1](#).
 - NO>>> Perform the Y78 campaign first. Once the campaign is performed, new pump installed and PCM updated, the PCM will have all of the updates listed in this document. This Bulletin does not apply.**
