NUMBER: 18-055-22 REV. A

GROUP: 18 - Vehicle Performance

Flash: Powertrain Control Module (PCM) Updates

2020	(DD)	RAM 3500 Cab Chassis
2020	(DP)	RAM 4500/5500 Cab Chassis

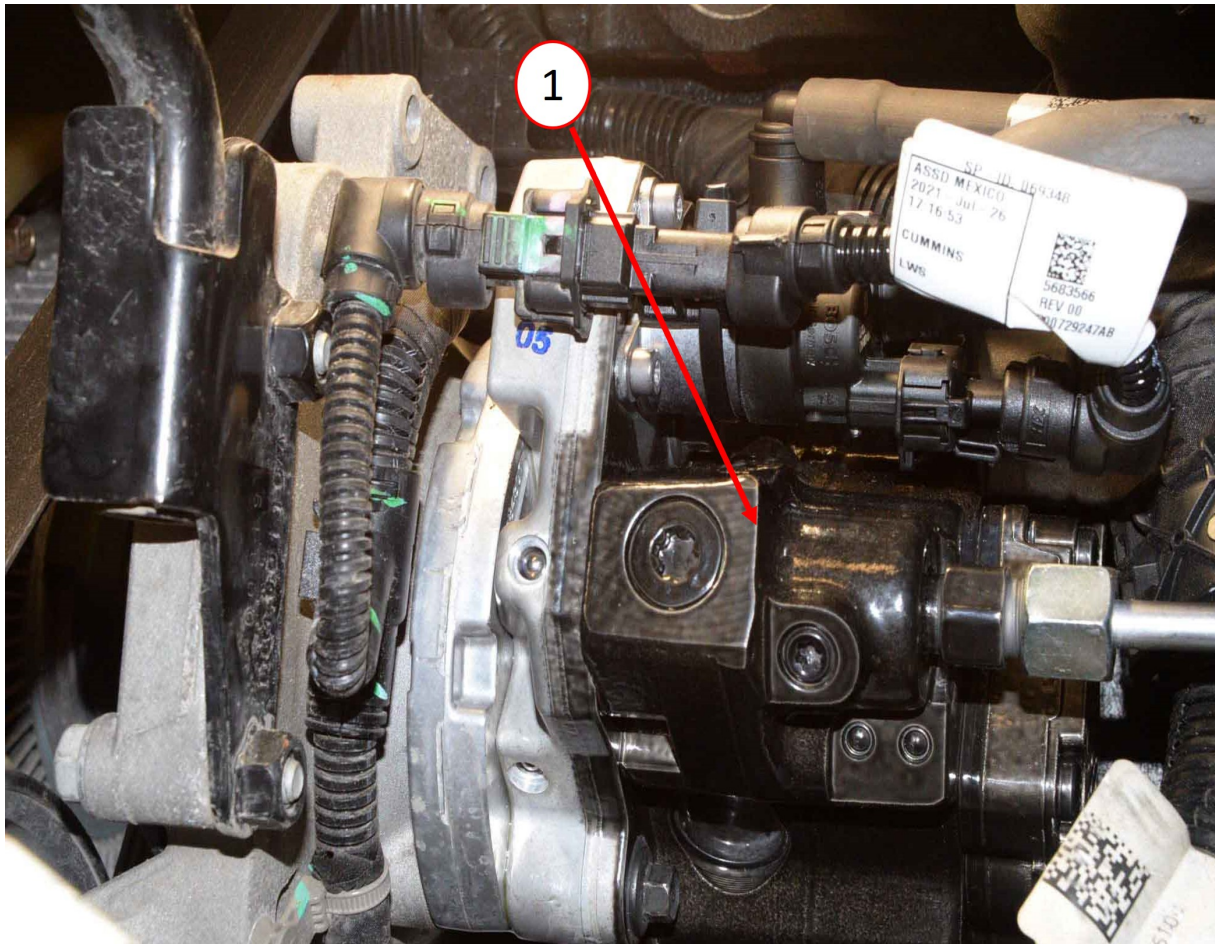
Fig. 1
CP3.3 Design Pump

NOTE: The only calibration available will be for the updated CP3.3 design High-Pressure Fuel Injection Pump (Fig. 1) . Please ensure that recall Y78 has been completed first before proceeding with this update.

1. Inspect the High-Pressure Fuel Injection Pump to see which pump is currently installed on the vehicle (Fig. 1) . Also review the vehicle VIP report to see if campaign Y78 has been performed.

1 - CP3.3 Design Pump From Top View.

2. Does the VIP report indicate that Y78 has been performed, and is the vehicle equipped with the new design fuel injection pump released under the campaign?
 - YES>>> Proceed to [Step 1](#).
 - NO>>> Perform the Y78 campaign first. Once the campaign is performed, new pump installed and PCM updated, the PCM will have all of the updates listed in this document. This Bulletin does not apply.
