Service Bulletin

Bulletin No.: 22-NA-123

Subject: Black Radio Display Screen and No Communication with the Video Processing Module (VPM)

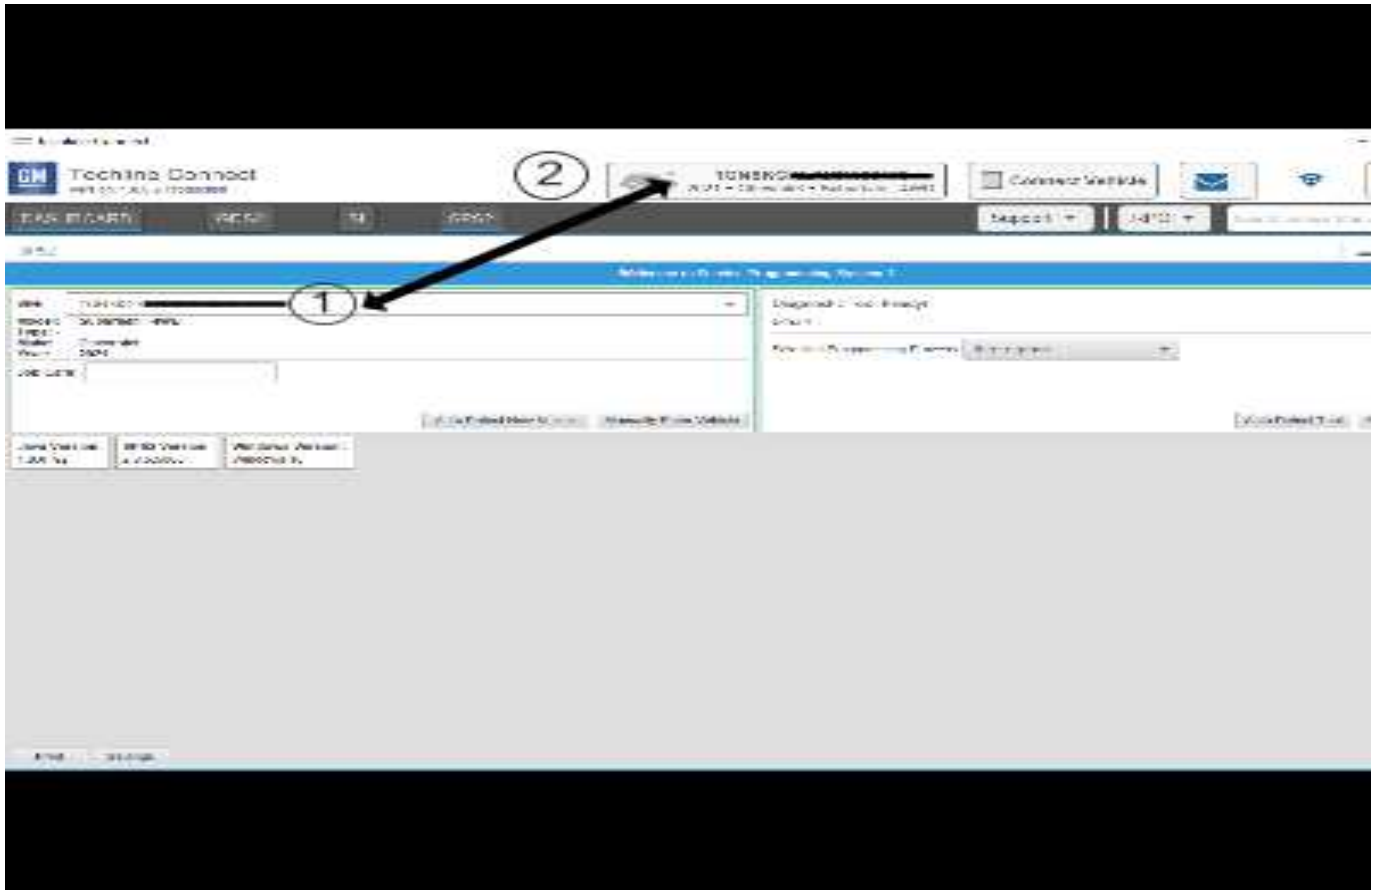
Caution: Be sure the VIN selected in the drop down menu (1) is the same as the vehicle connected (2) before beginning programming.

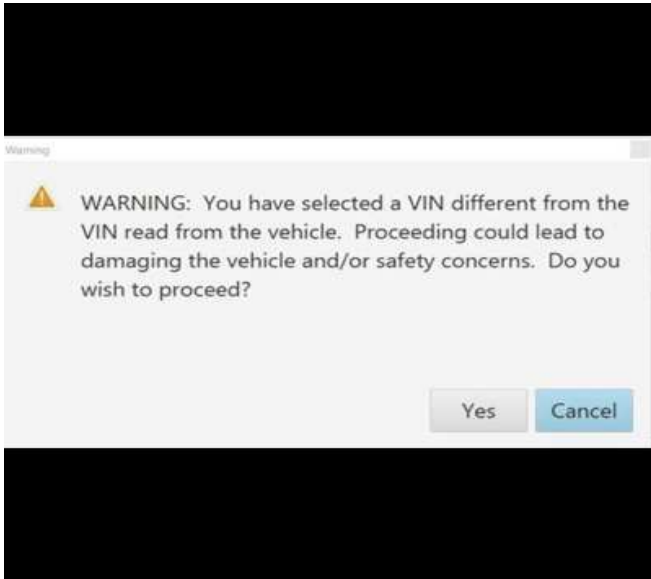
5877000

Important: If the vehicle VIN DOES NOT match, the message below will be shown
