<p>TO: Mercedes-Benz Dealer Principals, General Managers, Sales Managers, Service Managers, Parts Managers</p>	<p>FROM: Anthony Washington, Department Manager, Regulations and Certifications</p>
<p>Re: Service Campaign Launch Notification Model 447 (Metris) Model Year 2021 Retrofit HERMES Module</p>	<p>DATE: May, 2022</p>

Campaign No. 2022040004 May, 2022

SUBJECT: **Model 447 Model Year 2021
Retrofit HERMES Module**

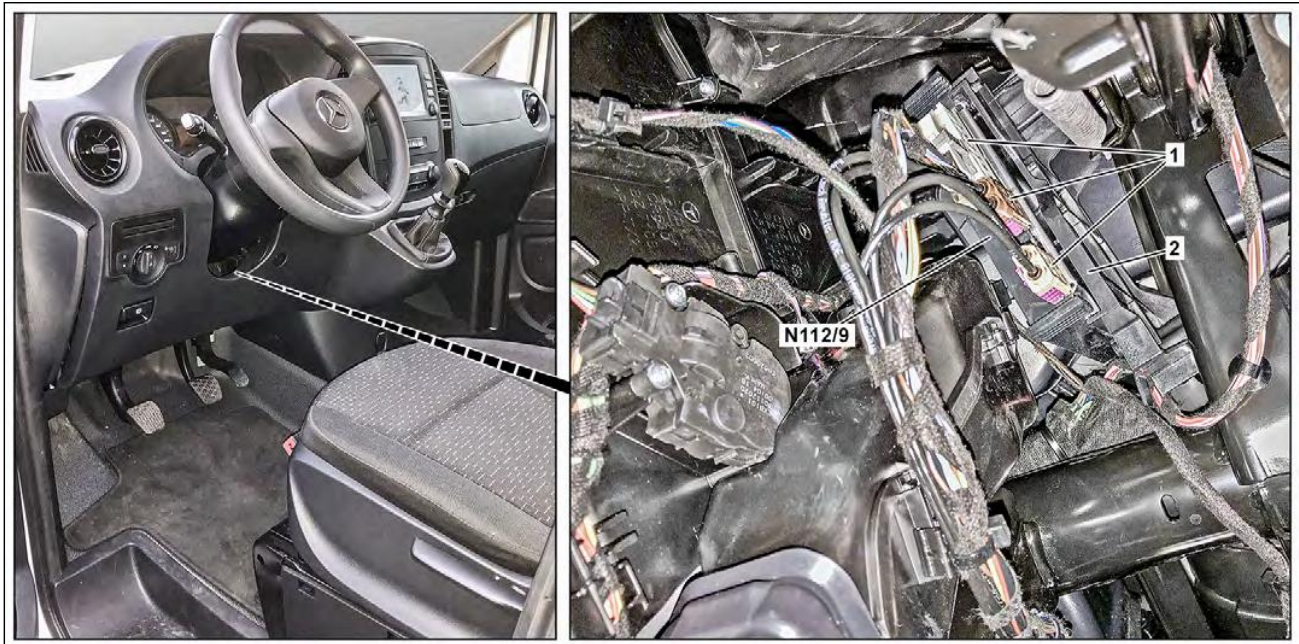
S82.95-A014-79

| 1 | Electrical connectors | N112/9 | HERMES control unit |
| 2 | Bracket | | |

5	Disconnect electrical connectors (1).		
6	Release front and rear lock on holder (2) and remove dummy control unit to one side.	<p>

Install		
7	Install new HERMES control unit (N112/9) on holder (2) and lock.

8	Connect electrical connectors (1).

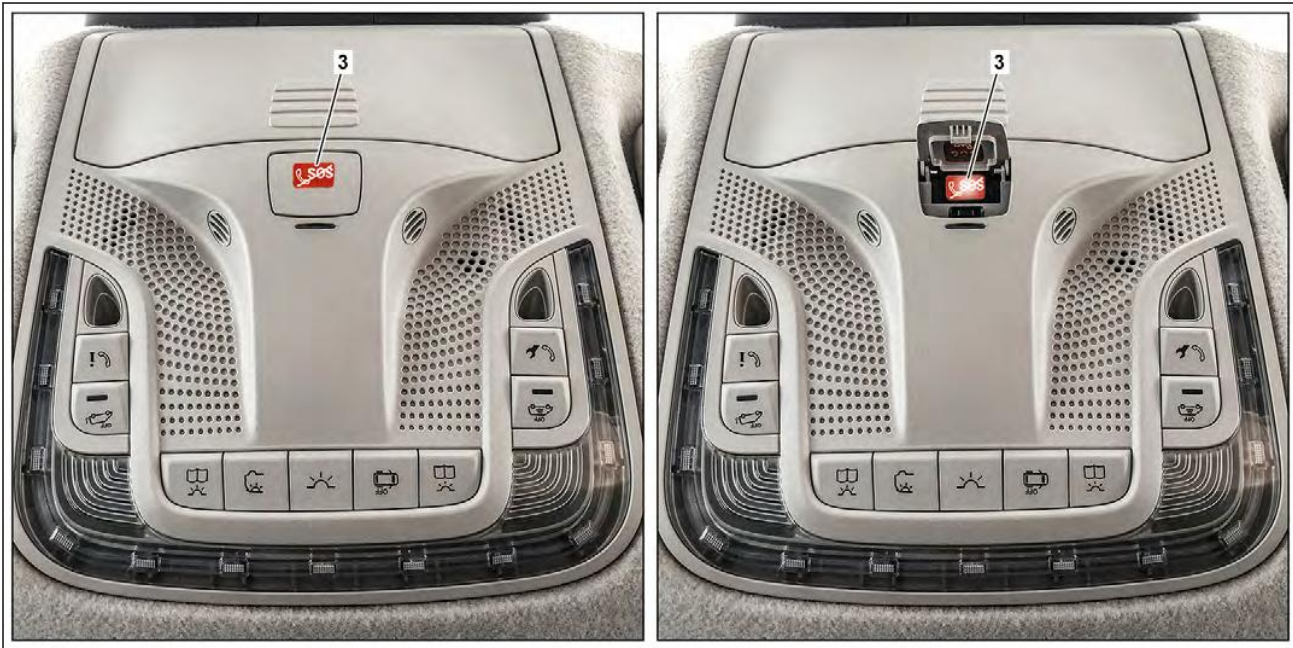
S82.95-A016-79

- 3 SOS information label

18 AR	Remove charger from vehicle.		AR54.10-S-1127E
19	Remove SOS information sign (3) from cover and "Emergency call" button from overhead control panel.		
20	Remove supplementary booklet (4) from vehicle.	<p>i Dispose of supplementary booklet (4) "Notes on vehicles without communication module" with item number A 000 584 50 15 properly. Observe the applicable legal requirements and specifications of the relevant country.</p> <p>i All functions of the emergency call system are available with the repair work described here, therefore the supplementary booklet (4) is no longer required.</p>

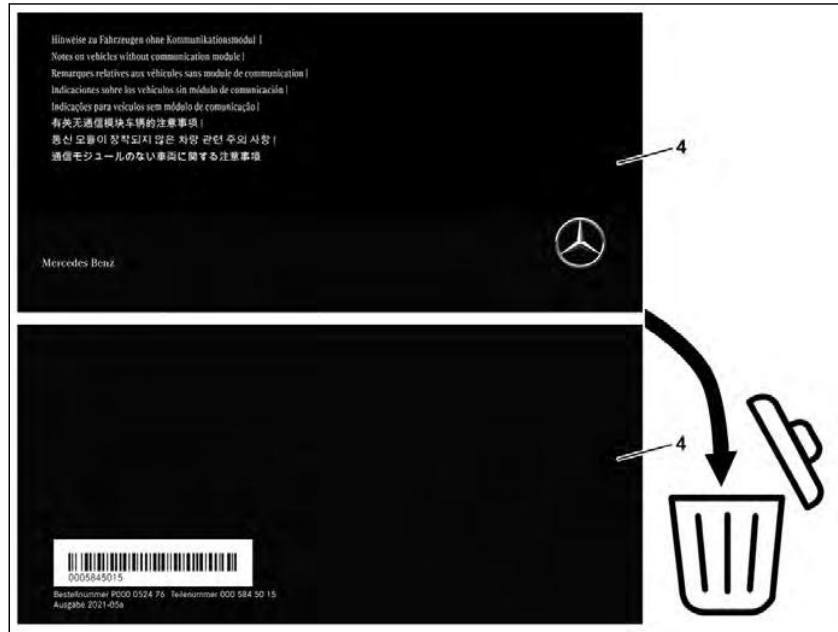
D82.95-A013-76

4 Supplementary booklet
