# Technical Service Bulletin

## 51 Water ingress into the front footwells

51 22 25 2067103/2 June 6, 2022. Supersedes Technical Service Bulletin Group 51 number 22-24 dated May 23, 2022, for reasons listed below.

Model(s)	Year	VIN Range	Vehicle-Specific Equipment
A8 e quattro	2020 – 2021	All	PHEV

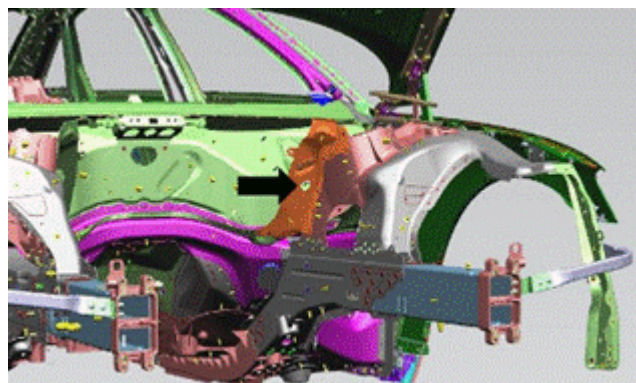
A missing body plug is discovered in the plenum chamber bulkhead causing water intrusion.

The plenum chamber bulkhead provides an opening for a vacuum line on all A8 models (Figures 1 and 2). For A8 TFSI e PHEV models this opening is not used. In the production process of an A8 TFSI e PHEV model, a body plug was to be installed to close off this opening. The body plug may not have been installed in this opening on A8 TFSI e PHEV models only.

*Figure 1. Location of the plenum chamber bulkhead opening.*

Remove the speed nut for the heat shield on the plenum chamber bulkhead and loosen the heat shield to provide access to this opening. Install body plug 4N0 611 817 A in this opening (Figure 3).

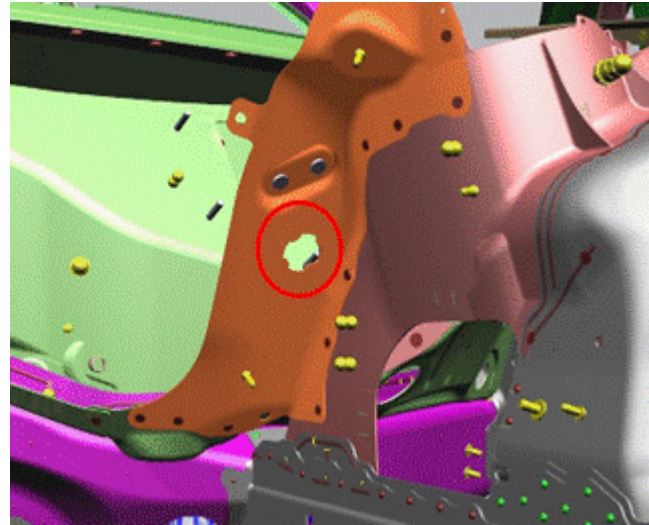
*Figure 2. Magnified view of the plenum chamber bulkhead opening.*
