# Technical Service Bulletin

## 68 Noises from the MMI screen

68 22 37 2061722/3 June 6, 2022. Supersedes Technical Service Bulletin Group 68 number 21-31 dated January 14, 2021, for reasons listed below.

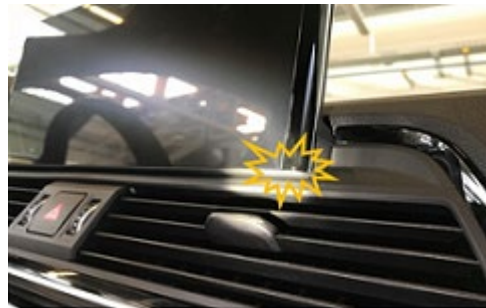
Check the gap between the MMI screen and the center vent with a feeler gauge (Figure 1). A gap of 1.0 mm is ideal to avoid any noise-related concerns. If the gap is less than 0.5 mm, perform the following repair.

**Figure 1.** *The gap between the MMI screen and the center vent should be 0.5 mm or greater.*

Recheck the gap between the MMI screen and the center vent to ensure a gap of at least 0.5 mm (Figure 1).
