TECHNICAL SERVICE BULLETIN

Water Leak Onto Front Carpet From A-Pillar

22-2242

Ford 2015-2022 Mustang

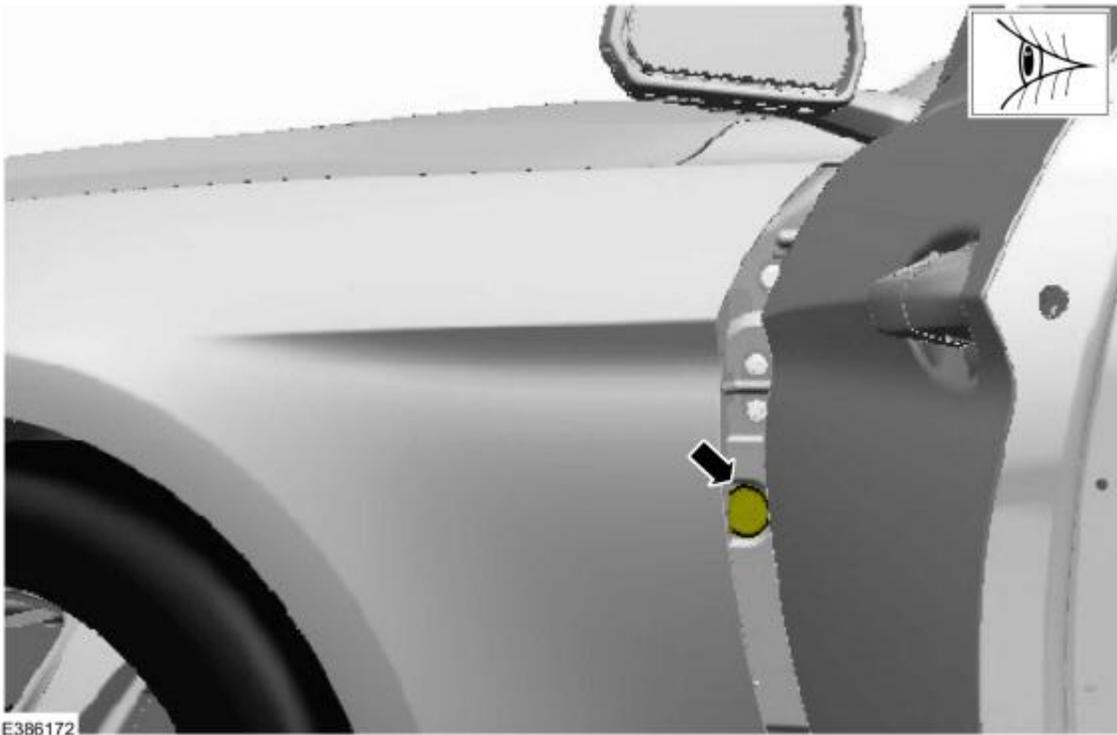
NOTE: The A-pillar body seals are an adhesive patch that seals a 19 mm (0.75 in.) diameter hole in the sheet metal. These seals must have complete adhesion around all edges. If any portion of the sealing surface is compromised, water entry into the cabin may result.

Figure 1 - Left A-pillar shown, right A-pillar similar

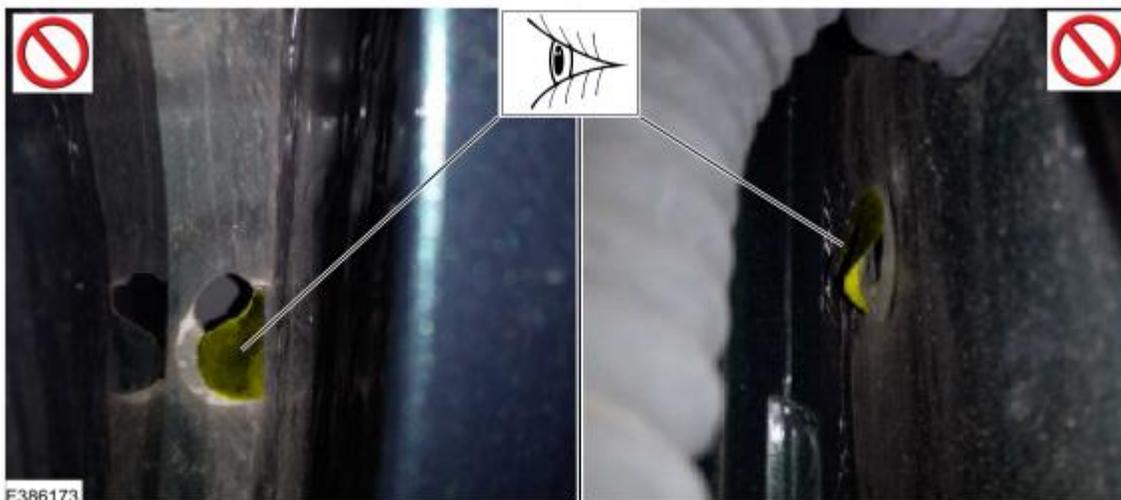
Issue: Some 2015-2022 Mustang vehicles may exhibit a water leak onto the front carpet that originates from the either the left or right A-pillar. This may be due to a detached A-pillar body seal. Follow the service procedure to repair the vehicle.

Figure 2 - Example of failed A-pillar sticker seals

- (1). Yes - this article does not apply.
 - (2). No - proceed to Step 4.
4. Inspect the fender insulator to be sure it does not restrict access to the A-pillar body seal. If the fender insulator covers any portion of the A-pillar body seal, the foam fender insulator can be slightly indented to allow for unobstructed access to the seal.
 5. Apply paint-safe, protective tape to the door and fender edges.
 6. Use fingers and/or pliers to completely remove and discard the A-pillar body seal.

7. Use alcohol wipes to remove all remaining adhesive left by the discarded body seal.
8. Apply Motorcraft® Anti-Corrosion Coating to all exposed metal around the A-pillar body hole. Allow the Motorcraft® Anti-Corrosion Coating to dry following the instructions on the container.
9. Use a small paint brush to apply touch-up paint to the exterior surfaces that were previously coated with Motorcraft® Anti-Corrosion Coating. Allow paint time to dry following the instructions on the touch-up paint container.
10. Install and fully seat the new rubber body plug into the A-pillar body hole.
11. If the other A-pillar body seal requires repair, repeat Steps 4-10.
