Customer Satisfaction Program

N222371310 Over The Air Update Causing Battery Drain

Release Date: June 2022

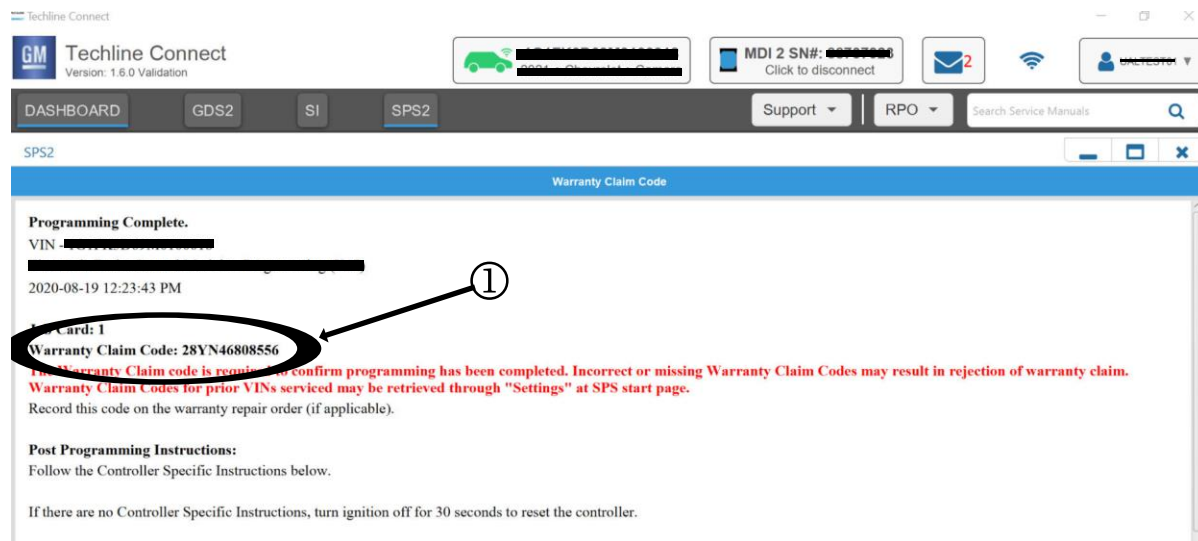
5644478

Note: The screenshot above is an example of module programming and may not be indicative of the specific module that is being programmed. Module selection and VIN information have been blacked out.

Important: To avoid warranty transaction rejections, you **MUST** record the warranty claim code provided on the Warranty Claim Code (WCC) screen shown above on the job card. Refer to callout 1 above for the location of the WCC on the screen.

16. Record SPS Warranty Claim Code on job card for warranty transaction submission.
17. Check for DTC's U1961 and U1962. If codes are current, perform the Serial Data Authentication Configuration by selecting the button in the lower right-hand corner on the controller program screen.
18. Verify there is not an excessive battery current drain by performing the battery electrical drain/parasitic load test. Refer to *Battery Electrical Drain/Parasitic Load Test* in SI. The vehicle may take 10-15 minutes before it will power down.
