Technical Service Bulletin

90 Audi connect user management option greyed out or SOS and Roadside with no function (DTC P169A00 / U13EB00)

90 22 73 2052299/5 June 29, 2022. Supersedes Technical Service Bulletin Group 90 number 22-46 dated February 22, 2022 for reasons listed below.

Model(s)	Year	VIN Range	Vehicle-Specific Equipment
All Audi Vehicles	2019 – 2023	All	Not Applicable

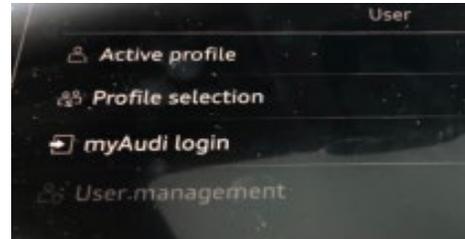
Figure 1. User management.

- The Audi Connect “User management” screen is greyed out and the customer cannot complete the key user pairing (Figure 1).

- **DTC P169A00** (Transport mode active) is stored in the engine control module (ECM), J623 (address word 0001).
- **DTC U13EB00** (Emergency call module and communication unit Flight mode activated) is stored in the emergency call module and communication unit, J949 (address word 0075).

1. Change the adaptation for flight mode in diagnostic address 0075 at, *Self-diagnosis >> Go to address 0075 >> Adaptation values “Basis connect function” >> Flight mode >> Deactivate.*

2. Hit "Apply".
3. Cycle the ignition off and then back on.
4. Within Self-diagnosis go to DTC readout for diagnostic address 00175 and clear the DTC.
5. Cycle the ignition off and then back on again.
6. Verify that the SOS light is green and/or the Audi connect User management option is now selectable.
7. If the issue persists disconnect the tester, roll the windows up, close all doors, and lock the vehicle for 2-3 minutes to allow the car to go through a sleep cycle, then retry steps 4-6 if necessary.

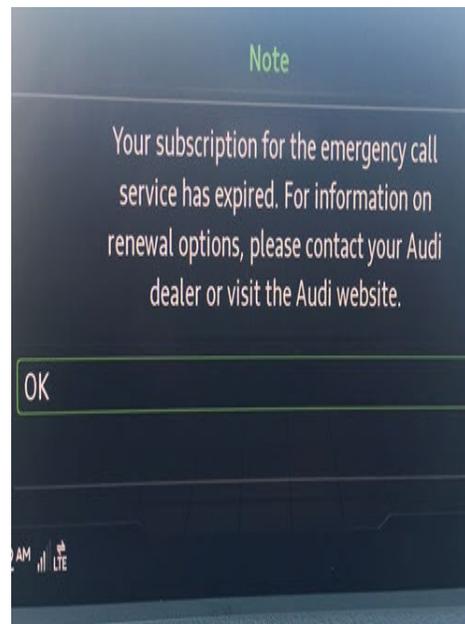
Figure 2. Error message in MMI.

- The SOS emergency button is red or flashing red. When the customer presses the button, the message “Your subscription for the emergency call service has expired. For information on renewal options, please contact your Audi dealer or visit the Audi Website” (Figure 2) is displayed.
