Service Bulletin

Bulletin No.: 21-NA-097

Subject: Rattle or Buzz Noise from Instrument Panel Area

Brand:	Model:	Model Year:		VIN:		Engine:	Transmission:
		from	to	from	to		
Chevrolet	Silverado	2015	2018				
	Silverado 2500HD/3500HD	2019	2022				
GMC	Sierra	2015	2018				
	Sierra 2500HD/3500HD	2019	2022

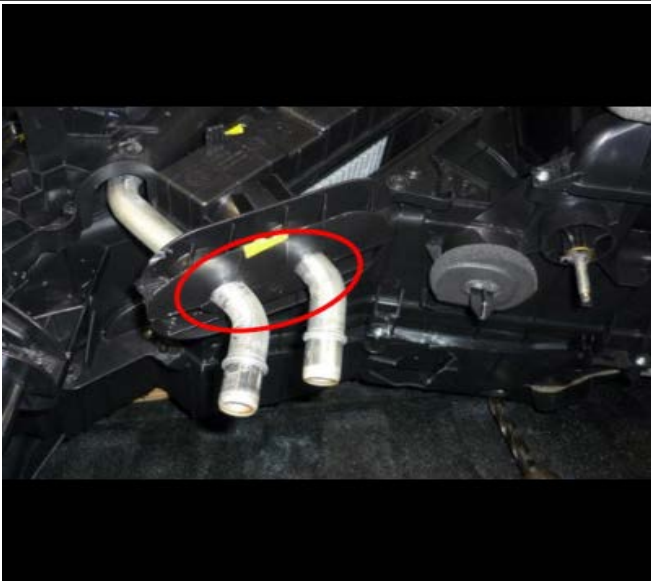
Involved Region or Country	North America, Middle East, Israel
Condition	Some customers may comment on a rattle/buzz type noise from the center instrument panel area.
Cause	<div>

</div> <p>5812781</p> <p>This condition may be caused by the heater core pipes contacting the HVAC case.</p>
Correction	Install a foam insulator between the heater core lines.
