Service Bulletin

Bulletin No.: 21-NA-265

Subject: Coolant Leak Under Truck, Malfunction Indicator Lamp (MIL) Illuminated - DTC P2C48 Set

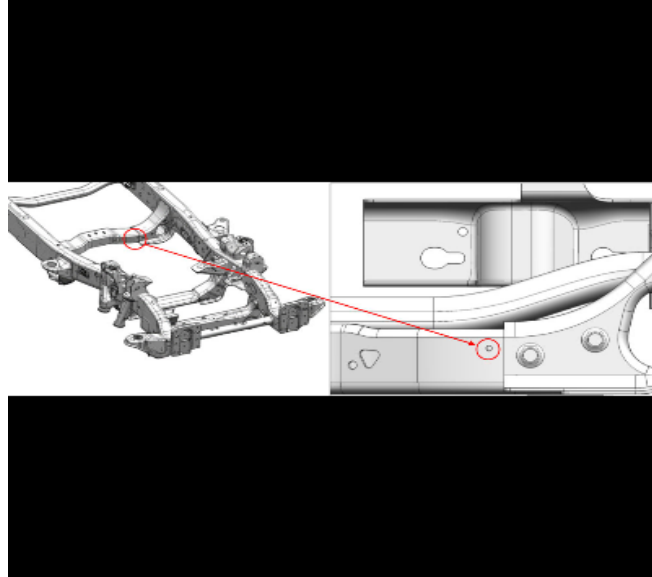
5924533

| Cause | This condition may be caused by the fuel cooler coolant hose contacting front drive shaft at cross-member. <ul style="list-style-type: none">– Typically can happen when driving through deeper water or snow. |

1. Utilizing a 6.5 mm drill size, drill a hole in the transmission crossmember in the approximate location noted in the graphic above.
