# TECHNICAL SERVICE BULLETIN

## Exterior Door Does Not Open From The Outside Handle

22-2246

27 June 2022

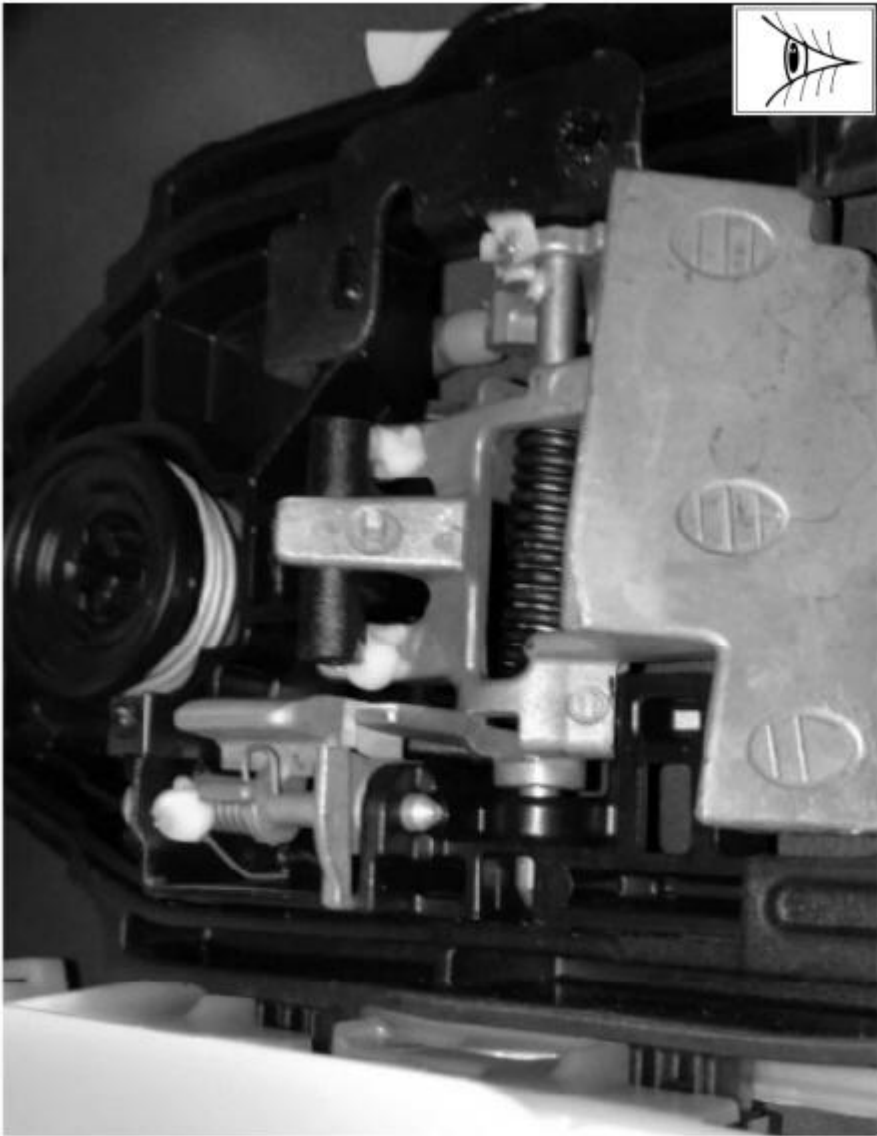
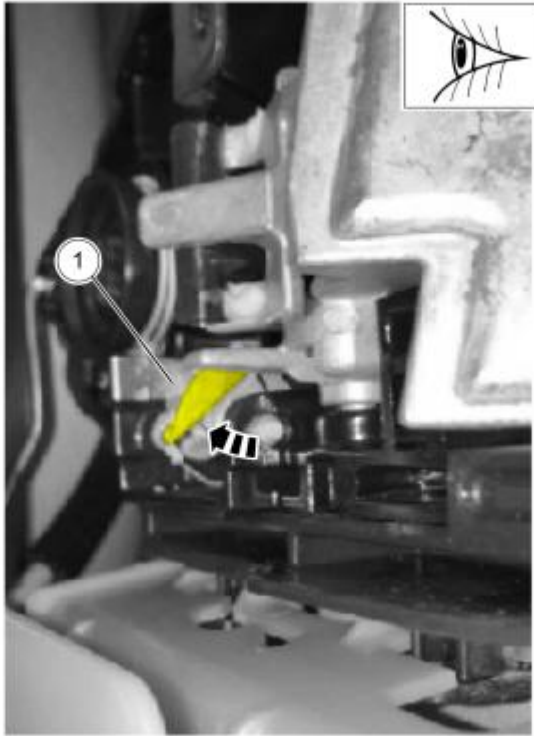
3. Inspect the exterior door handle reinforcement for permanent engagement inertia lock clip engaged and the inertia lock rotated outboard (Figures 1-2). Is the inertia lock rotated outboard and the permanent engagement inertia lock clip engaged?
