# Heater Hose Reduced Clearance May Cause Early Horn Failures

# 83-161

**Freightliner  
Service Bulletin**

**Description of Revision:** *This bulletin replaces the version dated 08/25/2021. The bulletin title has been revised.*

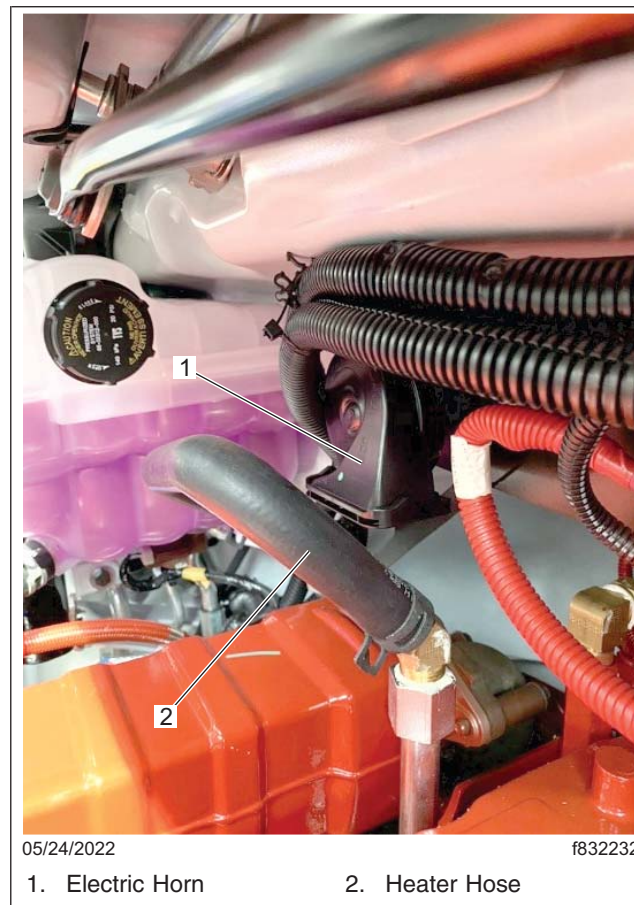
Some Business Class M2 106 vehicles built from January 2017 through June 2021 may have a heater hose installed too close to the vehicle's electric horn(s). This service bulletin applies to Business Class M2 106 vehicles with a 160 mm cab equipped with Cummins ISB engines with either single or dual horns. It also applies to heater systems with or without automatic shut-off valves. Horn failures have been reported due to high heat produced by the heater hose. In some cases, the horn comes in direct contact with the heater hose. See [Fig. 1](#).

**Fig. 1, Heater Hose Adjacent to Electric Horn**

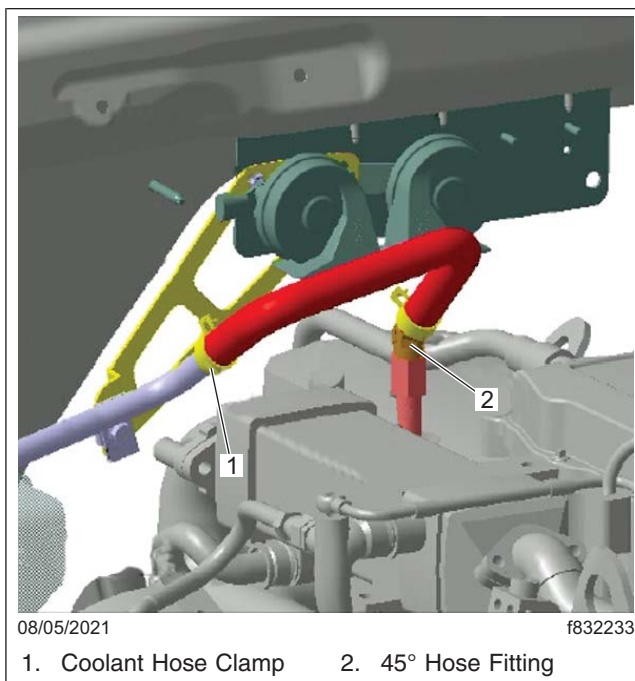
**Fig. 2, Original Heater Hose Installation**

3. Disconnect the batteries.
4. Open the hood to access the heater hose installation.
5. Drain the coolant.
6. Remove the coolant hose as follows.
  - 6.1 Remove the clamp opposite the 45 degree fitting, as shown in **Fig. 2**.

- 6.2 Remove the 45 degree fitting shown in **Fig. 2**. Use a wrench to hold the end of the heater coolant supply tube as you remove the fitting.
7. Install the tube reflecting sleeve (part number BEN 476445028) on the heater hose and secure it with tie straps. See **Fig. 3**.

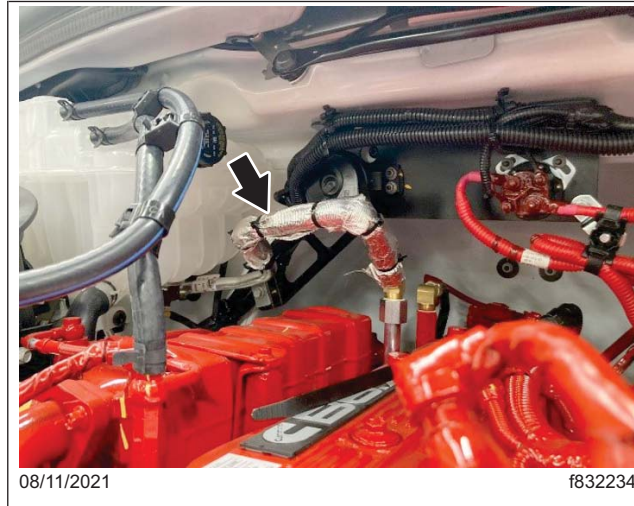
**Fig. 3, Tube Reflecting Sleeve**

NOTE: The additional 90 degree fitting is not required if the heater coolant system is equipped with an optional supply shut-off valve. In this case, only install the tube reflecting sleeve.

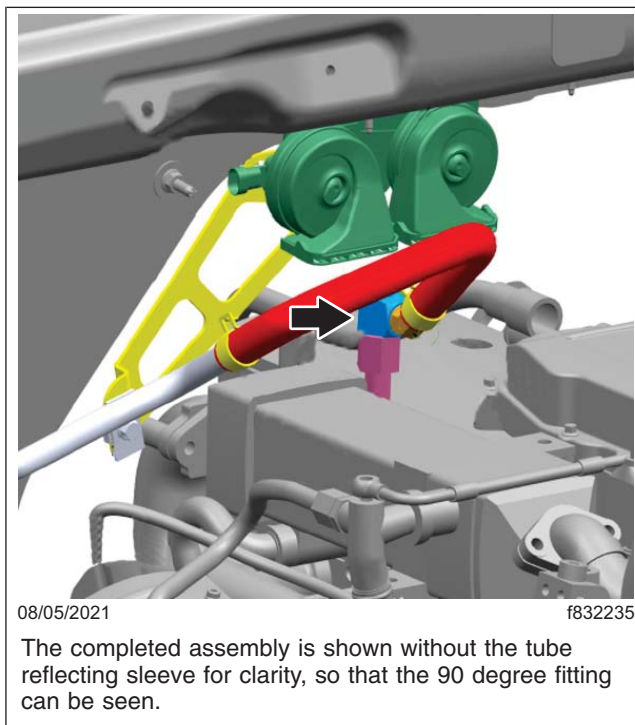
**Fig. 4, Updated Heater Hose Installation**

8. Attach the 90 degree fitting (part number 210503 000027) under the 45 degree fitting. See [Fig. 4](#).

- 8.2 Tighten the fitting assembly by hand.
- 8.3 Using a wrench to hold the end of the coolant supply tube, attach the fitting assembly to the tube. Tighten the fitting assembly 40 lbf-ft (54 N-m).
- 8.4 Attach the heater hose to the fitting assembly and secure it with a clamp (part number 23-09796-309).
