WARRANTY BULLETIN

Subject: **Front Sprocket Wear - Interim Solution**

No. **2019-11**

MODEL YEAR	MODEL	ADMISSIBLE UNITS
2015 2016 2017 2018 2019 (only some specific VIN)	Spyder® F3 Spyder® RT	Go to BOSSWeb/Warranty/Campaign Monitoring to know the quantity of units in your inventory impacted by this campaign

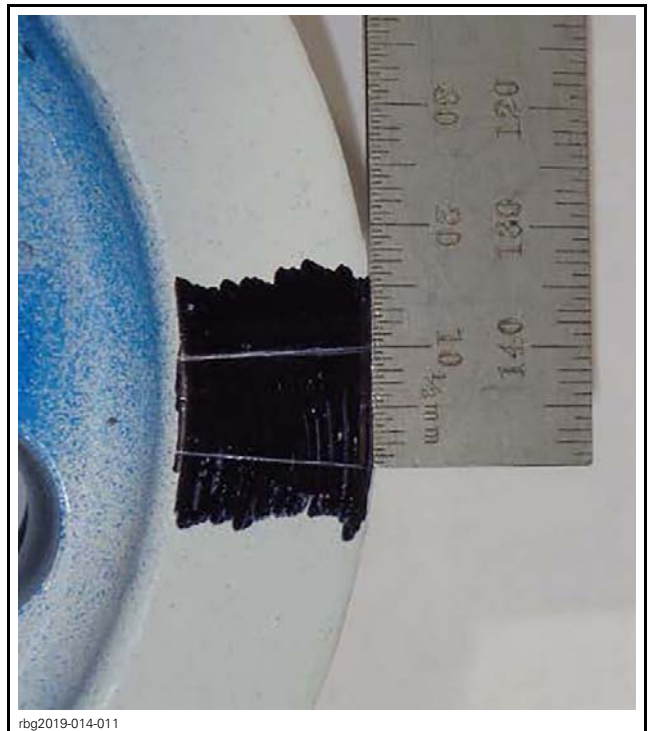
As covered in the *SAFETY CAMPAIGN BULLETIN 2019-10*, the front sprocket may be defective and may be subject to premature wear.

10. Measure the distance between both lines.

If the distance is **less than** 5 mm (3/16 in), proceed to step 11.

If the distance is **more than** 5 mm (3/16 in), replace front sprocket with a new one before proceeding to step 11.
