SERVICE BULLETIN

**CONVENTIONAL CAB STRUCTURE FRONT
MOUNT REPAIR**

BULLETIN NO: SB-22-014

SUBJECT VEHICLES: 2011MY-2019MY Conventional trucks equipped with a J08 engine

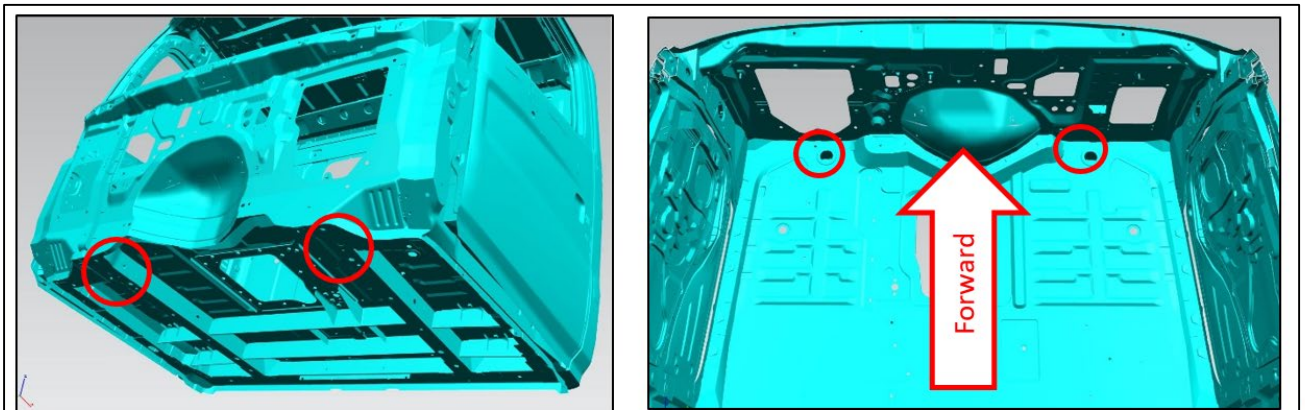
1. The location for the two potential crack locations are illustrated below.

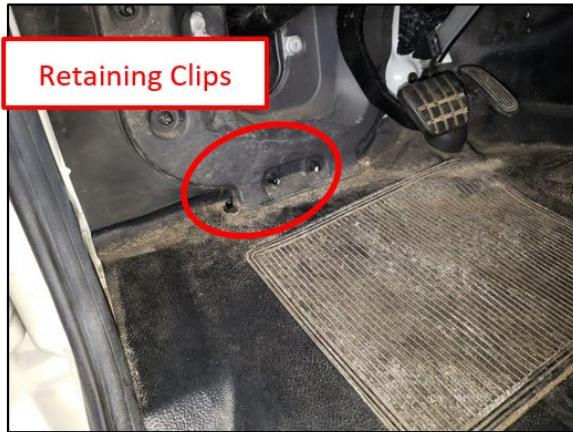
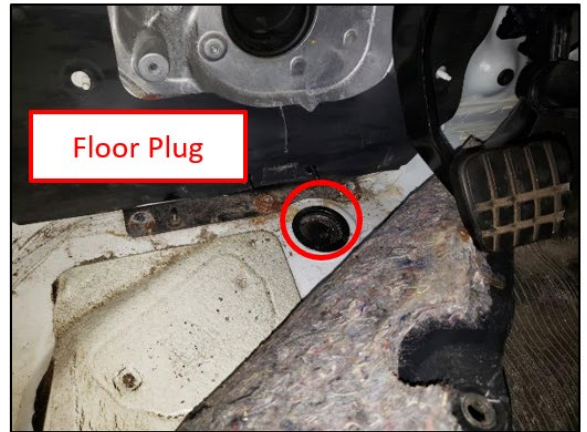
2. To inspect, the floor liner will need to be pulled back on both sides of the vehicle by removing the retaining clips and lifting up the floor liner. Remove the cab floor plugs to inspect for cracking around the bolt washers. Driver side is shown below.

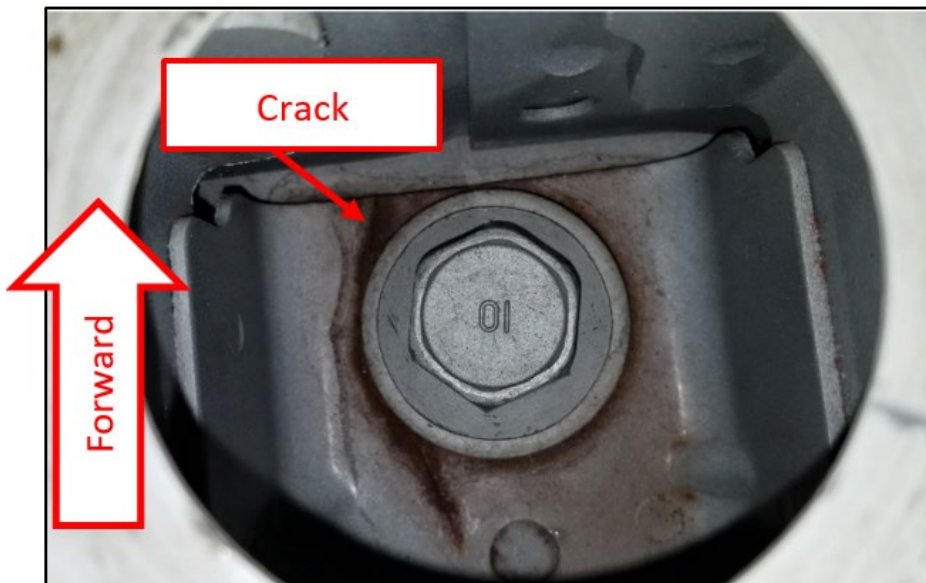
3. Example of a crack condition is shown in the photograph below. If there is no cracking, on both the driver side and the passenger side, do NOT proceed with this repair.

4. If cracking is identified in one or both sides, BOTH the driver side and passenger side of the cab floor forward mount channel will need to be reinforced with weld in place upper and lower reinforcement plates. Supporting the cab by means of an overhead hoist will be required throughout this repair procedure.
