Rear-end door is difficult to open

Topic number	LI72.20-P-073466
Version	2
Function group	72.20 - Tailgate, rear door
Date	6/16/22
Validity	Model 463 model year 2019 with code X20
Reason for change	Availability of replacement part

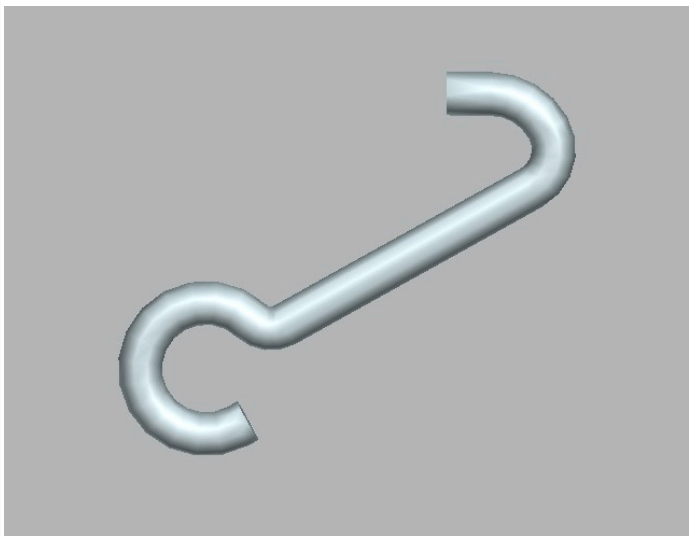
Attachments	
File	Description
Koppelstange_modifizierte Version.jpg

The link rod between the door lock and the central locking actuator motor may jump out when locking the vehicle.

1. Remove door trim of rear-end door AR72.20-P-6615XG
2. Only partially loosen dampening from the rear-end door (replace if damage is present)
3. Replace link rod that has sprung out (see picture 2 and parts note)
4. Perform function test.
5. Assemble in the reverse order
