SIB 63 02 22

2022-05-09

EXCESSIVE CONDENSATION IN HEADLIGHT

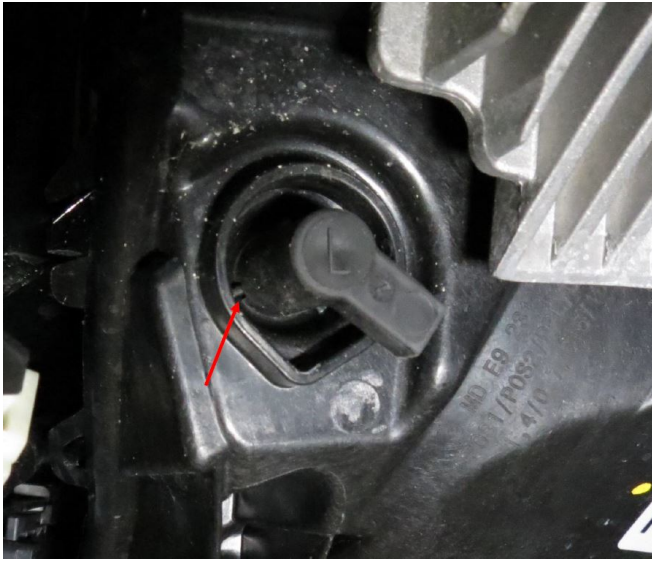
Note: The updated vent is notched to align with a rib on the headlight. Ensure the vent is aligned and fully seated onto the headlight.

Each headlight vent is side specific and marked by L (left) and R (right).

2. Using a suitable tool, remove the outer covers from each headlight.

3. Install the updated vents on both sides.
