SIB 64 02 22

2022-05-18

WINDSHIELD MISTS OVER AFTER DEPARTURE / NOISES IN THE RECIRCULATED AIR FLAP AREA

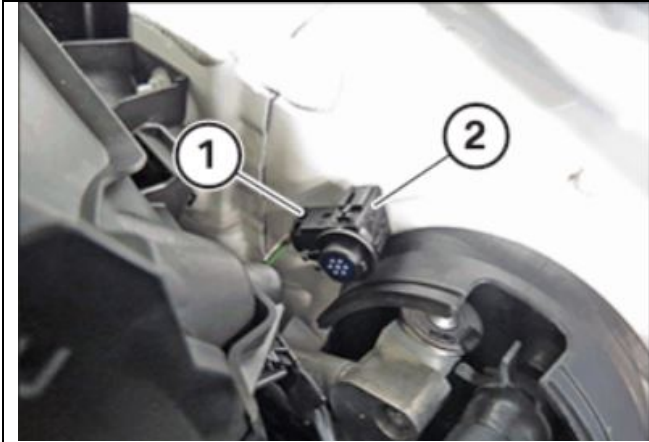
Implausible measured values of the AUC automatic air recirculation control sensor (recirculated air control).

Verify the part number of the installed automatic air recirculation control sensor.

If part number **64 11 5 A3F 255** or **64 11 5 A3F 250** is installed, this must be replaced by a new automatic air recirculation control sensor. Follow ISTA Repair Instruction **REP 64 11 991** “Removing and installing sensor for automatic recirculation air control”
