SIM 64 01 22

2022-05-18

WINDSHIELD MISTS OVER AFTER DEPARTURE / NOISES IN THE RECIRCULATED AIR FLAP AREA

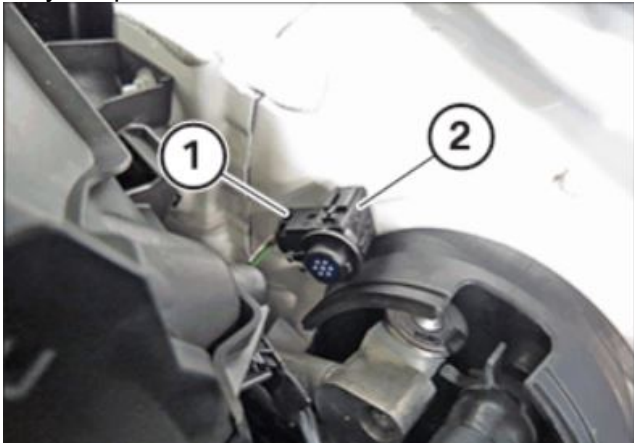
Verify the part number of the installed automatic air recirculation control sensor.

If part number **64 11 5 A3F 255** or **64 11 5 A3F 250** is installed, this must be replaced by a new automatic air recirculation control sensor. Follow ISTA Repair Instruction **REP 64 11 991** "Removing and installing sensor for automatic recirculation air control"
