SIB 21 01 22

CLUTCH NOISES WHEN DRIVING OFF FROM A STANDSTILL

2022-05-26

Service Information Bulletin

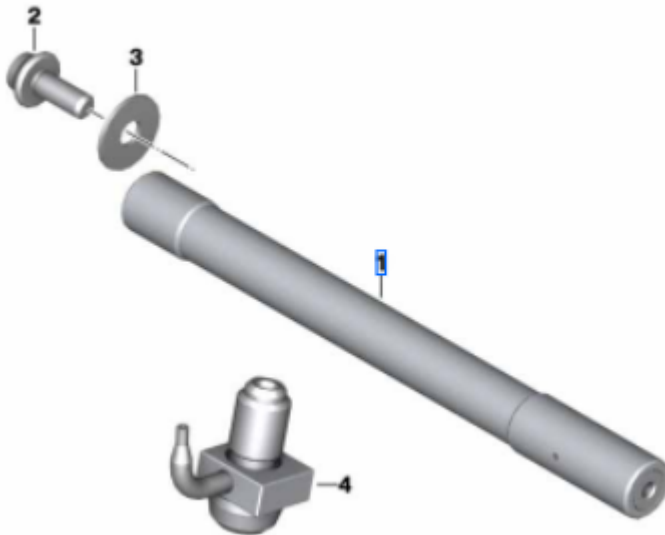
Figure 1: Oil Pipe (#1 in picture)

In the clutch friction phase when driving off, the clutch makes squeaking noises.

A modified oil pipe which increases the oil supply to the clutch, part number below, must only be installed in the event of a noise complaint by a customer.

In case of such a complaint, inspect the clutch discs for damage and signs of overheating; if none are found, replace the oil pipe using the information below, reusing the clutch components.

If damage and signs of overheating are found, replace the oil pipe using the information below, and replace the clutch disc set, remembering to thoroughly oil it before installation.

NOTE: Because the new and old oil pipes differ only in their internal structure - there are no external distinguishing features – there is a risk of mixing them up. Mark the new oil pipe prior to the removal of the old oil pipe.

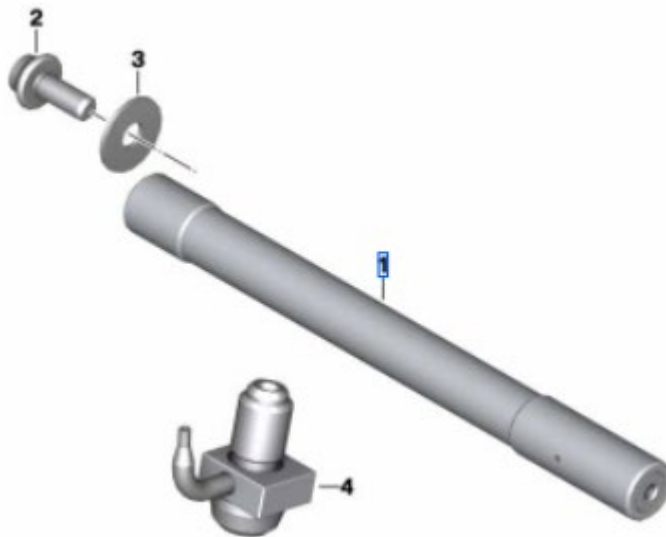
Figure 1: Oil Pipe (#1 in picture)

In the clutch friction phase when driving off, the clutch makes squeaking noises.

A modified oil pipe which increases the oil supply to the clutch, part number below, must only be installed in the event of a noise complaint by a customer.

In case of such a complaint, inspect the clutch discs for damage and signs of overheating; if none are found, replace the oil pipe using the information below, reusing the clutch components.

If damage and signs of overheating are found, replace the oil pipe using the information below, and replace the clutch disc set, remembering to thoroughly oil it before installation.

NOTE: Because the new and old oil pipes differ only in their internal structure - there are no external distinguishing features – there is a risk of mixing them up. Mark the new oil pipe prior to the removal of the old oil pipe.
