**Location:** Powertrain - Cooling Systems

**Topic:** Coolant leak from engine coolant pump

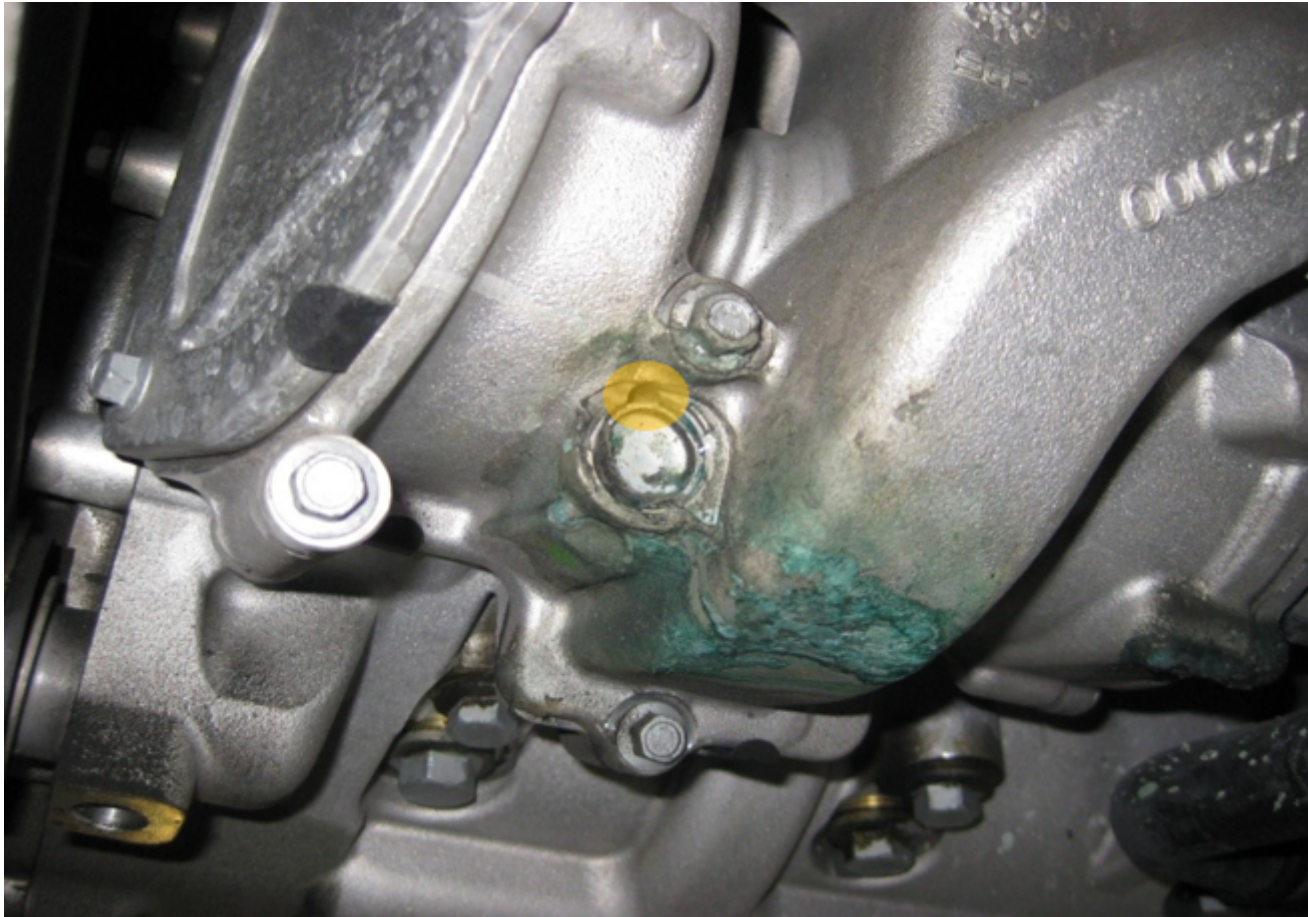
1. On earlier models only, the coolant pump evaporation chamber was situated above the core plug. (See highlighted image below)

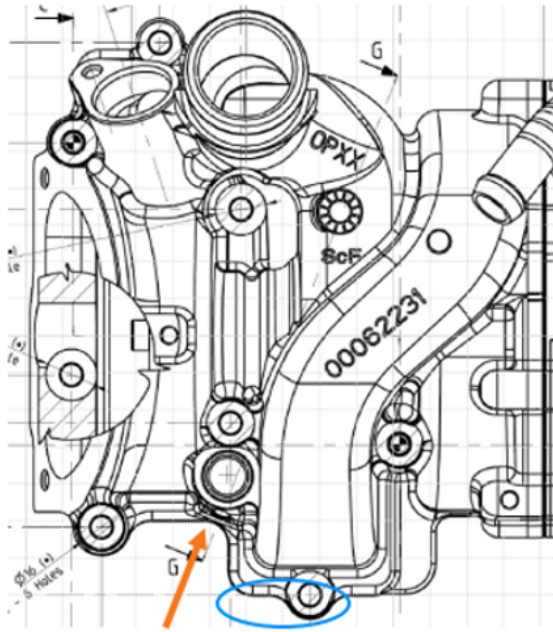
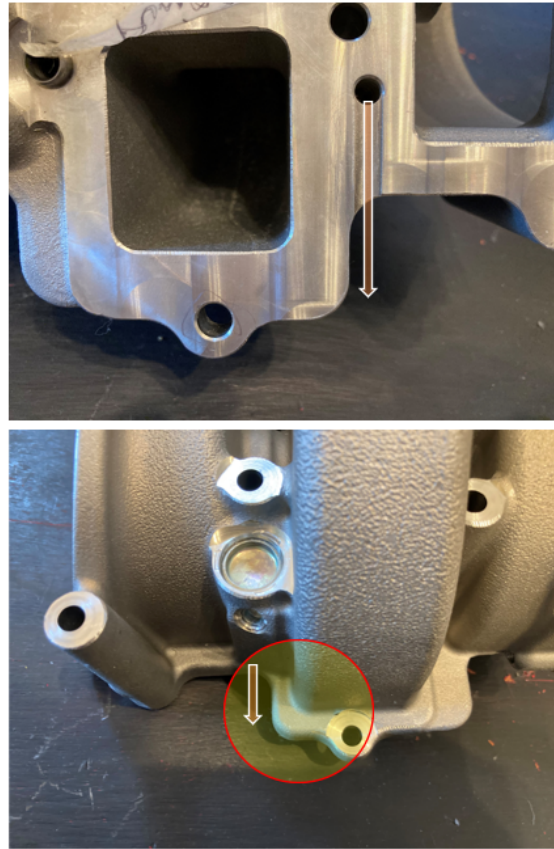
### Front Evaporation Chamber Exit Information

The front evaporation chamber exit can be easily misdiagnosed as a coolant pump gasket leak.

2. The images below show the front evaporation chamber exit where the coolant pump casing seals to the engine. Staining can collect near the highlighted bolt as a result of normal operation.

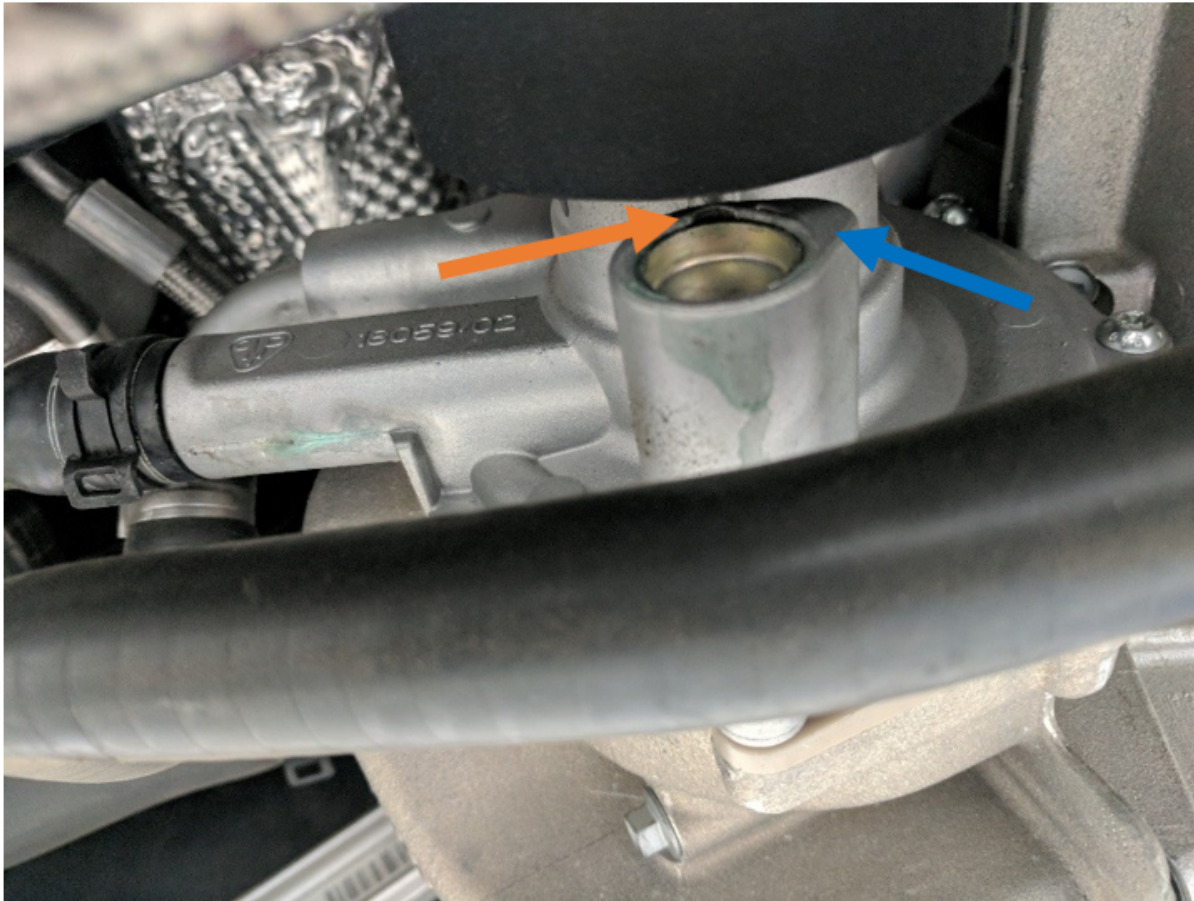
The rear evaporation chamber is below the output drive for the Air Conditioning Compressor and will show signs of staining on the underside.

3. At the rear of the coolant pump (Air Conditioning drive side) there is a core plug which covers the rear evaporation chamber. There is a small gap in the top of the casting to allow evaporation to occur, ref orange arrow. (On older parts beginning with "11", the evaporation chamber exit will be at the side of the core plug, ref blue arrow.

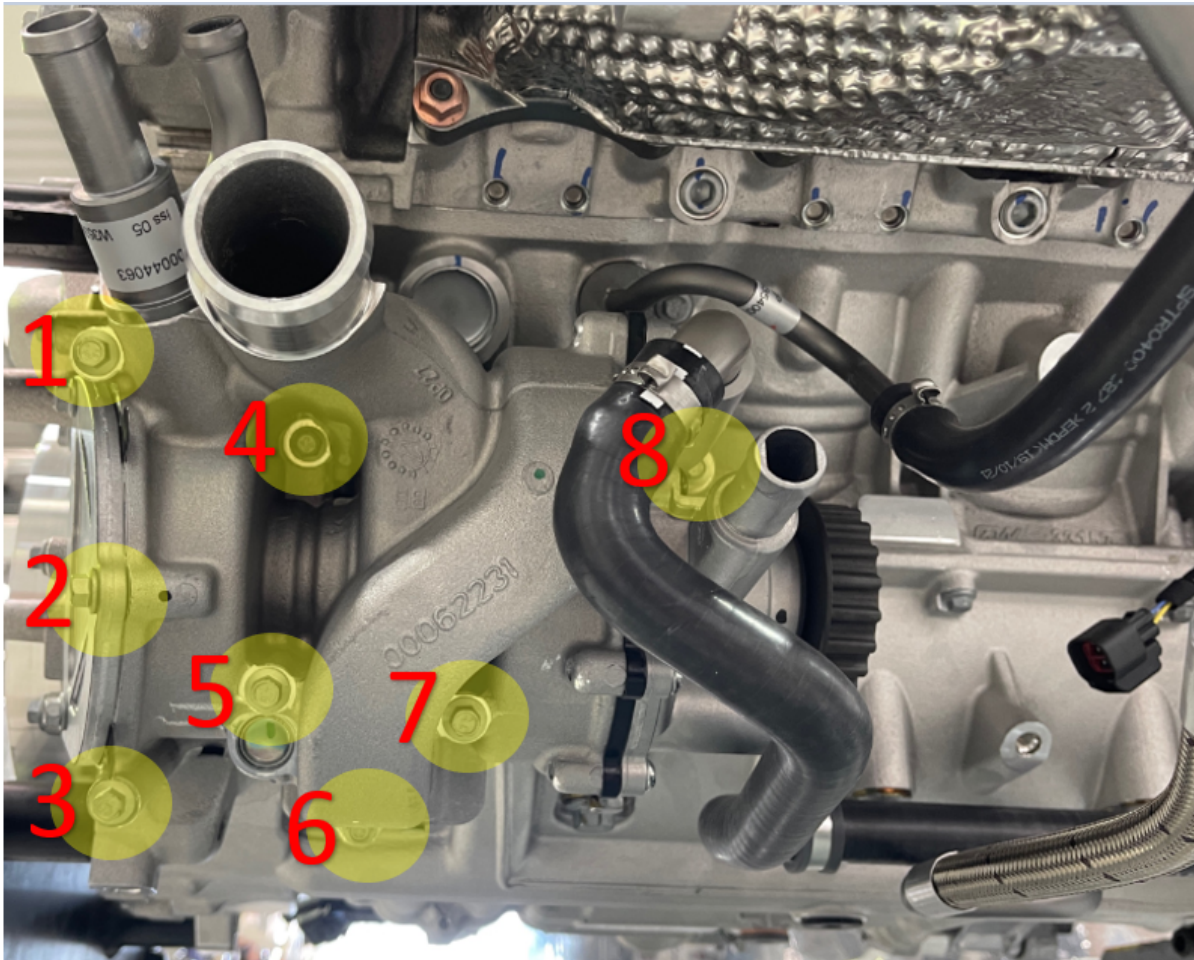
**NOTE:** Fixing number 2 is behind the service cover

12. If a leak is present and the water pump is to be replaced following the above steps, during the removal process, record the break off torques of the below fixings. These fixings are specified as the coolant pump to block mounting bolts. These values will be requested as part of the warranty claim.
