# McLaren Elva Door to Hinge Bolt Relaxation

| <b>Bulletin type:</b> | Service Campaign |
| <b>Campaign reference:</b> | SCB 26 A 005 |
| <b>Situation:</b> | Hinge to door bolts require replacement |

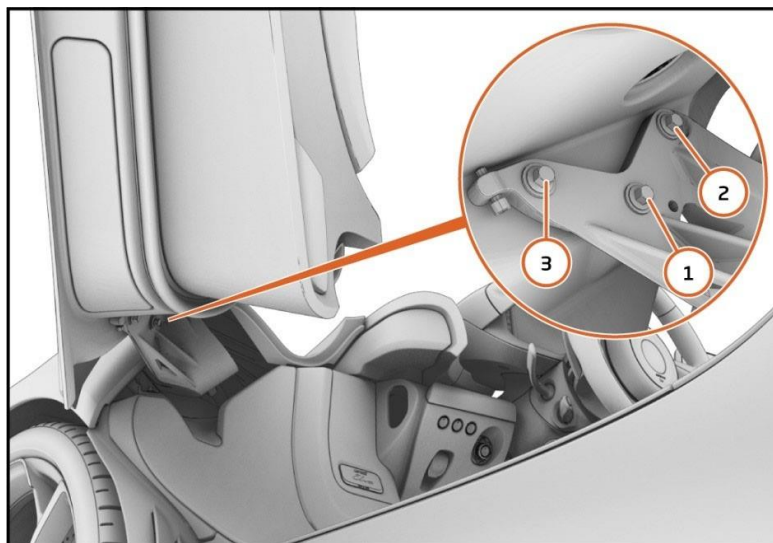
Through continuous product quality monitoring, McLaren Automotive has identified that on a specific number of McLaren Elva vehicles the door to hinge bolts on both driver and passenger doors may experience torque relaxation. Over an extended period of time, degradation of door gap and flush and potential clashing of the door striker to the latch surrounding may occur. To address this, McLaren has released a solution which includes the fitment of a longer bolt variant (three bolts per door hinge) following a specific torque up sequence.

Image 1 – Location of the three door to hinge bolts
