TECHNICAL INSTRUCTIONS

LIMITED SERVICE CAMPAIGN 22LD01

OPTIONAL BODY-COLORED REAR SPOILER DESIGNED FOR:

CERTAIN 2021 MODEL YEAR IS 300 VEHICLES

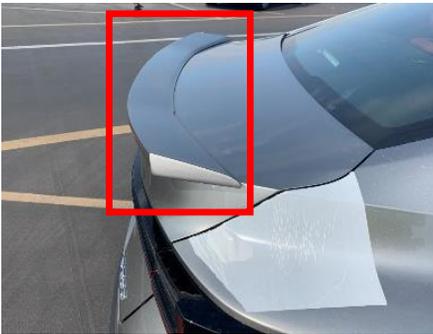
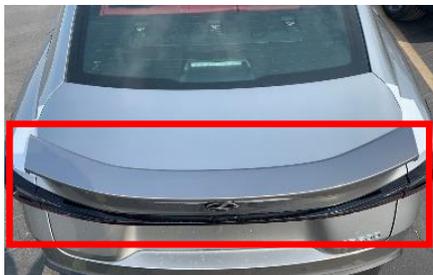
Lexus Body-Colored Spoiler

NG

AFFECTED

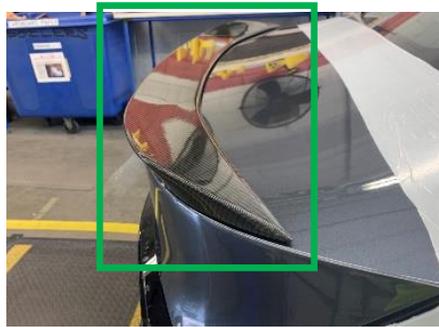
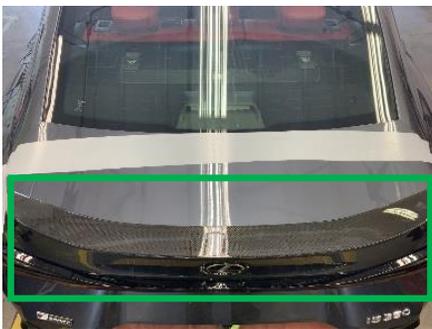
Lexus Carbon Fiber Spoiler

GOOD

NOT AFFECTED - CAMPAIGN COMPLETED

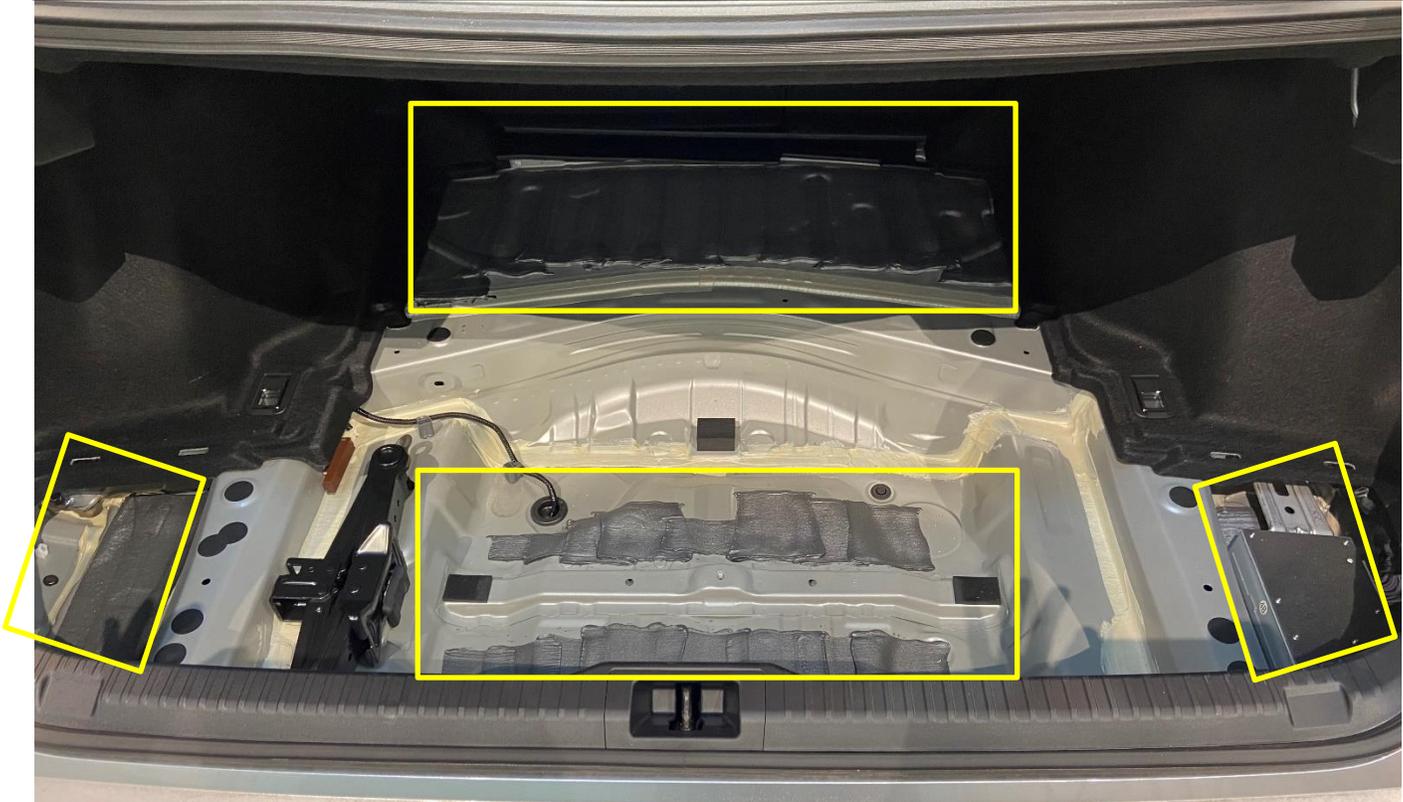
Organic Growth Inspection Areas

- a) Visually inspect the areas, shown below, for signs of organic growth caused by water intrusion.

NOTE: The areas shown immediately below are the most prone to organic growth because they are coated in factory applied LASD (liquid applied sound deadening).

Note that Organic growth must be remediated before doing any other repairs such as spoiler replacement or component replacement.

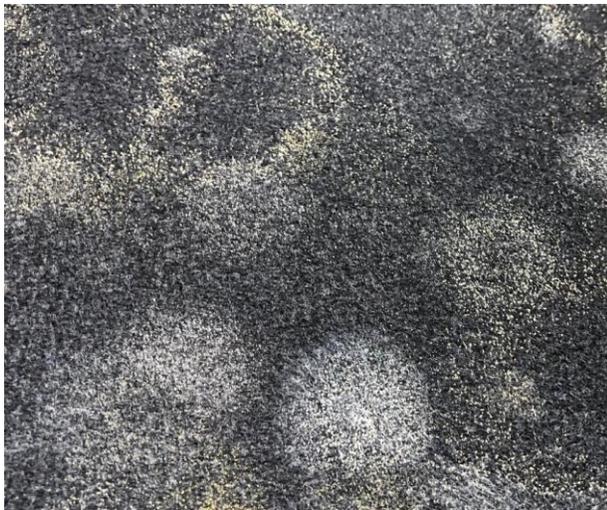
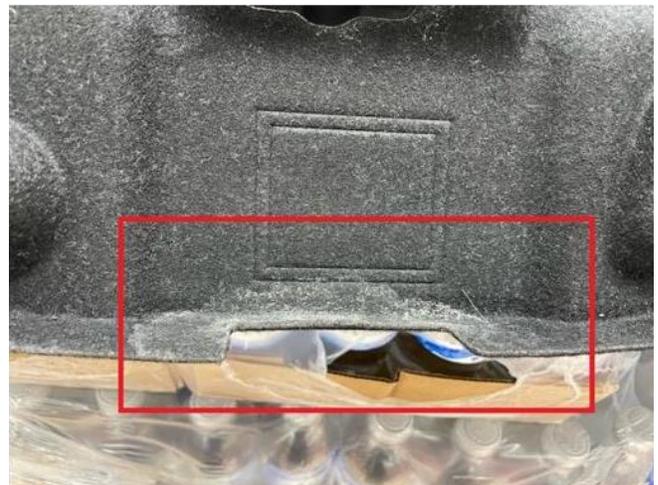
Examples of Organic growth

11. **VISUALLY INSPECT TRUNK FABRIC LINER COMPONENTS FOR ORGANIC GROWTH**
a) Visually inspect the fabric liners, shown below, for signs of organic growth caused by water intrusion.

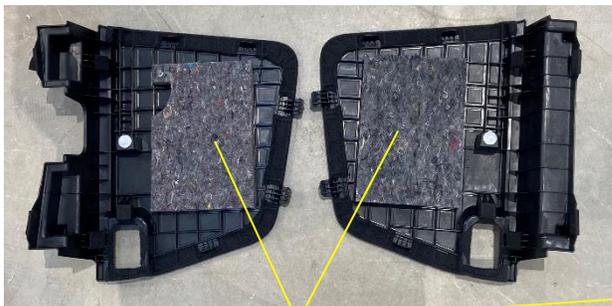
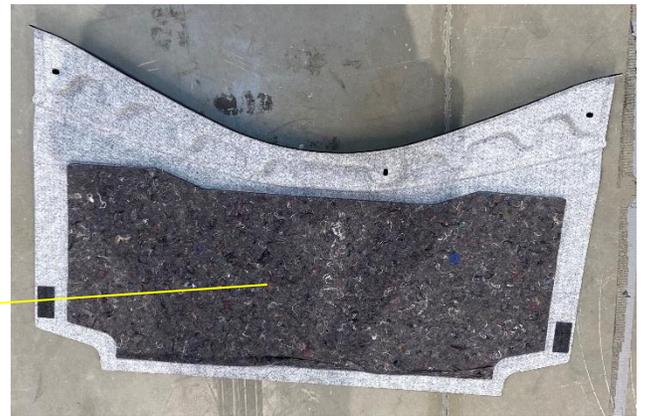
- b) Organic growth is most commonly found on the jute padding. But you should inspect both sides of the panel

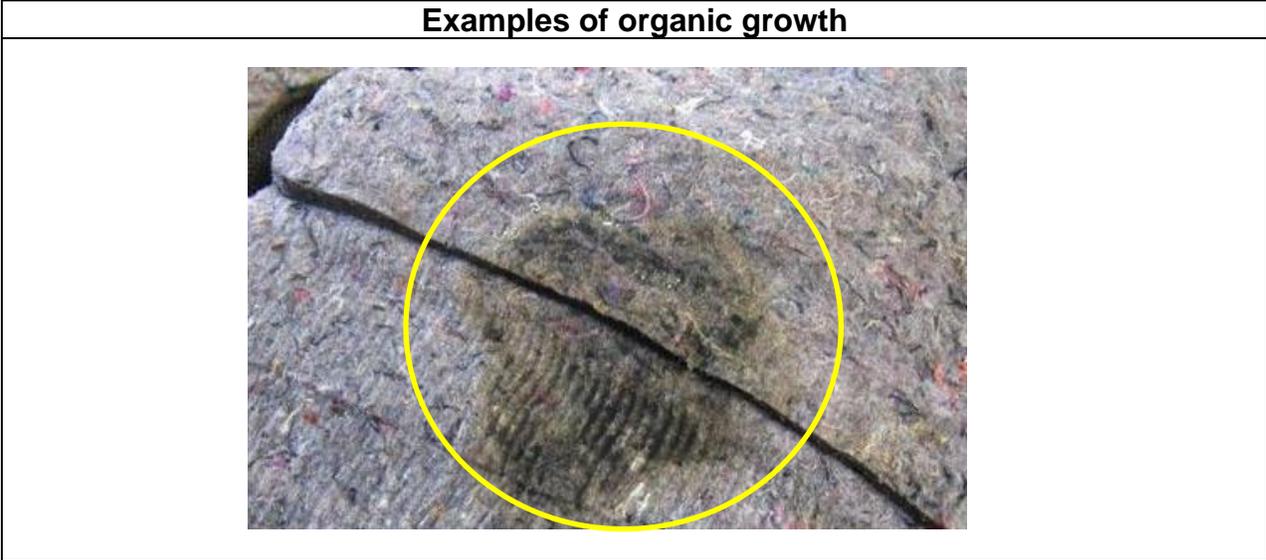
Organic growth is most commonly found on the jute padding
