REAR FENDER LINER (MUDGUARD) DOES NOT FIT CORRECTLY

Service Alert No.: SA-037/22

2023 CX-50

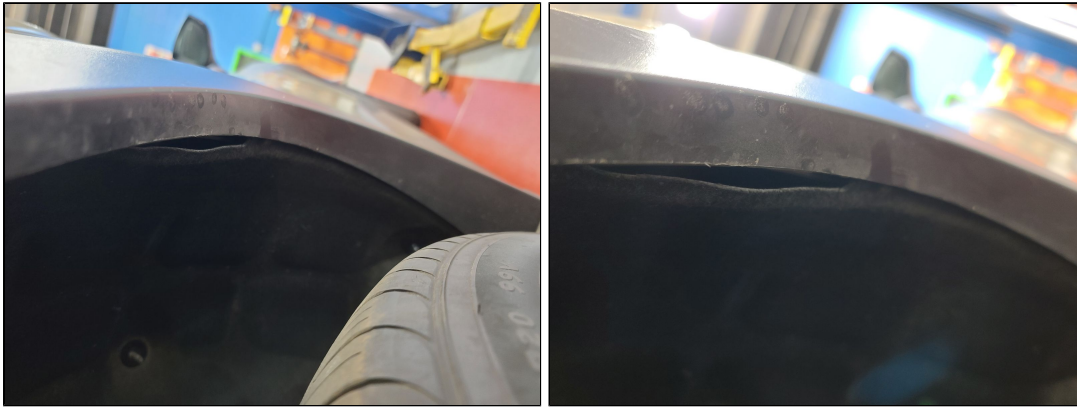
Customers may complain about either rear fender liner (mudguard) hanging down because it is too short to fit into the fender trim.
