Title: A26 Fuel Delivery Pressure Sensor (FDP) and Harness Pigtail Eliminated

Applies To: All A26 Engines

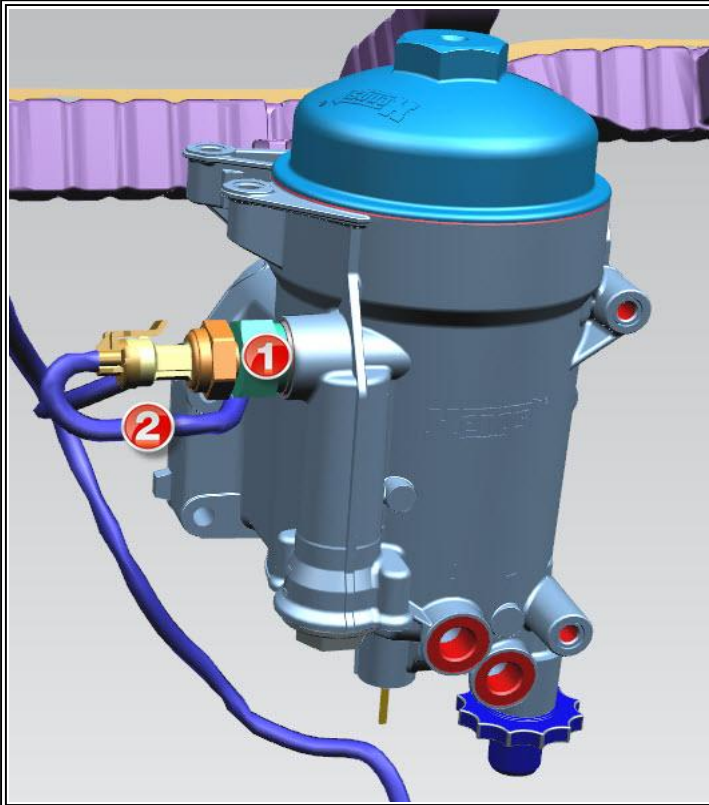
Figure #1: Engine Mounted Fuel Filter Housing

This document will explain the removal of the fuel delivery pressure sensor and harness pigtail on the A26 engine. The early built A26 engines had the fuel delivery pressure sensor installed in the engine mounted fuel filter housing (Figure #1) however, the ECM never monitored the signal from it. Later the sensor was removed, the port was plugged, and the engine harness was modified to remove the pigtail and the connector for it.

Item 1: Fuel Delivery Pressure Sensor (FDP)

Item 2: FDP harness pigtail and sensor connector

IT IS ACCEPTABLE to install a C92 harness on a newer engine not equipped with the FDP sensor.

- The unused pigtail (Figure #1 item 2) and connector for the FDP sensor can simply be tied off and tucked out of the way OR
- The pigtail (Figure #1 item 2) can be cut off, and apply heat shrink tubing at the wire ends
- The wiring for those circuits to the ECM are not used
