**Title: Cab Water Leak Troubleshooting Tips**

**Applies To:** LT, RH, ProStar, HX Steel Cab, and Lonestar sleeper cabs. However some aspects may also apply to all cabs in the High Performance Vehicle family - MV, HV, LT, RH, ProStar, LoneStar, TransStar, WorkStar(HV), DuraStar(MV), HX- (Steel cab) and TerraStar. Does not apply to: 9000i, PayStar(HX) Aluminum Cab, CityStar, CV, or LoadStar.

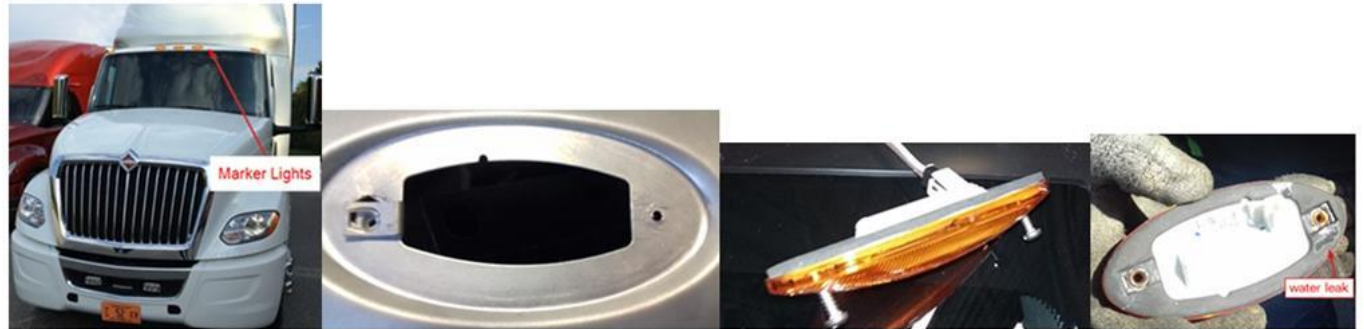
3. Roof marker lights
- Each marker light is held in place with two #8 SS sheet metal screws. Depending on the date of manufacture; one goes directly into the cab roof and the other goes into a U-nut clip. Sometimes the U-nut tears the foam gasket. Sometimes the screw that goes directly into the cab roof strips the hole and causes the gasket not to compress and seal. This design has had two updates. To resolve any marker light leak, replace/add two new flat U-nuts to each location.

- Remove each marker light to inspect and verify seal integrity. (See attached photos for example of defective seal.)
  - Check all five marker lights as more than one could be leaking. The small hole without a U-nut should be drilled out to approximately 10 mm and a new flat U-nuts 4325645C1 added to achieve proper torque for sealing. A light coat of RTV sealant on the foam gasket can be used if needed. Be sure to coat the drilled hole to prevent rust and use the new flat U-nut P/N: 4325645C1 in all places.

Be sure to remove and inspect all five marker light seals and be careful to not over torque the fasteners upon reinstallation.

- The hole size needs to be 10mm in order for the U-nut to engage to the panel and have proper float in the hole for this application.
  - Torque the two screws for each marker light to 20 +/- 10 IN-LBS (2.3 +/- 1.15 NM). **DO NOT OVER TORQUE AS PLASTIC LENS WILL CRACK.**

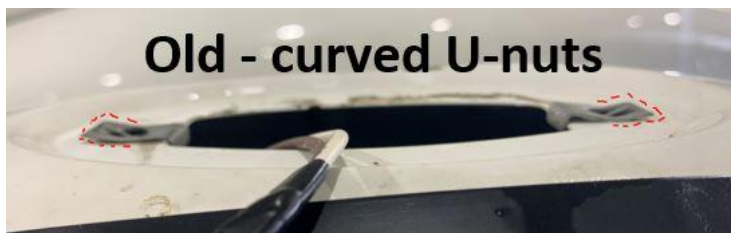
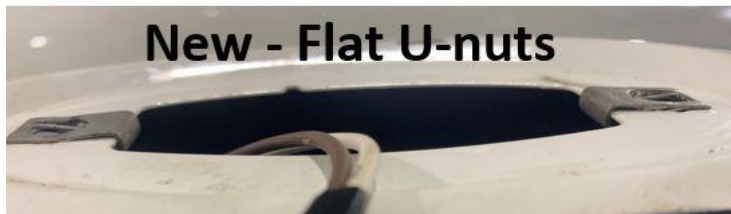
Images show the difference between the old and the new U-nut

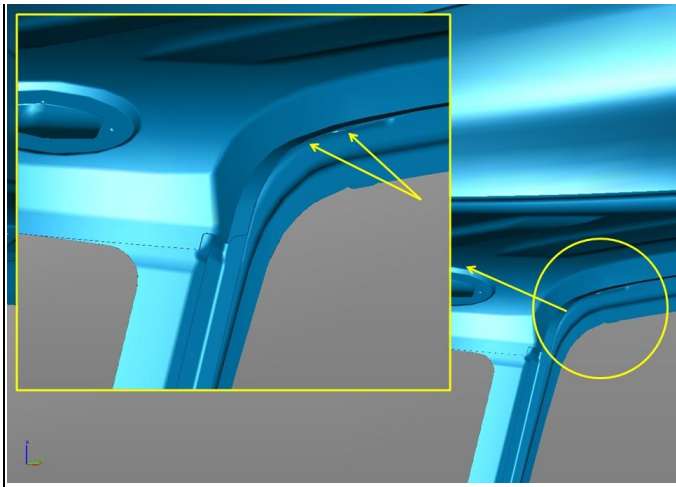
Although this seam is covered by the door seal, water can work its way under the seal and through this seam if this seam is not sealed properly at the factory.

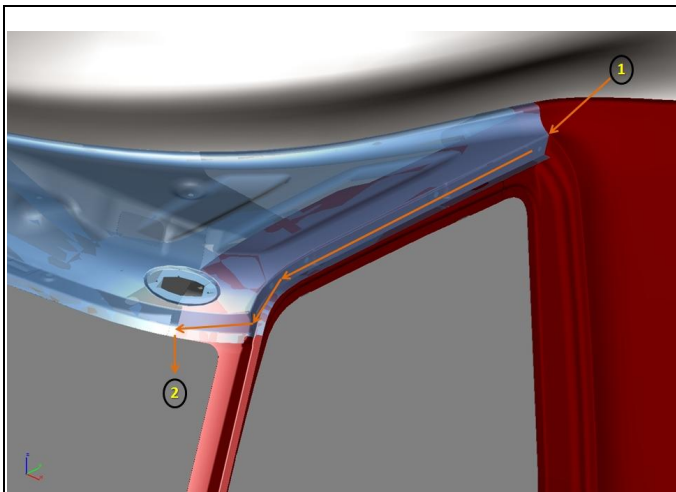
1. Water enters here.

2. Water exits here and drips down the inside of the windshield.

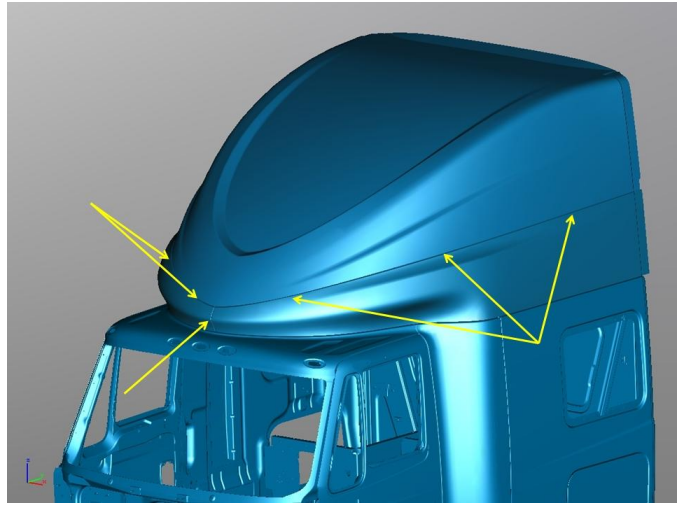
All roof seams should be checked for cracks or voids in the sealer.

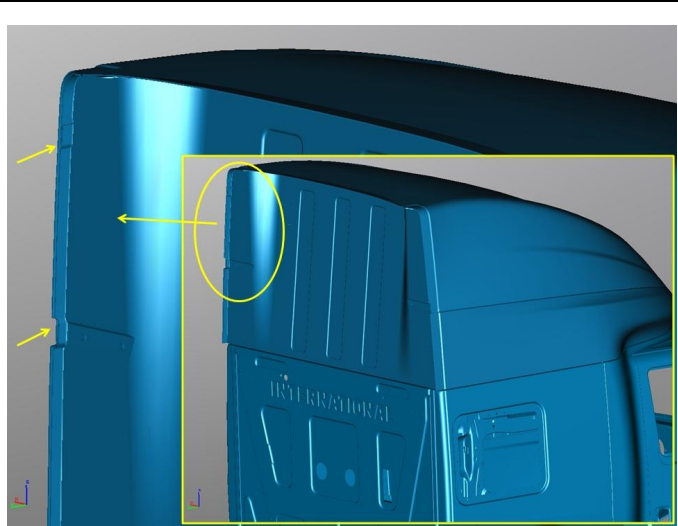
Seams at the rear corners of the Skyrise cab should be checked for voids.

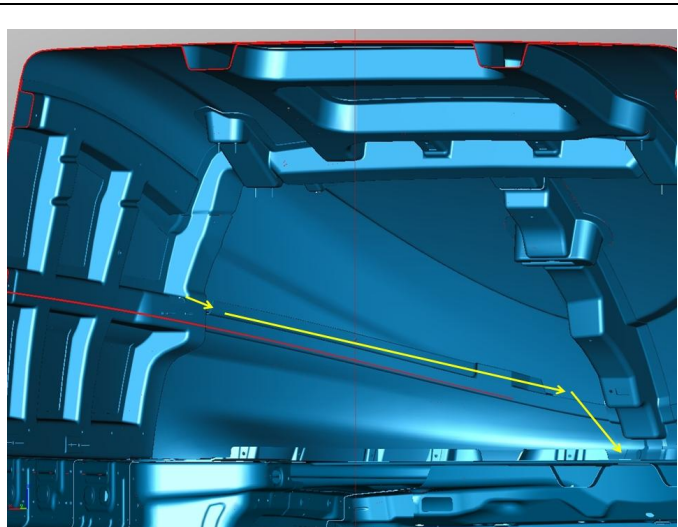
After penetrating the outer seams, water can travel along internal

reinforcement bond lines, ultimately draining into the trough formed by the lower roof panel and dumping near the front center of the driver compartment.

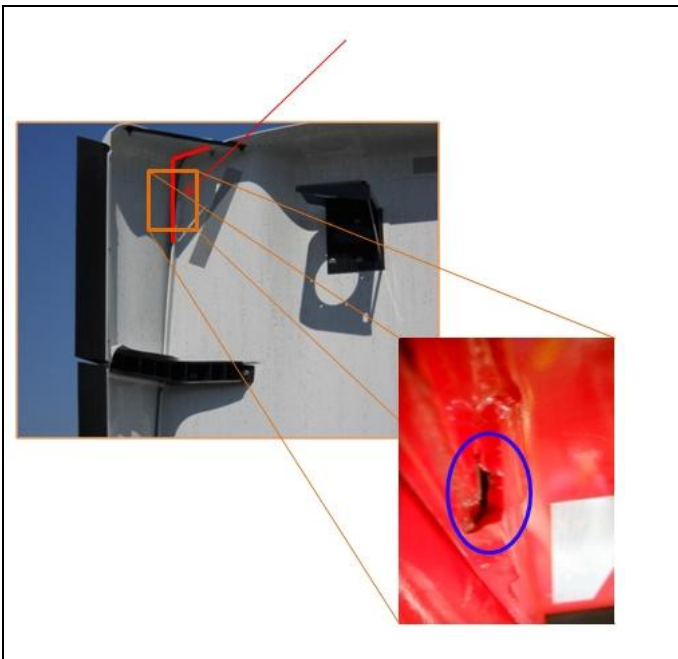
Top Photo - Driver side shown, passenger side symmetrically opposite.

This area is illustrated due to its obscurity as a water entry point. These instructions can be used on any roof seam that exhibits a void or inconsistency in sealer.

1. Using IPA (isopropyl alcohol) clean the seams/joints and any other suspect locations (visible voids/gaps) in the immediate area. Look to be sure the black plastic plug is not missing. If plug is missing replace with service part plug. (P/N: 498376C1)

2. Allow the surfaces to dry.
3. Apply Dow® BETASEAL™ (2611723C1) to the same areas cleaned in Step 1.
4. Immediately wipe off the surfaces (prolonged exposure to the Dow® primer could damage the paint). These surfaces are now prepped for good adhesion to the sealer.

5. Apply 3M® SMP Adhesive Sealant 760UV™ to the prepped surfaces. Force material into the joint where possible. For best results, apply sealer into the seam wiping in both directions.
6. Allow material to dry.

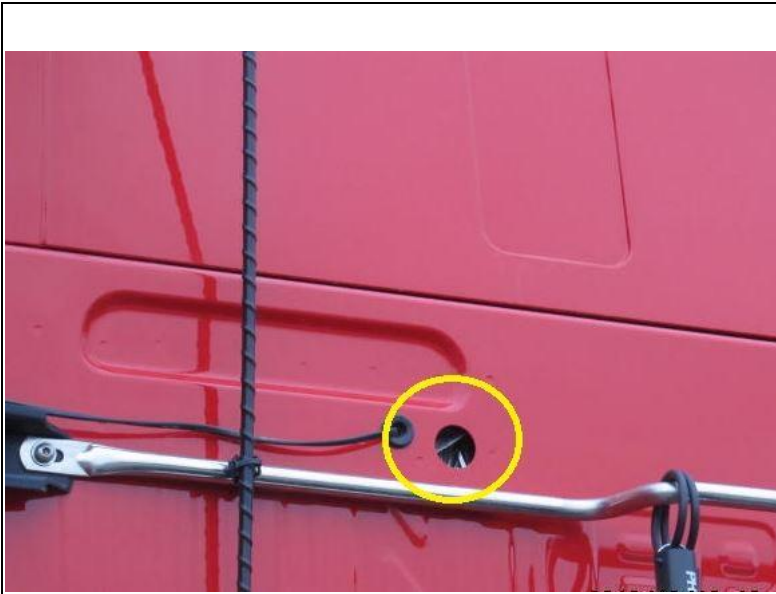
Example of missing plastic plug on BOC of most sleeper configurations. If this plug is missing; replace it with new one from service parts (p/n: 498376C1)

**Note: When inspecting BOC on Sleepers - Look to be sure the black plastic plug is not missing. If plug is missing replace with service part plug. (P/N: 498376C1)**
