Technical Service Bulletin

| Subject: KNOCKING NOISE FROM STEERING COLUMN WHILE DRIVING | Bulletin No.: 06-002/22 |
| | Last Issued : 06/14/2022 |

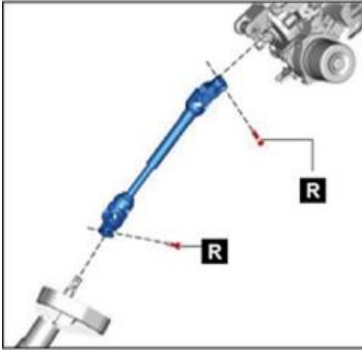
Replacement parts location

Some vehicle may exhibit a knocking noise from the steering column while driving. This may be caused by a gap between the intermediate shaft (upper side) and the joint bolt. To eliminate this concern, the intermediate shaft and the joint bolts have been modified to reduce backlash.

1. Verify the customer concern.
2. Replace the intermediate shaft with a modified one according to the instructions on MGSS (INTERMEDIATE SHAFT REMOVAL/INSTALLATION [US]).
3. Verify the repair.
