N222367510 Incorrect Accessory Exhaust

Release Date: July 2022 Revision: 00

Condition	Certain 2022 model year GMC Sierra 1500 vehicles, equipped with Accessory Exhaust Upgrade, (RPO
	WBC), may cause damage to the rear fascia.
Correction	Dealers will replace the exhaust, and if necessary, replace the rear fascia, parking sensor and wiring if
	damaged. Dealers will also issue a refund check since no accessory exhaust upgrade is available at
	this time.

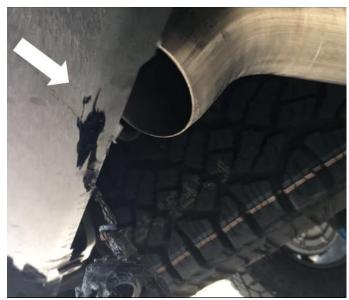
6093606

- 2. Inspect the rear fascia near the exhaust for evidence of damage as shown.
 - a. If damage is found to the rear fascia OR the rear park assist sensors or associated wiring harness, replace the entire rear fascia and impact bar. Refer to *Rear Bumper Impact Bar Replacement* in SI.
 - b. If any of the rear park assist sensors or associated wiring harness is damaged (or potentially compromised), then replace the affected park assist sensors and wiring. Refer to *Parking Assistance System* in SI.
 - c. If no damage is found, proceed directly to step 3.
- 3. Replace the exhaust. Refer to Exhaust Muffler Replacement and Exhaust Rear Pipe Replacement in SI.
- 4. Lower the vehicle. Refer to Lifting and Jacking the Vehicle in SI.
