Technical Service Bulletin

Subject: CORROSION AT THE CONTACT PART BETWEEN THE ROOF MOLDING CLIPS AND THE ROOF PANEL	Bulletin No.: 09-017/22
	Last Issued : 06/09/2022

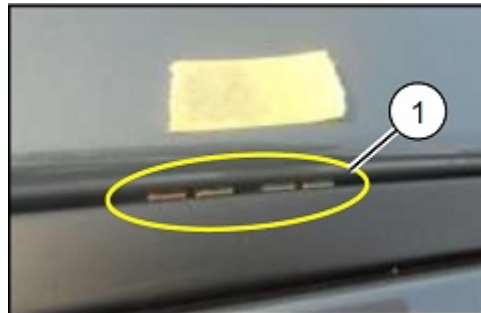
Some vehicles may have rust (1) on the contact parts between the clips (for attaching the roof molding) and the roof panel (ditches of the roof rail).

This is caused by the gap between the roof molding attachment clips and the roof panel not being wide enough to allow paint to be appropriately applied to the roof panel. To eliminate this concern, the shape of the roof molding clip has been changed to enable paint application between the clip's rib and roof during the manufacturing process. Customers having this concern should have their vehicle repaired using the following repair procedure.

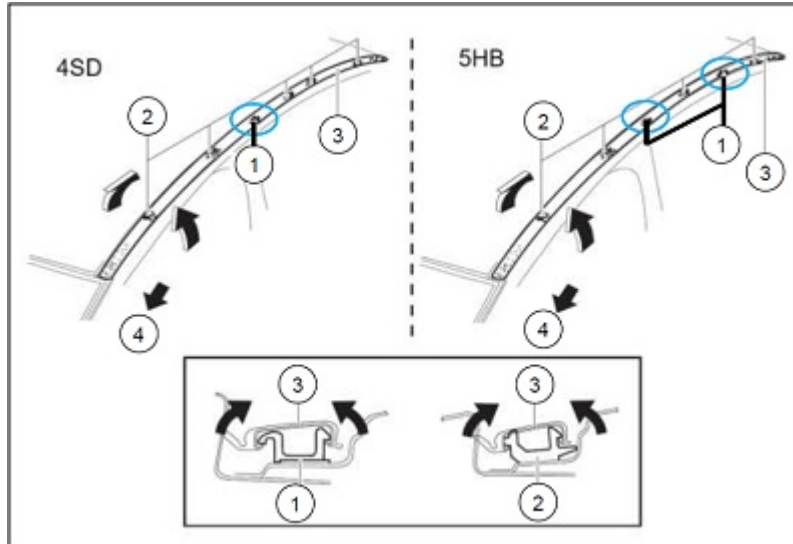
1	Clip A
2	Clip B
3	Roof Molding
4	Vehicle Front

1. Verify the customer concern.
2. Remove the roof molding clips, repair the rusted area, and replace the clips with new ones.
 - a. Remove the roof molding according to the procedure on MGSS (ROOF MOLDING REMOVAL).
 - b. Remove all mounted "Clip A's" from the vehicle. (Two clips for 4-door SD and four clips for 5-door HB).
