# Technical Service Bulletin

Mazda North American Operations  
Irvine, CA 92618-2922

<b>Subject:</b>  SPIDER WEB-LIKE CRACKING APPEARS IN CORNER(S) OF MAZDA CONNECT CENTER DISPLAY	Bulletin No.: 09-023/22
	Last Issued : 06/17/2022

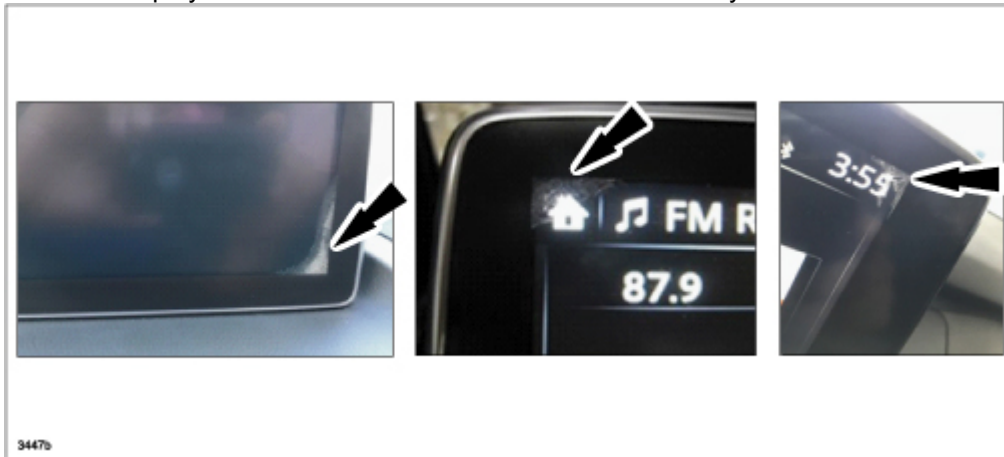
Some customers may complain about spider web-like cracking (as shown below) appearing in the corner(s) of the MAZDA CONNECT center display. The cracks are internal and cannot be felt by touch.

This concern may be caused by a lack of glue between the touch screen and the center display. To eliminate this concern in the future, the manufacturing process has been improved.

Customers having this concern should have their vehicle repaired using the following repair procedure.

1. Verify the customer concern.
2. Check if the screen is internally damaged (no external impact).
  - If YES, go to the next step.
  - If NO, this Service Information does not apply.
3. Replace the center display with a modified one according to the instructions on MGSS online:
  - CX-3 - CENTER DISPLAY REMOVAL/INSTALLATION
  - MX-5 - CENTER DISPLAY REMOVAL/INSTALLATION
4. Inspect the label at the bottom of the removed center display to check if the production date is on or after July 7, 2016.
