# Technical Service Bulletin

<b>Subject:</b>  <b>WARNING MESSAGE FOR DIRT ON FRONT RADAR SENSOR SURFACE APPEARS WHILE DRIVING IN SPECIFIC LOCATION</b>	<b>Bulletin No.: 15-004/22</b>
	<b>Last Issued : 06/01/2022</b>

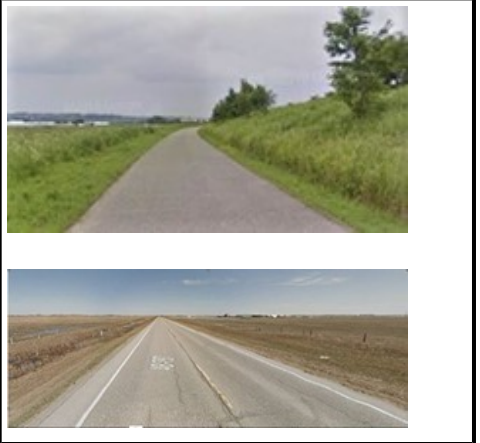
3	Roads with no reflective objects around

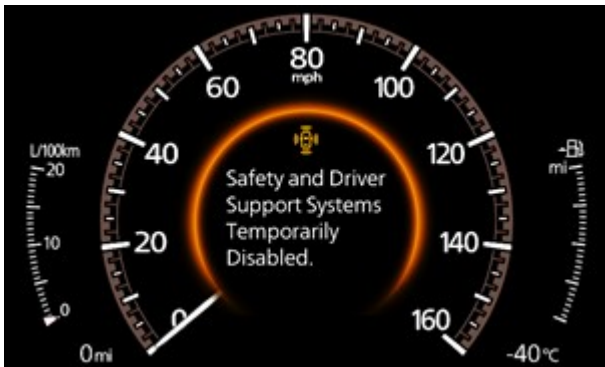
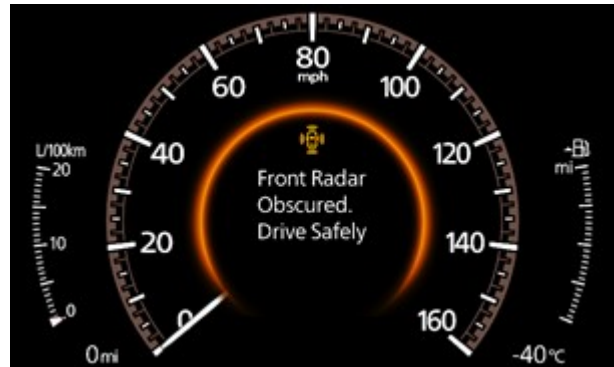
Warning message

Some vehicles may exhibit the warning messages “Safety and Driver Support Systems Temporarily Disabled” or “Front Radar Obscured. Drive Safely.” displayed in the instrument cluster despite no dirt on the front radar sensor while driving in specific locations as follows:

This is caused by inappropriate decision logic of the control software in the front radar sensor. To eliminate this concern, the control software of the front radar sensor has been modified.

1. Verify the customer concern.
2. Replace the front radar sensor with a modified one according to the instructions on MGSS.
