SERVICE BULLETIN

APPLICABILITY: 2019-22MY Impreza
 2019-22MY Crosstrek (Including Hybrid Model)
 2019-22MY Forester
 2019MY Legacy/ Outback
 2019-21MY WRX
 2019-21MY WRX STI
 2019-21MY BRZ- Navigation -equipped ONLY
 2019-22MY Ascent

NUMBER: 15-236-18R

SUBJECT: Reprogramming File Availability for Optimization of Harman Gen 3.1 and Gen 3.1α Audio and Navigation Head Units

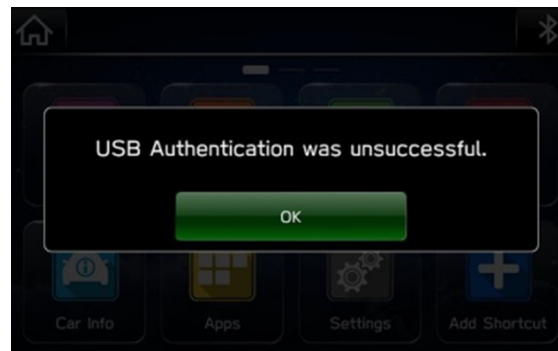
NOTE: If an attempt is made to install the wrong “grade” file into the wrong grade head unit (EXAMPLE: “Base” update file into a “Base Plus or Mid” or “High” head unit), the USB Authentication error screen below will be displayed:

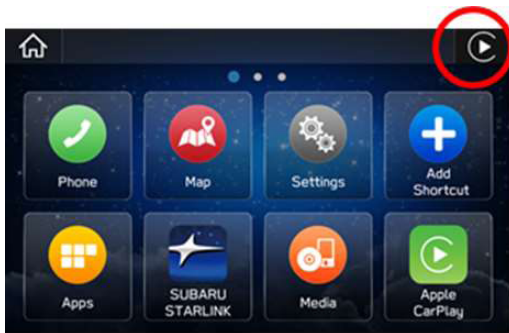
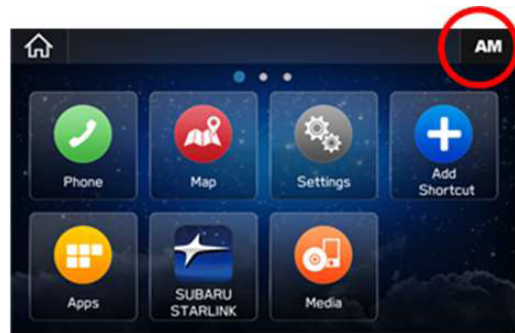
On Ver. 6.0 and before:

Music playing via iPhone in CarPlay.

After disconnecting, the music source changes to Radio automatically.

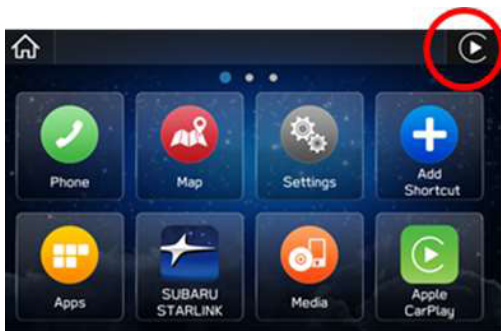
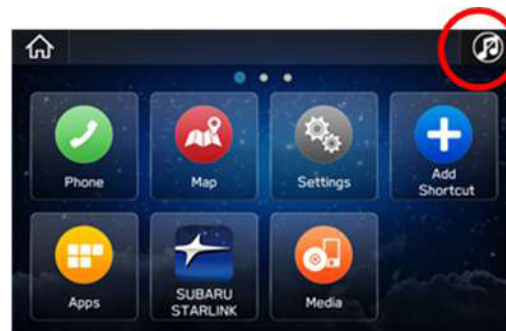
Music playing via iPhone in CarPlay.

After disconnecting, no music source is selected automatically.

If a source of music other than CarPlay has been playing when the iPhone is disconnected, the music source remains same (it is not turned off.)

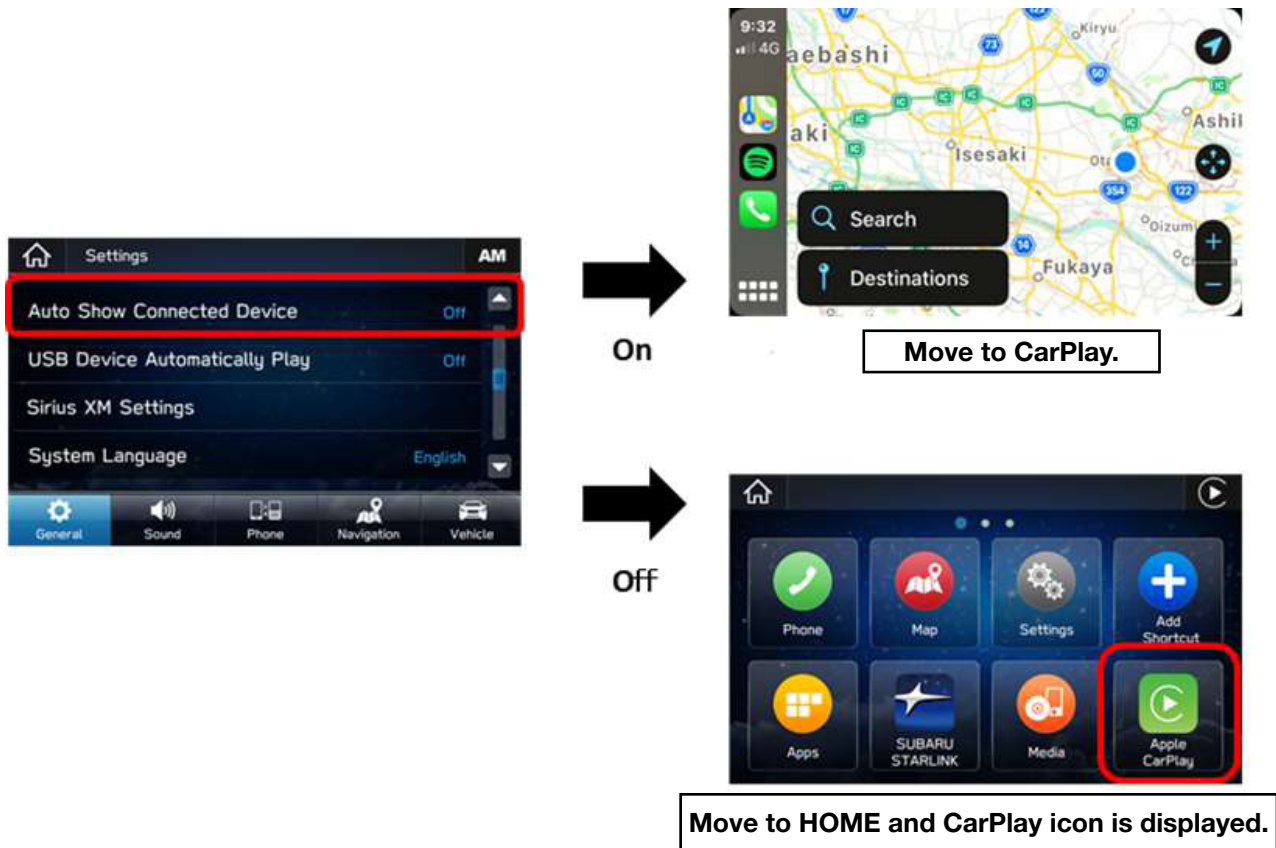
On Ver. 6.0 and before:

In a case where the iPhone was disconnected while playing music then reconnected while it is playing music, the system moves to CarPlay screen no matter what is set in <Auto Show Connected Device> in Setting (depending on iOS version of the iPhone.)

The <Auto Show Connected Device> is no longer available for CarPlay. The Setting menu shows only <Android Auto> to access the <Auto Show Connected Device> selection menu. If an iPhone with active CarPlay is connected, the Head Unit always moves to the CarPlay screen.

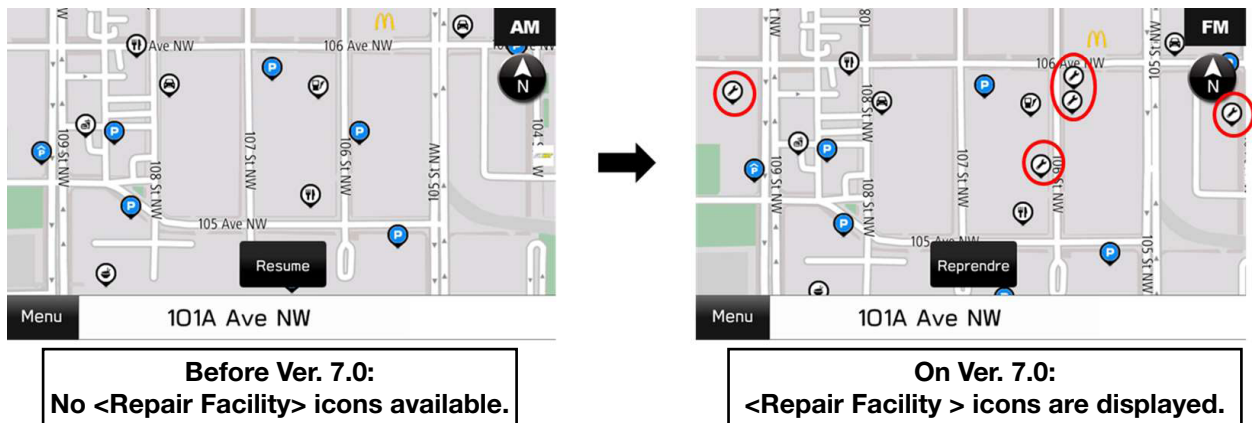
NOTE 4: Displaying Repair Facility POI icons:

<Repair Facility> Icons can be displayed in the NAVI Map.

<Repair Facility> Icons can be turned On or OFF by going to: Settings > Navigation > POI Icons.

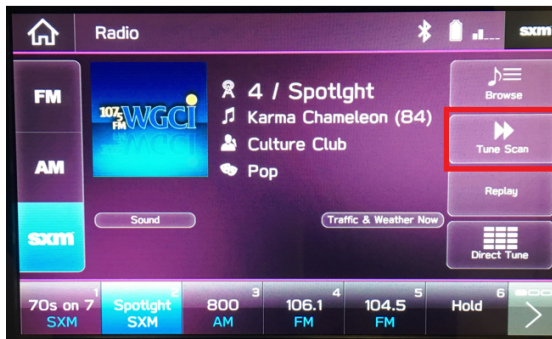
<Scan> previously displayed on SXM screen was changed to <Tune Scan> (a.k.a. SEEK).

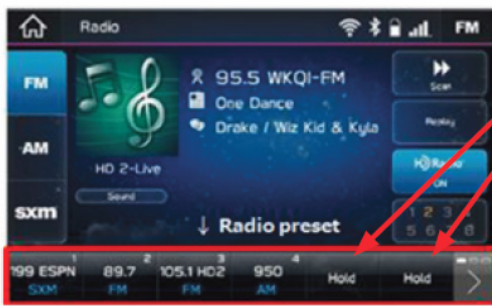
- 1) Station presets are lost. Touch buttons read “Hold”. (Applicable for software versions Rel_4.18.25.50 (or before)). Included in software version Rel_U1.18.38.50.
