**SERVICE INFORMATION BULLETIN**

**APPLICABILITY:** 2022MY WRX

**NUMBER:** 07-208-22

**SUBJECT:** Metallic Rattle Sound While Operating Horn

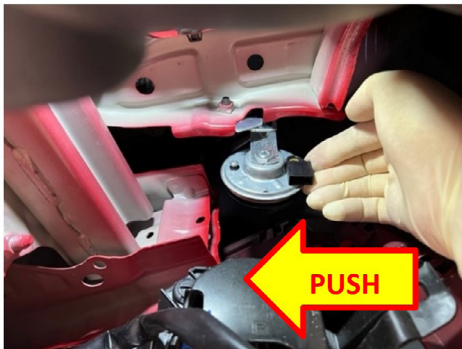
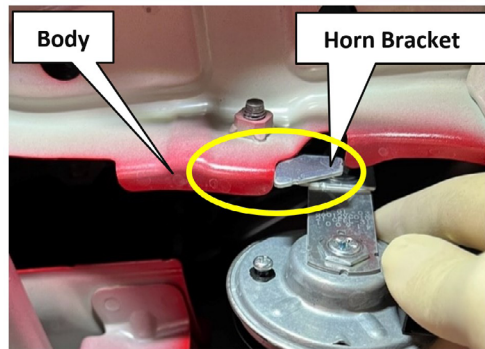
This Service Information Bulletin announces the work procedure for the passenger side horn. A customer may experience a “metallic rattle” sound when operating the horn. This may be caused by a resonating frequency within an excessive clearance between the passenger side horn mount and the body of the vehicle during operation. If this sound is duplicated, reposition the horn as per the procedure outlined below.

**STEP 6:** While applying slight pressure to the horn to ensure there is no clearance between the horn bracket and the vehicle body, Tighten the horn mounting bolt approximately one full turn.
