## SERVICE PROGRAM BULLETIN

**APPLICABILITY:** 2019MY Crosstrek

**SUBJECT:** Rear Seat Belt Webbing Locking

**NUMBER:** WRA-20R

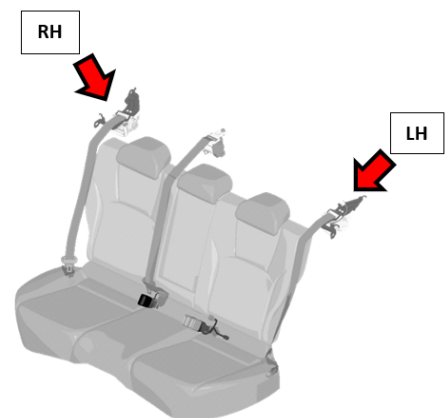
**NOTE:** Position Code and ID Code details are provided in the Service Procedure section below.

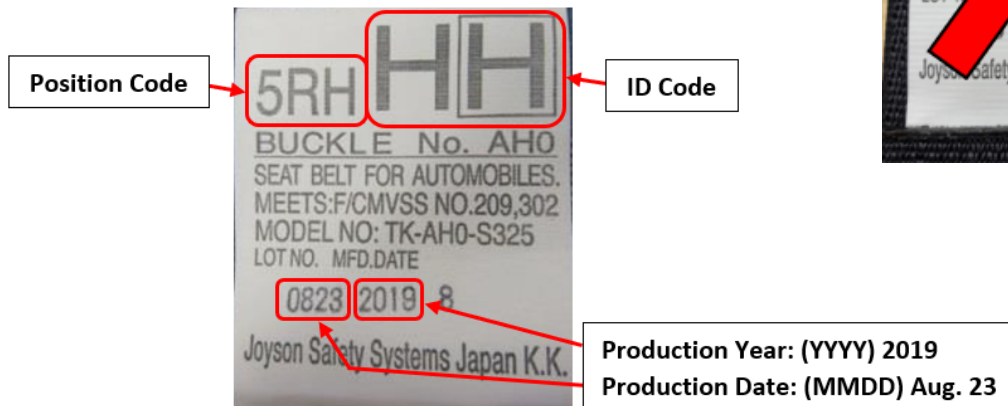
- **After seat belt removal, mark the tag with a permanent marker** as shown here to distinguish the old part from the replacement (new) part. If by chance the old parts become confused with the new parts, check the date code to identify the new seat belt assemblies using the photo below as a guide.

- Install the new outer seat belt assemblies in reverse order of removal. Confirm the new seat belt webbing is not twisted and can be pulled out and retracted smoothly.
