**WNF7 - Replace Threaded Joint of Universal Joint for Steering Column (Workshop Campaign)**

Model Line: **Taycan (Y1A)**

Model Year: **As of 2020 up to 2021**

Concerns: **Threaded joint of universal joint for steering column**

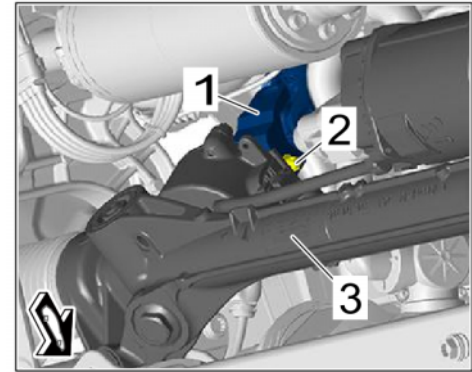
*Universal joint for steering column*

Information: **Due to a process error in production, there is a possibility that the threaded joint of the universal joint for the steering column might not comply with specifications on the affected vehicles.**

The customer may hear noise and play in the steering.

- 3 Replace threaded joint of universal joint for steering column.
  - 3.1 Unscrew screw ⇒ *Universal joint for steering column -2-*.  
However, leave steering column universal joint on the ⇒ *Universal joint for steering column -1-* power-steering gear ⇒ *Universal joint for steering column -3-*.
  - 3.2 Screw in **new** screw ⇒ *Universal joint for steering column -2-* and tighten to the specified tightening torque.

**Tightening torque 20 Nm (14.8 ftlb.) Torque angle +90°**
