## Lippert In-Wall Slide System

Submit a Pre-authorization and claim on Key Express with required photographs, **Flat Rate Code # 1214006B** with **KSB # 220630** noted in the customer complaint section. The time authorized for this repair is **5 hours**.

# REPAIR OF THE INVERTED GEAR RACK IN-WALL (SCHWINTEK) SLIDE-OUT SYSTEM

TSB Number:	146-001-2022		
Product:	Inverted Gear Rack In-Wall Slide-Out System manufactured between October 2021 and January 2022		
Date:	June 24, 2022	Labor Rate:	5.0 Hours Allowed (2.5 hours per side)

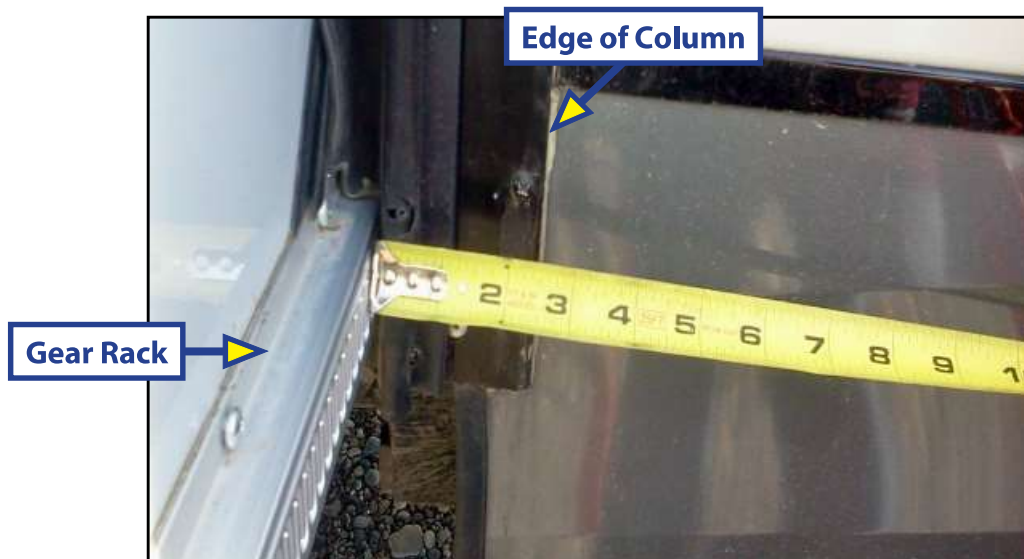
## Photos of Measurements After Completing Repair

1. Take measurements (similar to the measurement featured below) from the gear rack to the edge of the column with the tape measure pressed against the gear rack, not above or below it.
2. This measurement is best taken with the slide extended at 6 inches from the exterior of the coach and then again with the slide at full extension at all four corners for a total of eight measurements.

3. Tolerance is 2 3/8" to 2 5/8". Ideal measurement is 2 1/2".

Once system has been rebuilt and installed properly, 2 ½" (+ or – 1/8") from gear rack face to edge of column in and out on all four corners, proceed to warranty reimbursement.

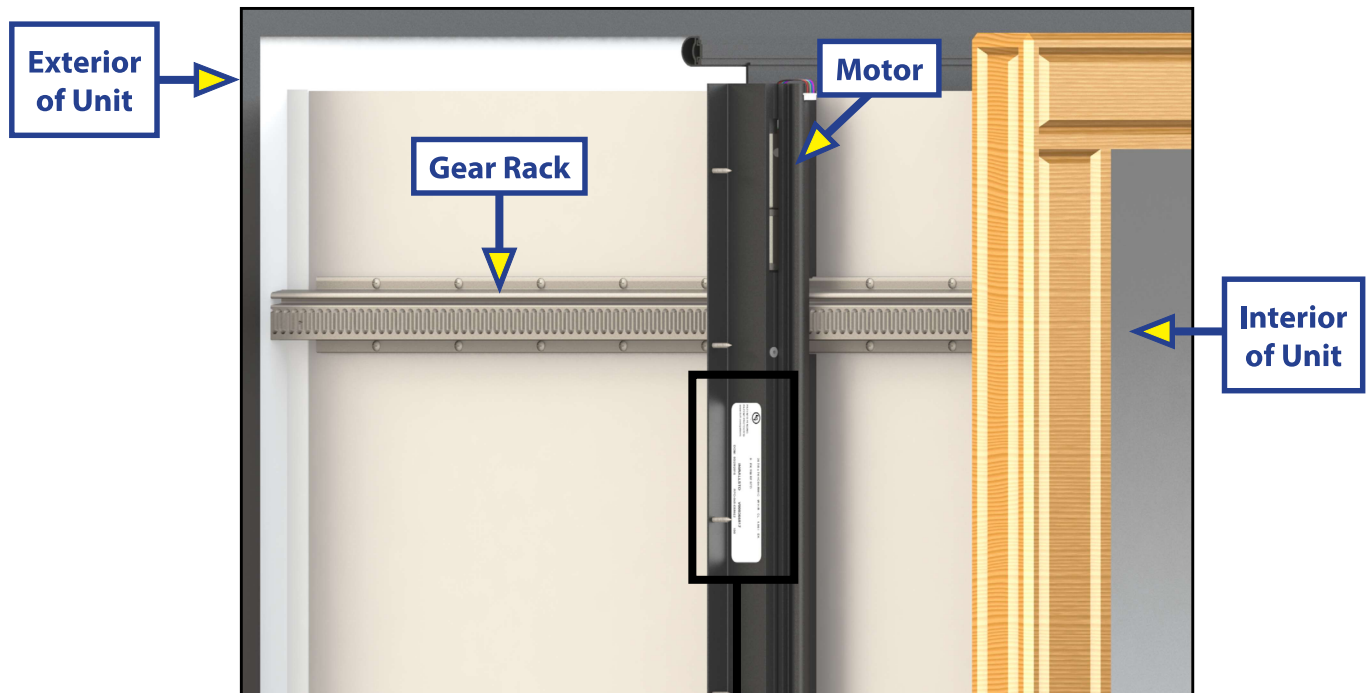
The specific inverted gear rack systems will have manufactured dates around Oct. 1, 2021, through Jan. 6, 2022. Dates are shown on the variant code tag located on the H-column. See location below.

**NOTE:** The tag featured is only a sample picture and not the actual variant code tag for the inverted gear rack slide-out.

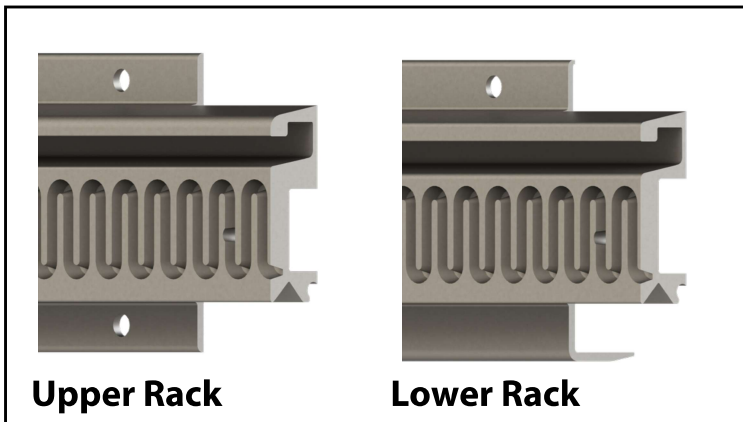
### Inverted Gear Rack

The inspection will be to validate the system as being part of the Inverted Gear Rack In-Wall Slide-Out system. The profile of the gear rack will be as shown below under the subsection "Identifying The Inverted Gear Rack In-Wall Slide-Out System."

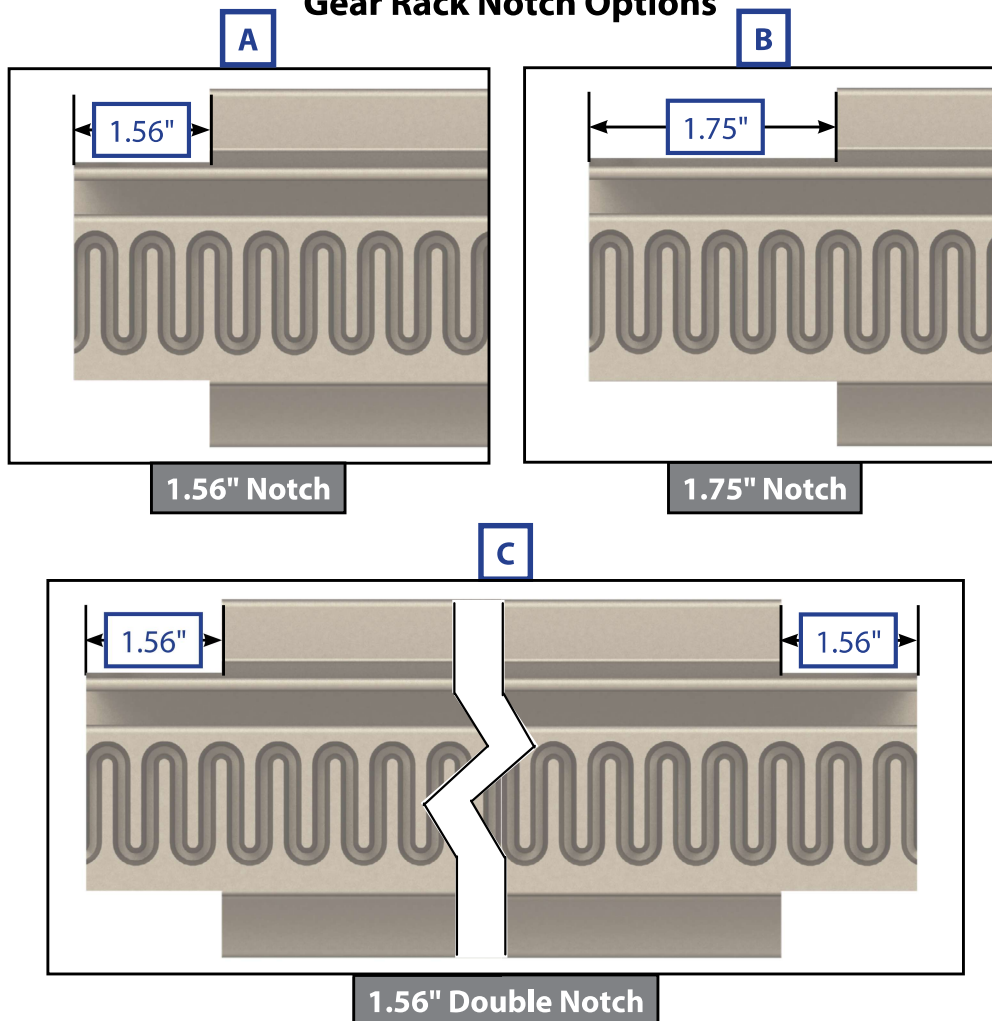
### Gear Rack Notch Options

The most common gear rack notch option is 1.56" PN 2022108946. However, using the previous gear rack images to identify the notch, order the kit number listed below.

Callout	Kit #	Description
A	<a href="#">2022108946</a>	1.56" Notch
B	<a href="#">2022108947</a>	1.75" Notch
C	<a href="#">2022108948</a>	1.56" Double Notch

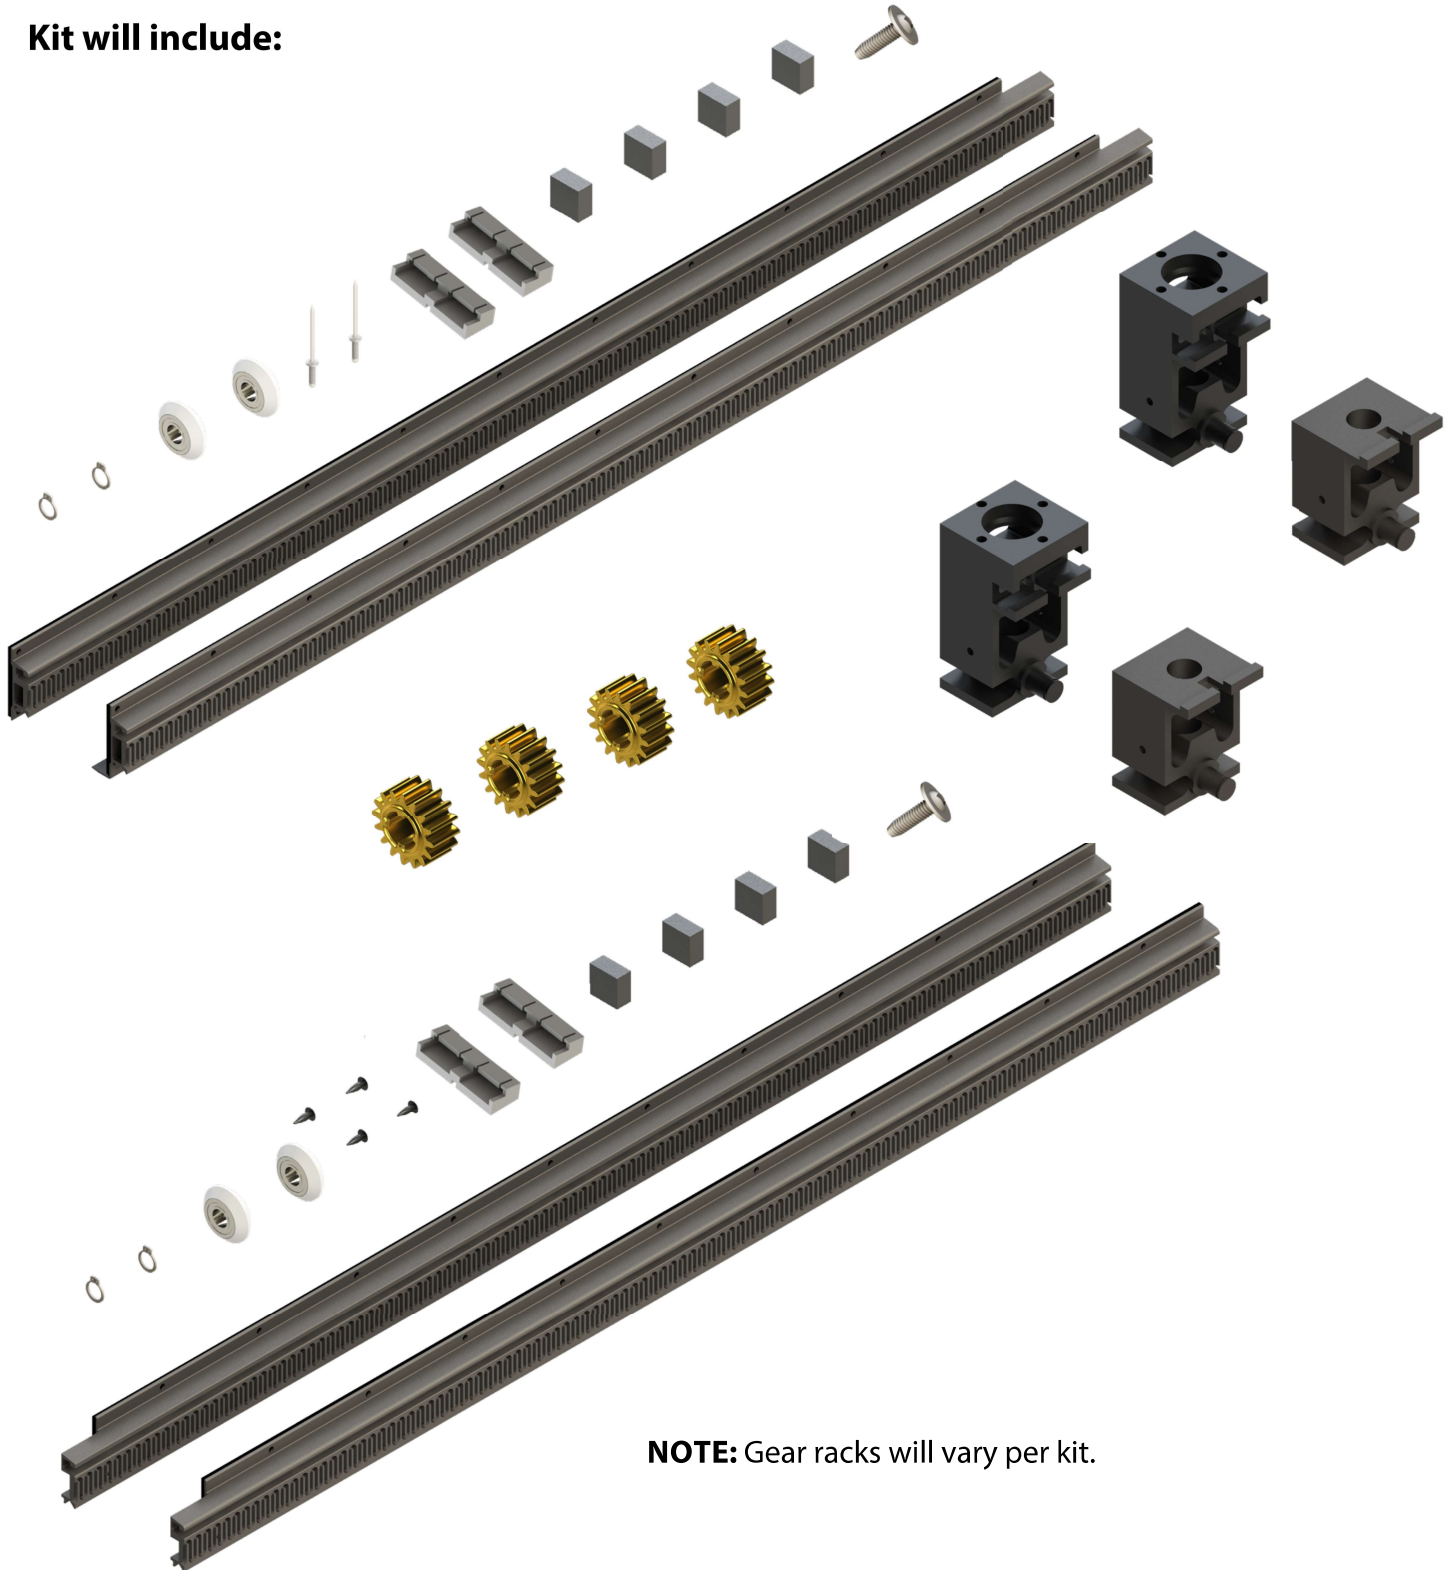
## Kit will include:

**NOTE:** Gear racks will vary per kit.

**NOTE:** The kit includes replacement parts for both the fixed and float sides of the system. It is important to replace BOTH sides and use ALL of the components when repairing units built during the October 2021 through the January 2022 timeframe.
