RCA-14-22-002-1: Improperly Routed Wheel Speed Sensor Harness

Document Type	Customer Satisfaction Campaign Bulletin
Date	June 8, 2022
Affected Region(s)	USA
Affected Model(s)	R1T
Model Year(s)	2022
Approximate Build Dates	August 2021 - November 2021

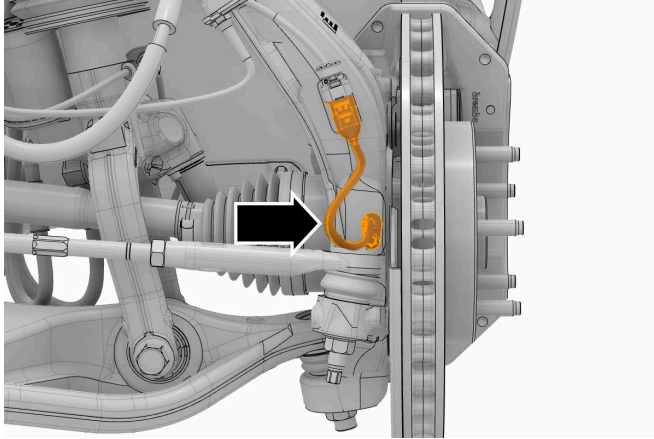
1. Raise and Support Vehicle (refer to service manual procedure 981020017).
2. LH front: Inspect the wheel speed sensor for damage. Make sure the wheel speed sensor harness is routed inward, as shown.

Note: Shown with components removed for clarity.

- If the wheel speed sensor is undamaged and the harness is routed inward, continue to the next step.
 - If the wheel speed sensor is damaged: Replace: Sensor, Wheel Speed, Front, LH (refer to service manual procedure 147010010).
 - If the wheel speed sensor harness is routed outward, perform the [Reroute Harness](#) procedure, then continue to step 3.
3. Repeat step 2 on the RH side.
 4. Reinstall all components that were removed for access and replace all non-reusable components.

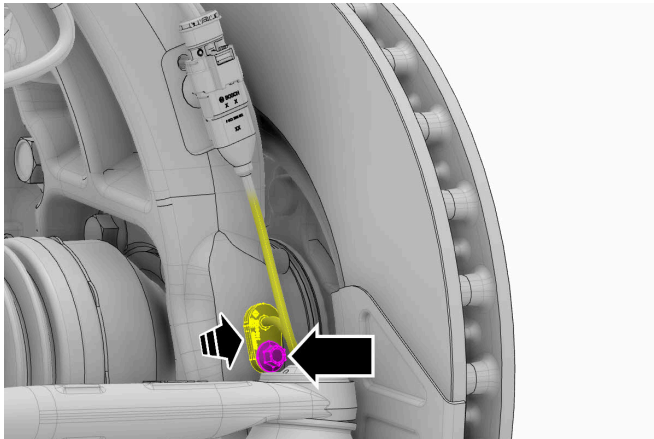
1.

Note: Shown with components removed for clarity.

2. Install the component as described in the Installation section of Service Manual procedure 147010010.
